Culvert Assessment Report

Findley Lake
Town of Mina

Chautauqua County, New York

April 2024

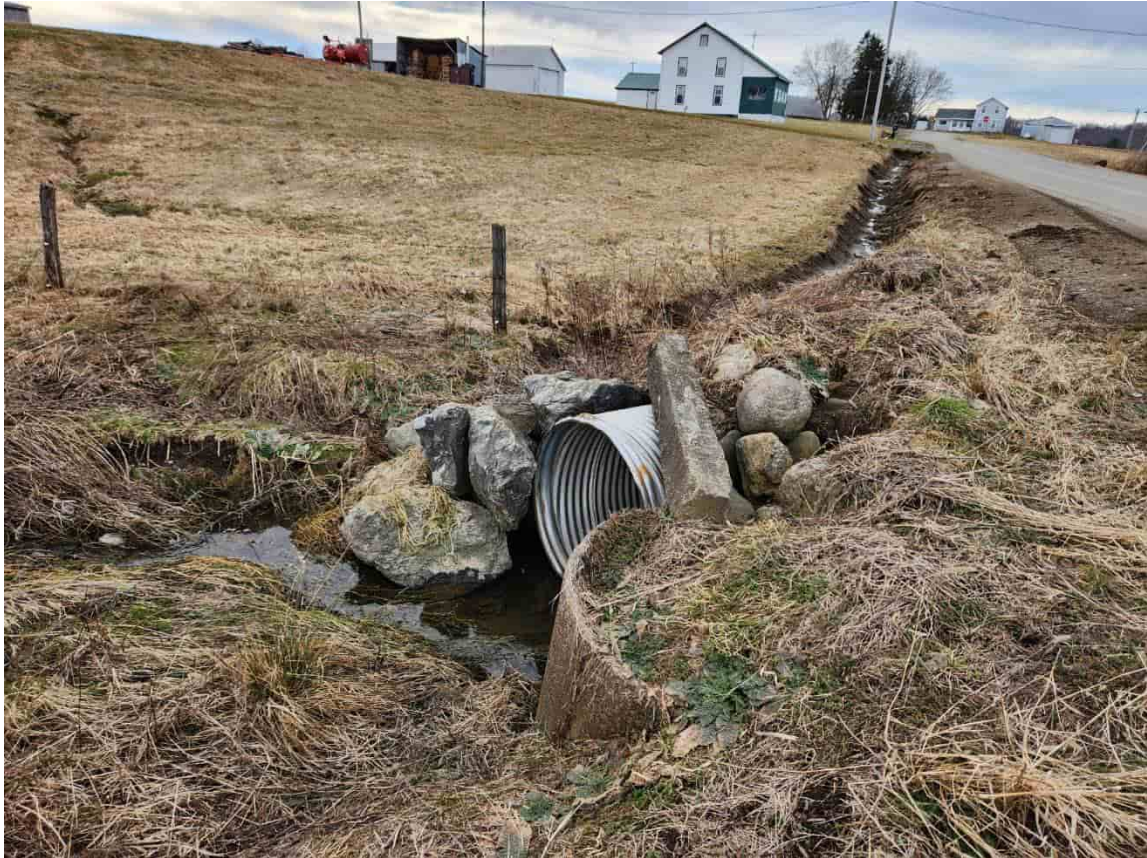
Culvert HH-3 consists of a Town of Mina owned roadway cross culvert conveying roadside drainage from the south side of Harrington Hill Rd, as well as streamflow from an unnamed tributary of Findley Lake, beneath Harrington Hill Rd. In its existing condition, culvert HH-3 consists of a 24" corrugated metal pipe (CMP) which was generally deemed as being structurally sound and in working condition; however, the culvert was initially oriented to receive inflow from the tributary stream and was not initially designed to drain multiple inflow sources with

different geometries. The result of this faulty geometry is notable scouring and erosion along the culvert end section. Additionally, the roadside drainage draining to culvert HH-3 flows down a roadway embankment with a moderate grade, resulting in additional erosion potential.

Photograph of existing culvert HH-3 configuration

These deficiencies would be most effectively mitigated by re-grading a portion of the roadway embankment and tributary floodplain areas to allow for more effective drainage of both inputs, ultimately reducing the potential for scouring and erosion. Additionally, inflow controls at the confluence of these two hydrologic inputs would reduce peak discharge rates entering the culvert. Inflow controls would likely consist of a combination of stone armoring and creation of a plunge pool or alternative velocity-reducing mechanism. To provide further protection against future erosion, the existing roadside ditch may also be retrofitted into a stone-lined channel for increased stability.

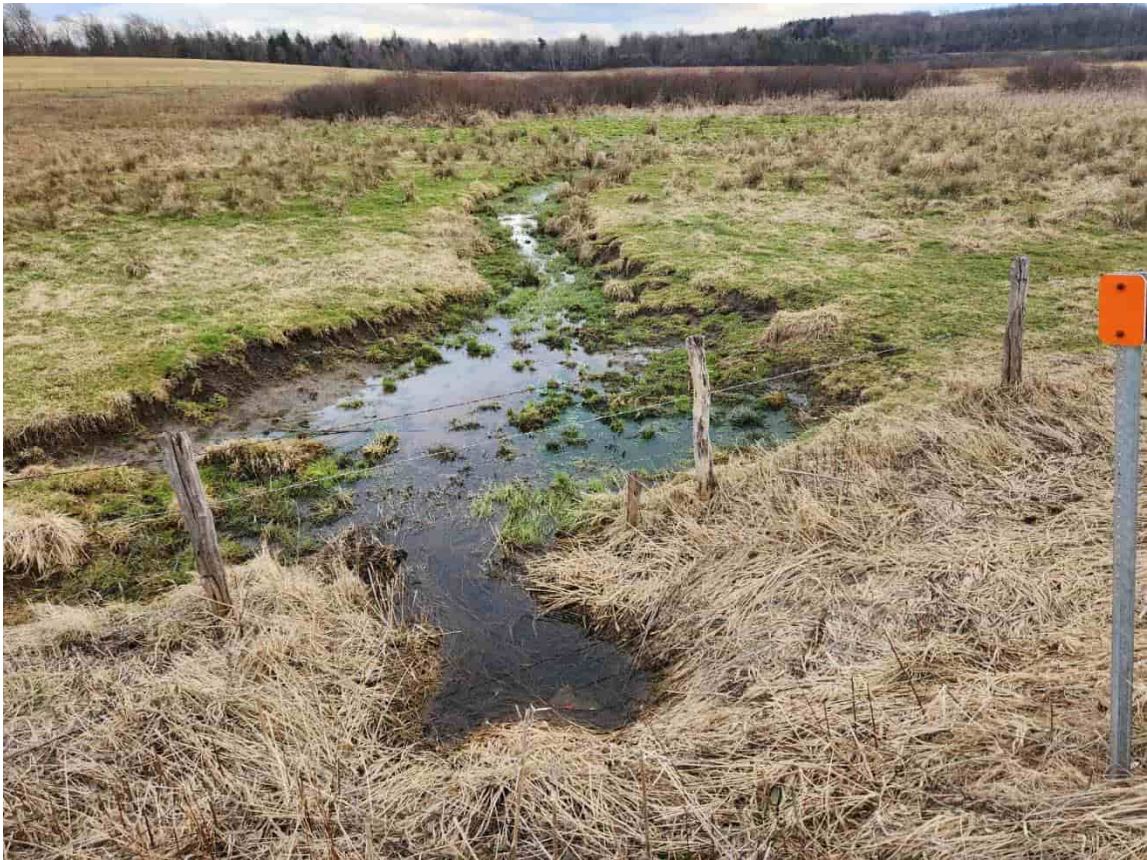
Culvert MR-3 consists of a County-owned 18-inch reinforced concrete pipe (RCP) conveying an unnamed, unmapped tributary of Findley Lake beneath Mann Road. Currently, culvert MR-3 does not have sufficient length to support the surrounding roadway and embankment on either side of the culver, resulting in subsidence of the roadway above and surrounding embankment.

In addition to adequate end section length, the areas immediately upstream of the culvert exhibit little to no downgradient slope, resulting in frequent ponding within these upstream reaches due to a lack of positive drainage.

Photograph of existing conditions and lack of positive drainage upstream of culvert MR-3

To mitigate these existing deficiencies, it is recommended that the existing culvert pipe be extended on both the upstream and downstream ends of the culvert, and that additional fill or stone armoring be brought in to supplement the existing embankment and provide greater stability to the roadway surface, especially during periods of intense stormflows. In addition to culvert extension and embankment protection, it is recommended that the areas immediately upstream of the culvert be evaluated for grading modifications which may increase the slope of the contributing channel, promoting positive drainage while reducing the likelihood and frequency of localized flooding of the areas surrounding the channel, and also enhancing the structural integrity of the channel.

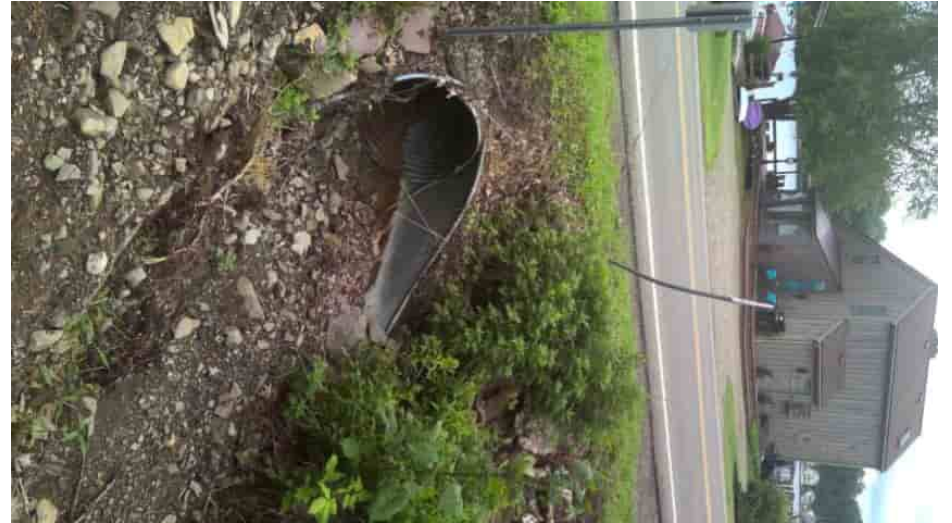
Inspection Notes: weight/pressure of road is pushing down on pipe
erosion directly upstream of pipe
direct discharge to lake, cannot view outlet

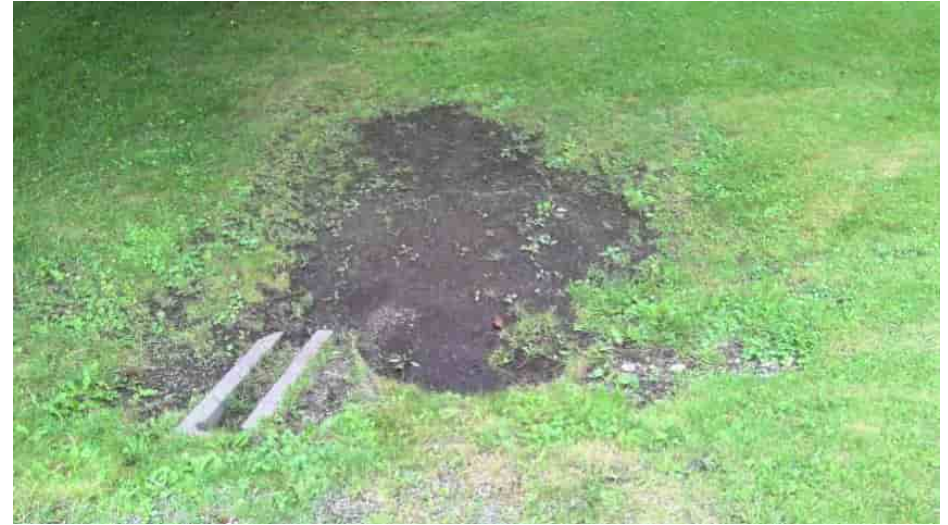
Inspection Notes: dense vegetation growth at inlet, erosion and deposition issues at outlet

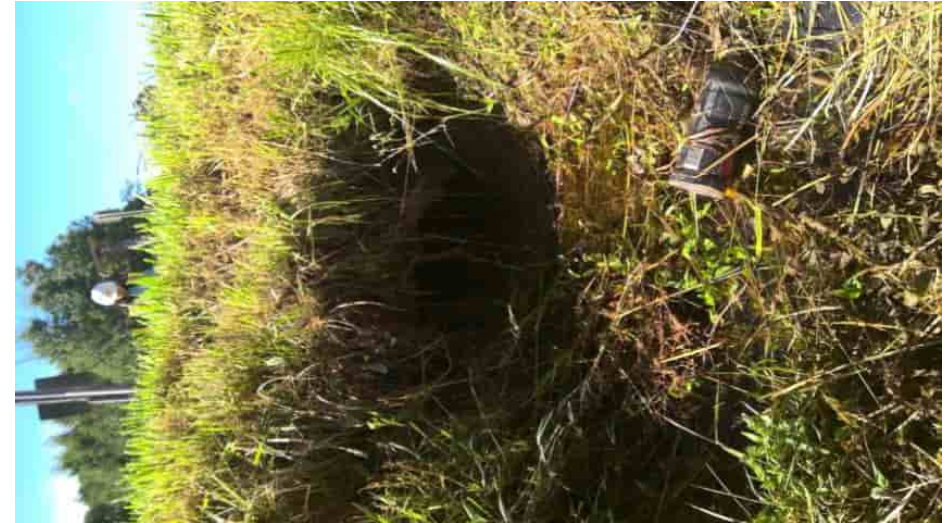
Inspection Notes: outlet mis-shaped

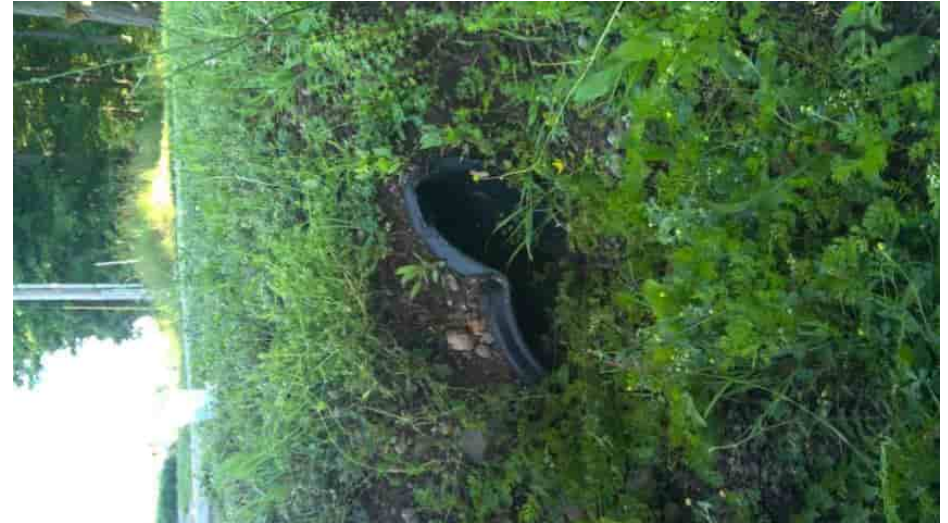
Inspection Notes: inlet in bad shape, pipe crushed

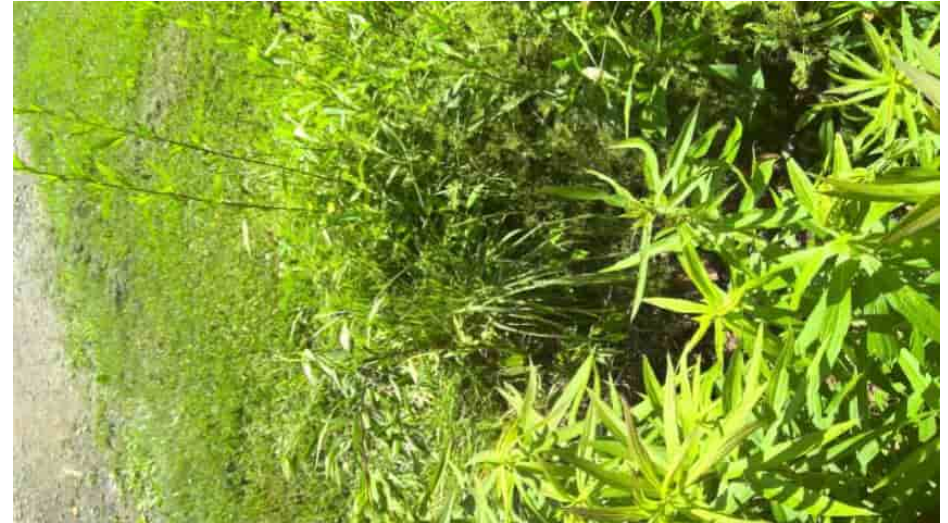
Inspection Notes: clear vegetation around inlet and outlet, clean out sediment in the pipe to allow more water flow, outlet is buried

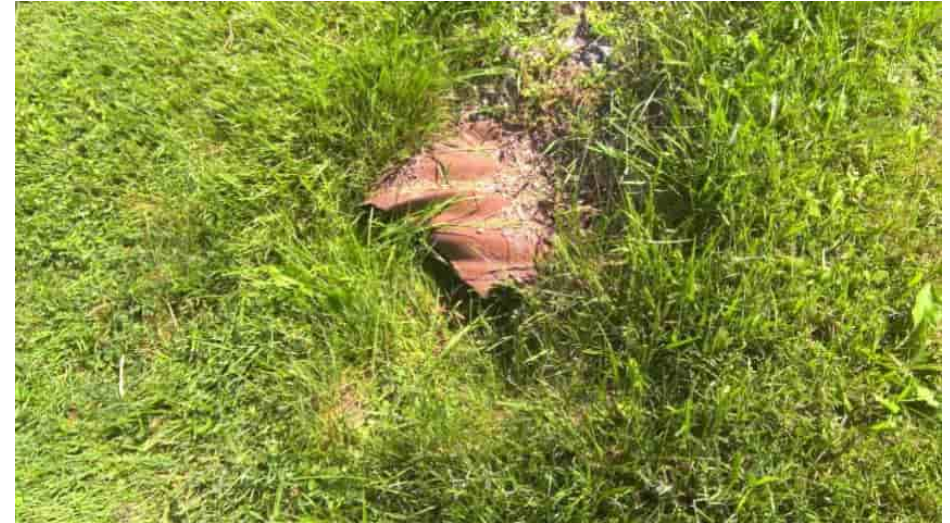
Inspection Notes: flattened, full of sediment poor condition

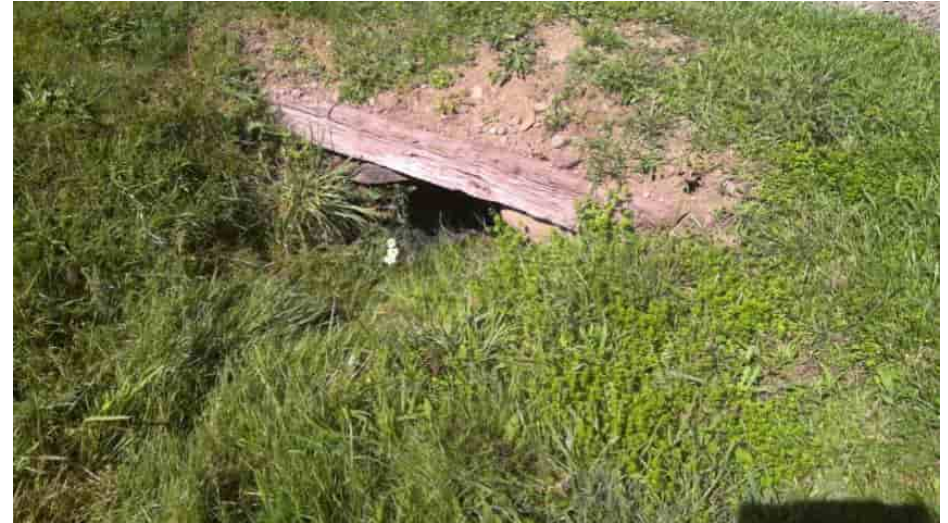
Inspection Notes: outlet eroded, headwall damaged

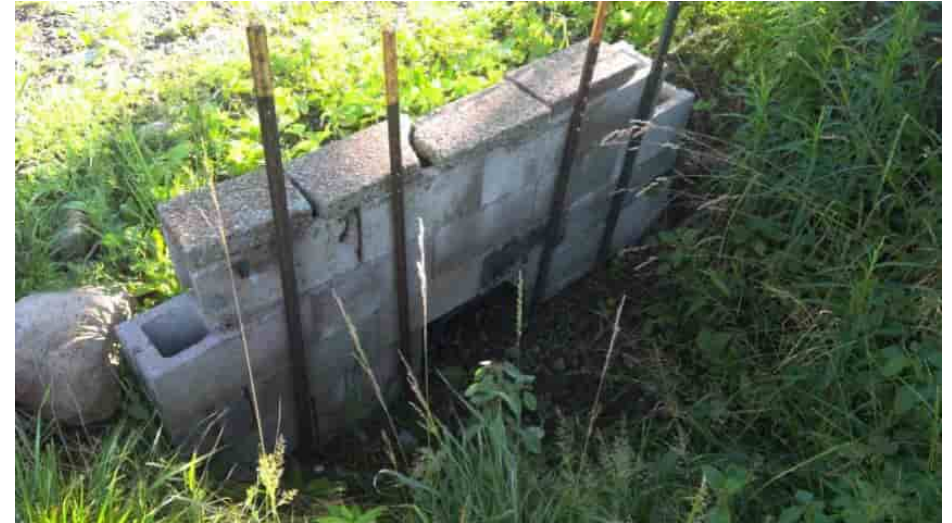
Inspection Notes: headwall crushing pipe a bit

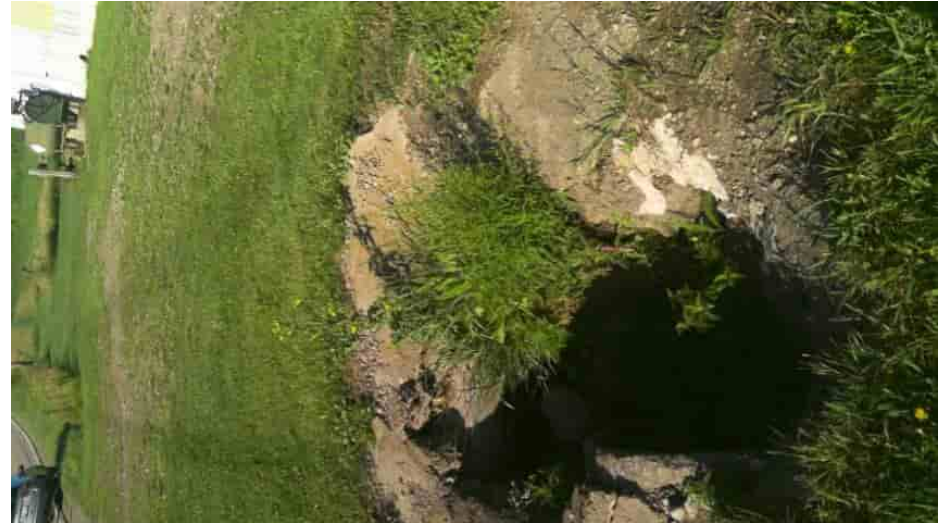
Inspection Notes: extreme erosion at outlet

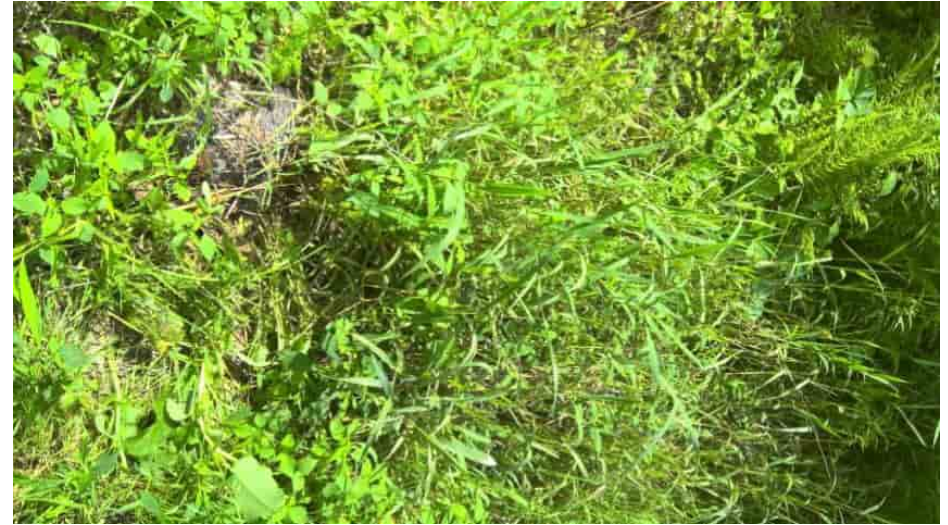
Inspection Notes: leaf litter debris clogging inlet, clean inlet
50-75 embedded outlet

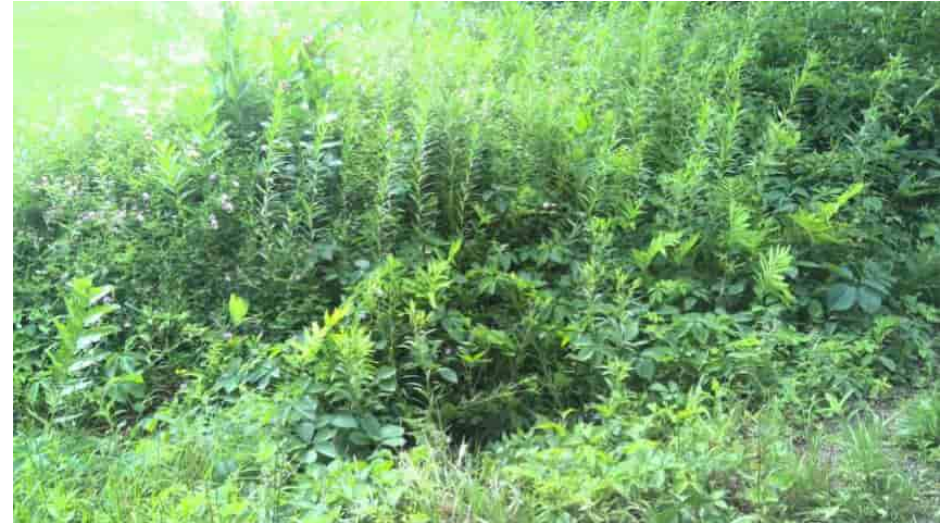
Inspection Notes: Minor debris accumulation at inlet; lots of vegetation; outlet pipe snapped off but still functioning
