Culvert Assessment Report

Findley Lake
Town of Mina

Chautauqua County, New York

April 2024

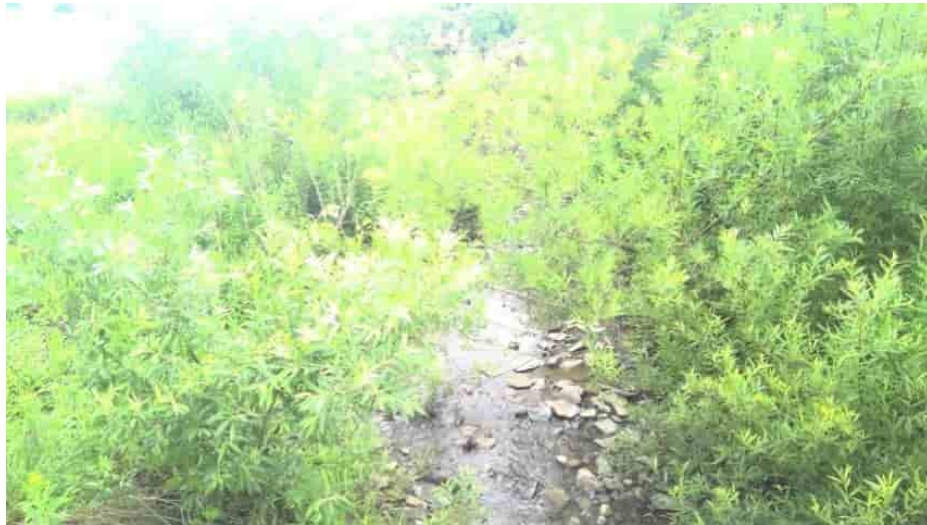
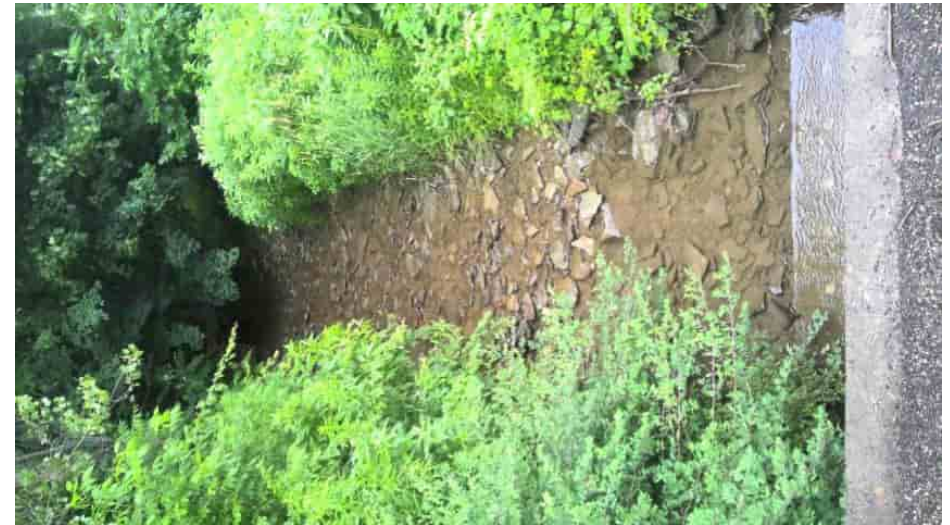
Inspection Notes: 14'W x 5'H
 Concrete box culvert
 State ID 2588
 Possible stream restoration
 bank erosion present downstream

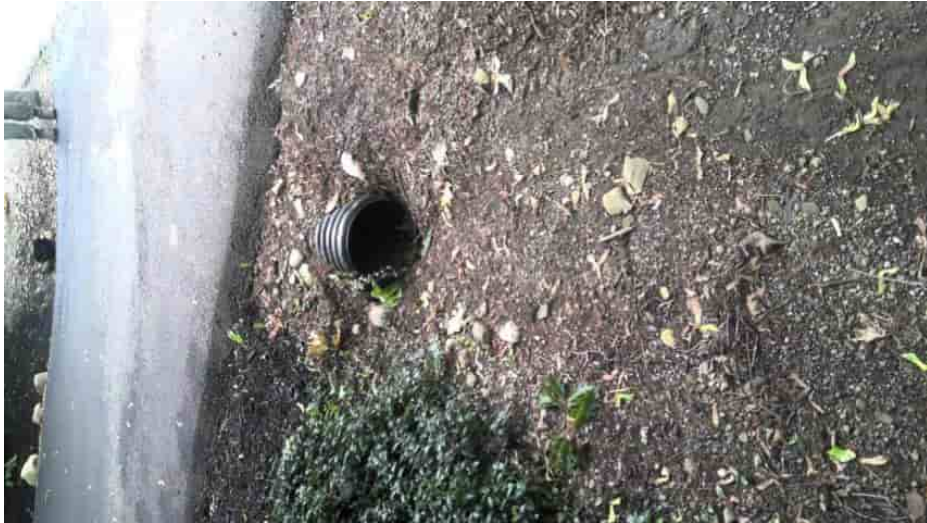
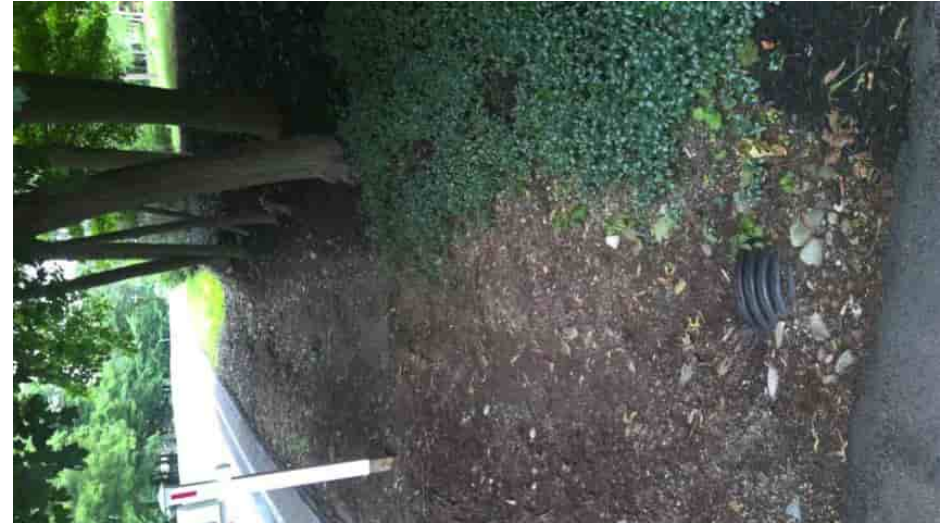
Inspection Notes: bare channel upstream of culvert, possibility of mulch washing in

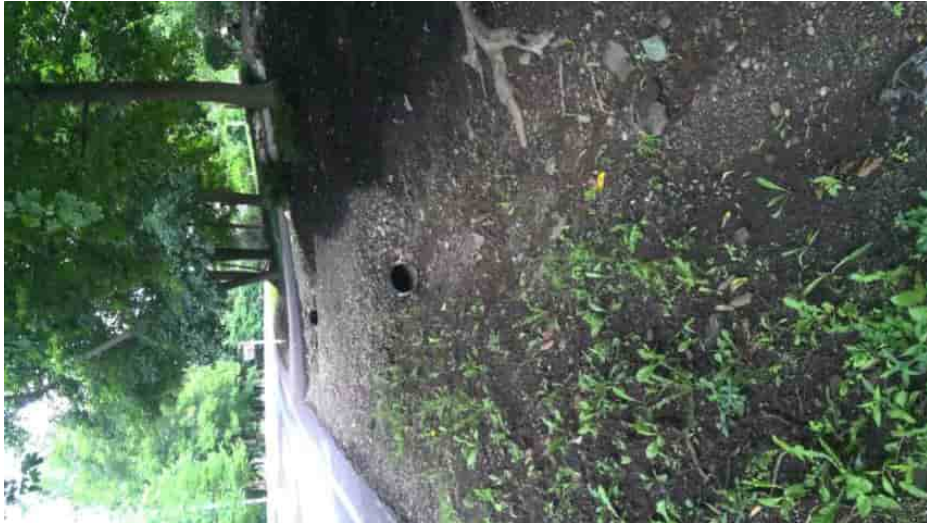
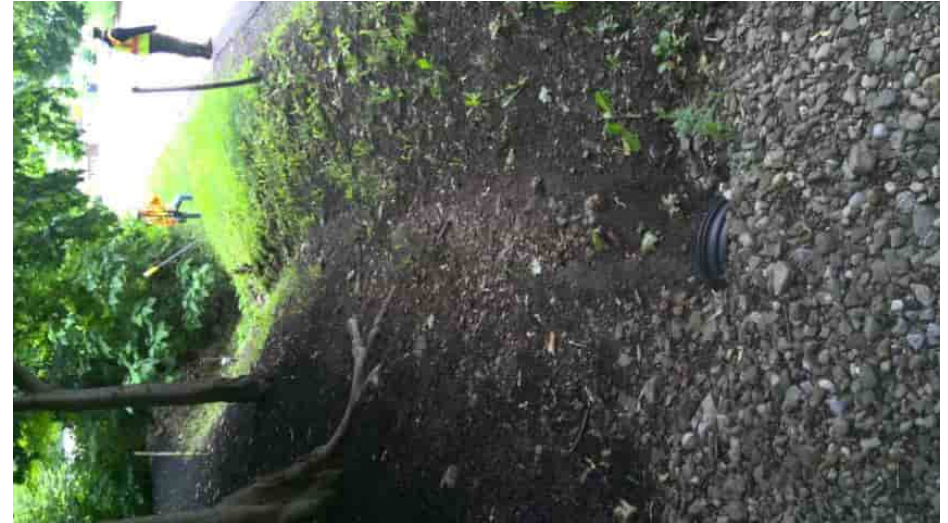
Inspection Notes: some potential erosion downstream of outlet

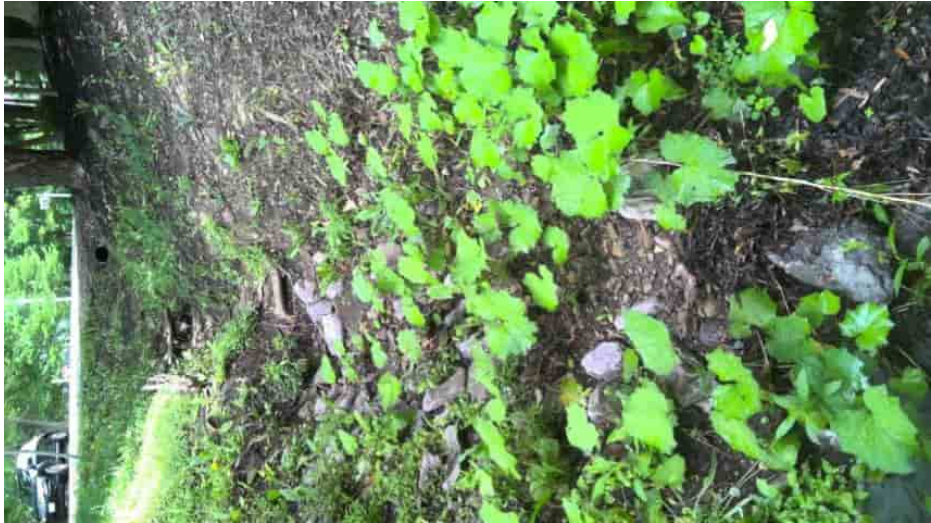
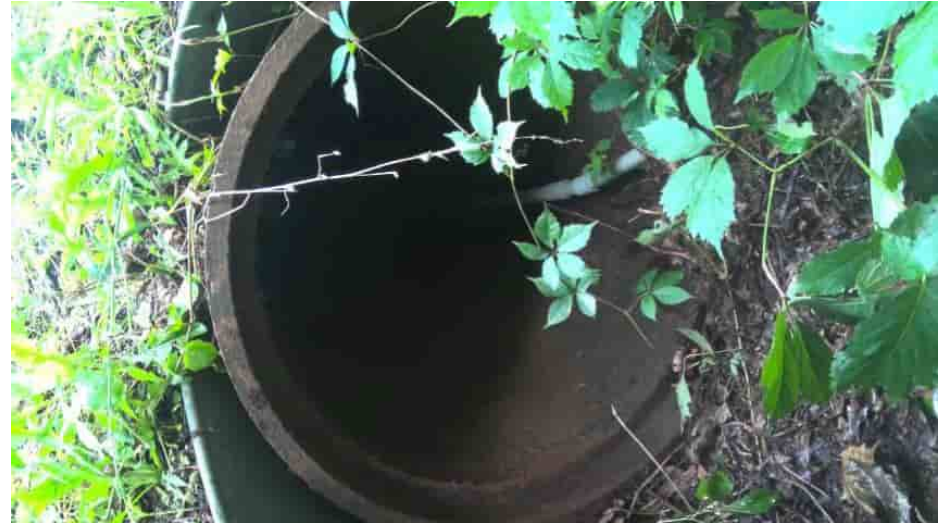
Inspection Notes: orangeburg/clay material; some erosion upstream; one-inch pipe in culvert, possibly from household; erodibility dst unknown state ID 426.5201.1097

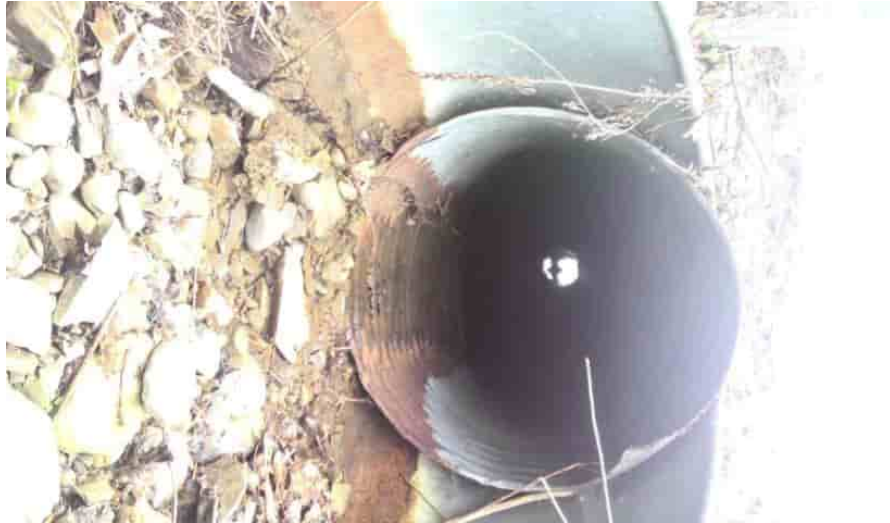
Inspection Notes: weight/pressure of road is pushing down on pipe
erosion directly upstream of pipe
direct discharge to lake, cannot view outlet

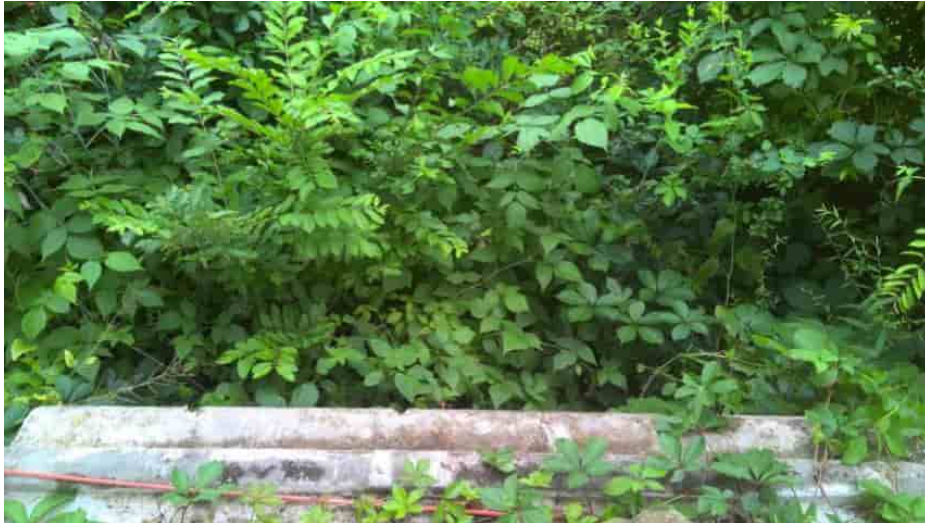
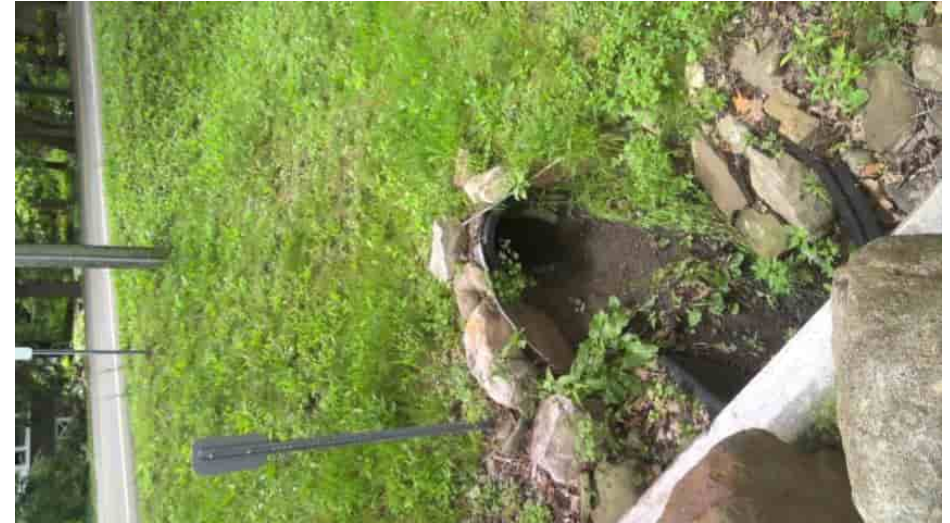
Inspection Notes: heavy vegetated downstream, outlet not visible one inch pipe going through

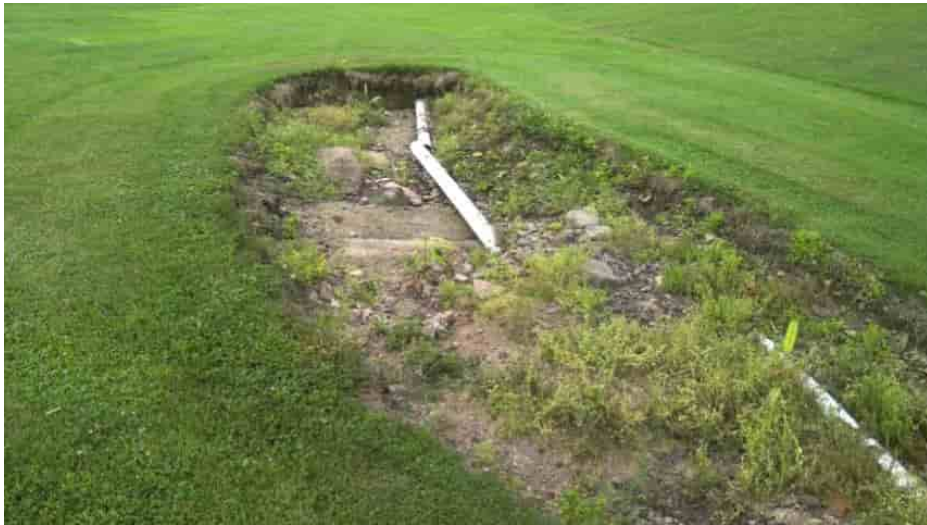
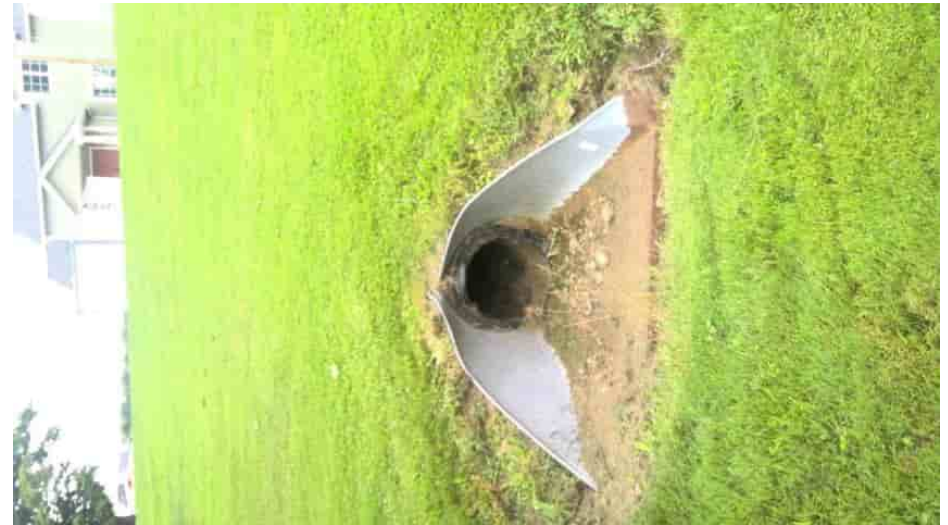
Inspection Notes: Grass clippings entering culvert; erosion a few feet upstream of inlet; can't view outlet

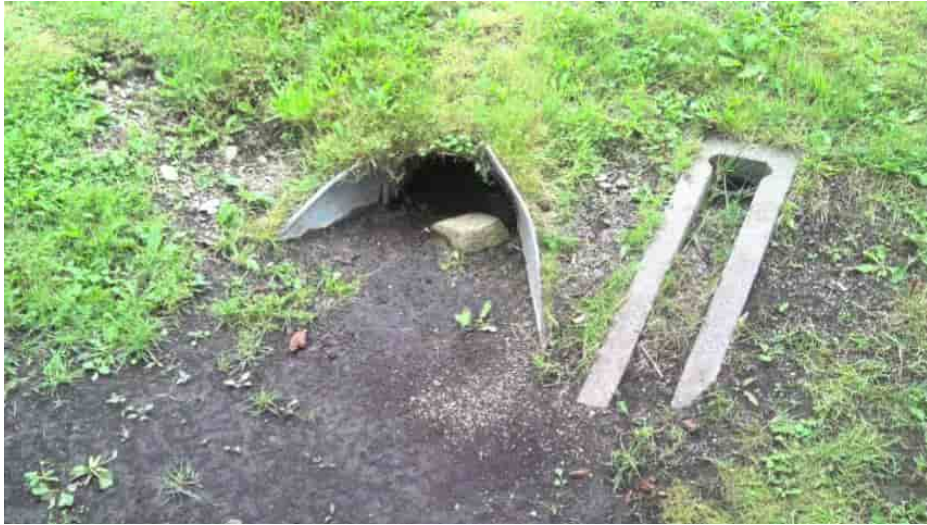
Inspection Notes: dense vegetation growth at inlet, erosion and deposition issues at outlet

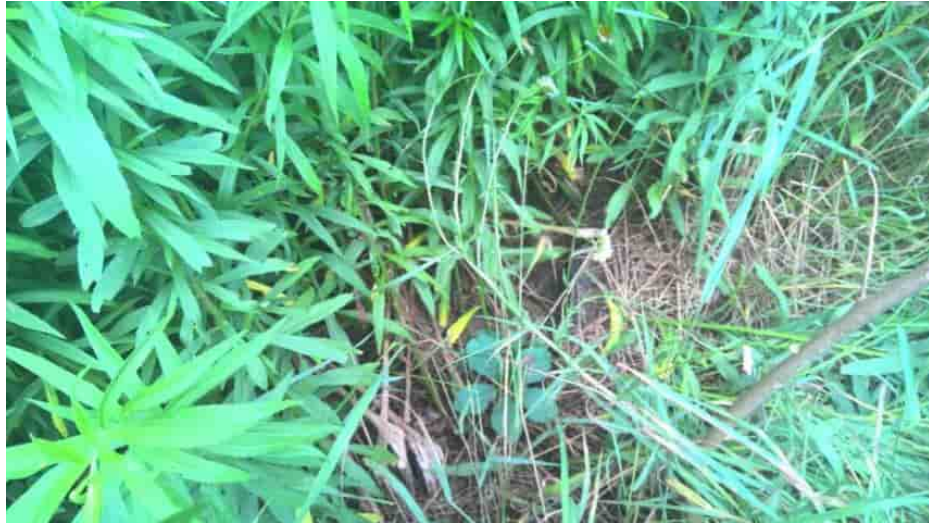
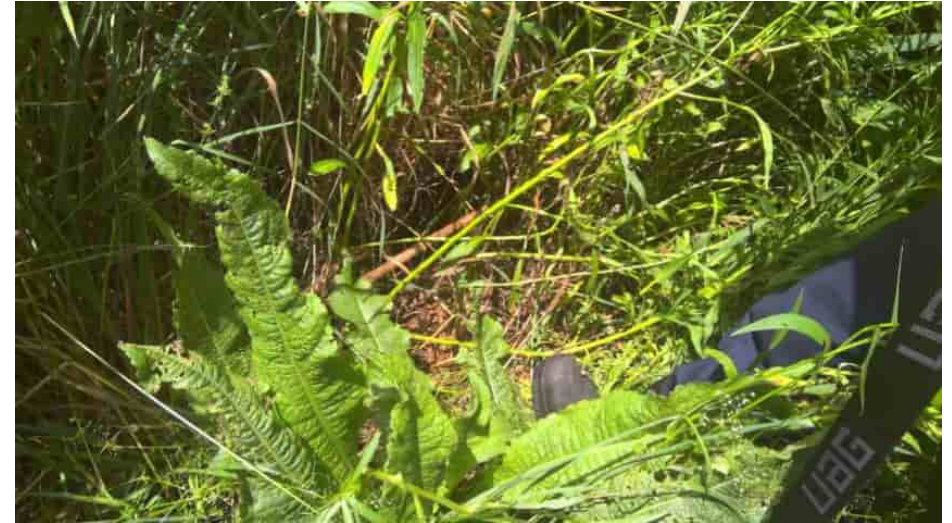
Vegetation:	Excessive	Outlet Protection?	<input type="checkbox"/>
Condition:	3- Severe	Outlet Protection Type:	
Embedded?	0-25%	Inlet Protection?	<input type="checkbox"/>
Headwall Condition:		Inlet Protection Type:	
		Maintenance Recommended?	<input checked="" type="checkbox"/>

Inspection Notes: No GPS coordinate, very heavily vegetated, clear some sediment and organic matter from culvert

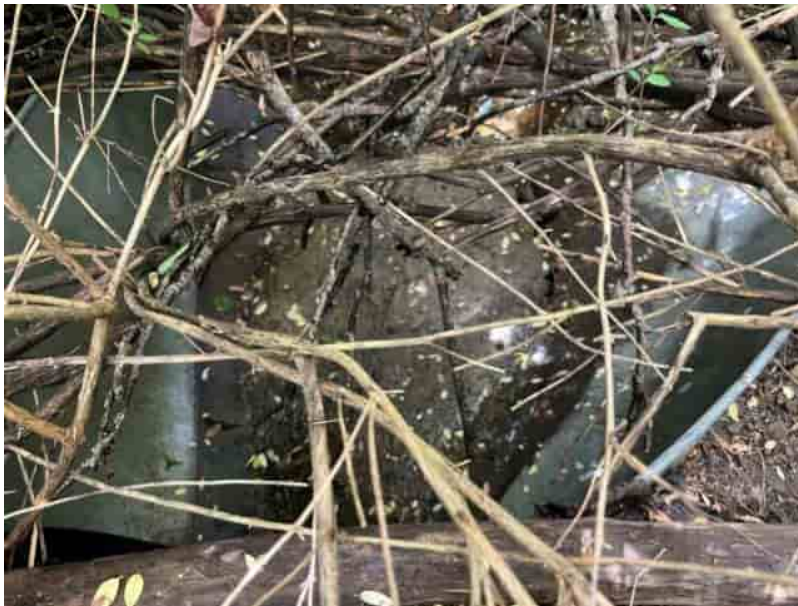
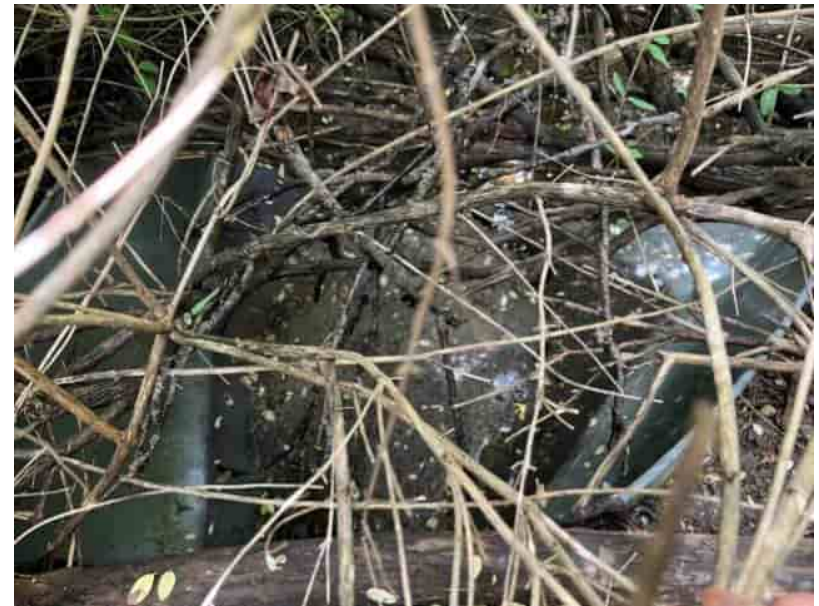
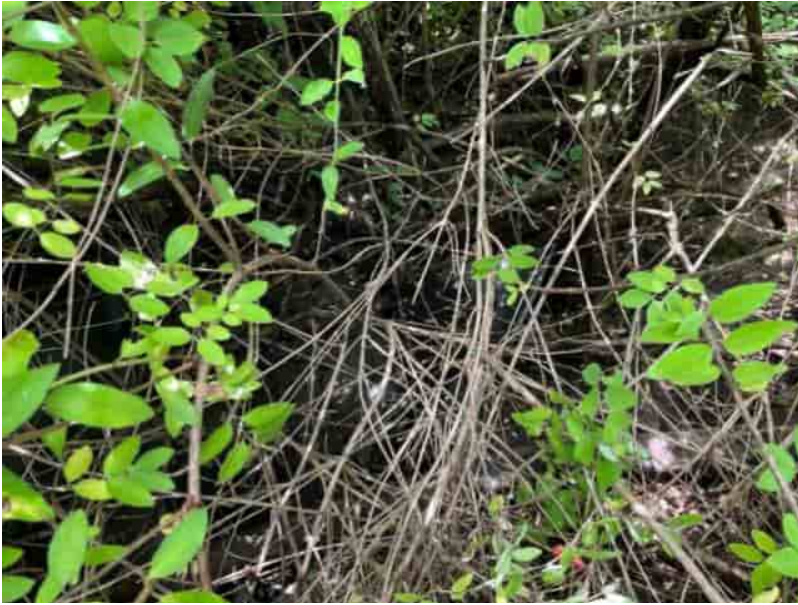
Inspection #: 22 **Date:** 7/13/2023
Culvert ID: 426-11 **Time:** 2:22:32 PM
Inspector: AC

Inspection Notes: very heavily vegetated, unable to locate inlet

Vegetation:	Excessive	Outlet Protection?	<input checked="" type="checkbox"/>
Condition:	2- Poor	Outlet Protection Type:	Concrete
Embedded?	0-25%	Inlet Protection?	<input type="checkbox"/>
Headwall Condition:		Inlet Protection Type:	
		Maintenance Recommended?	<input type="checkbox"/>

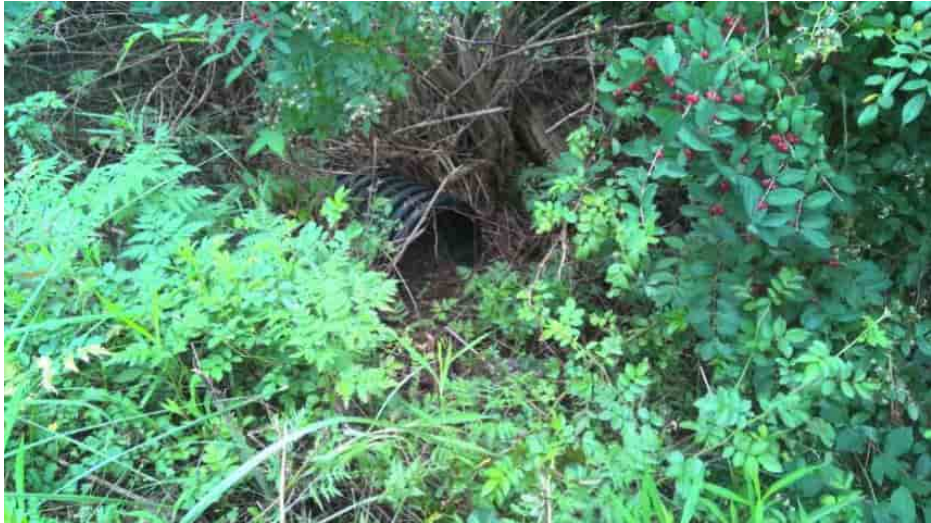
Inspection #: 23 **Date:** 7/13/2023
Culvert ID: 426-12 **Time:** 2:32:12 PM
Inspector: AC

Road:	NY-426	Corrugated?	<input checked="" type="checkbox"/>	Vegetation:	Excessive	Outlet Protection?	<input type="checkbox"/>
Shape:	Round	Smooth Interior?	<input checked="" type="checkbox"/>	Condition:	2- Poor	Outlet Protection Type:	
Size:	12	Driveway?	<input checked="" type="checkbox"/>	Embedded?	0-25%	Inlet Protection?	<input type="checkbox"/>
Material:	IDPE/PVC/Plastic	Headwall?	<input type="checkbox"/>	Headwall Condition:		Inlet Protection Type:	
Erodibility Rating:	2- Minor	Culvert Protruding?	<input checked="" type="checkbox"/>			Maintenance Recommended?	<input type="checkbox"/>
Inspection Notes:	outlet N of driveway, unable to find inlet

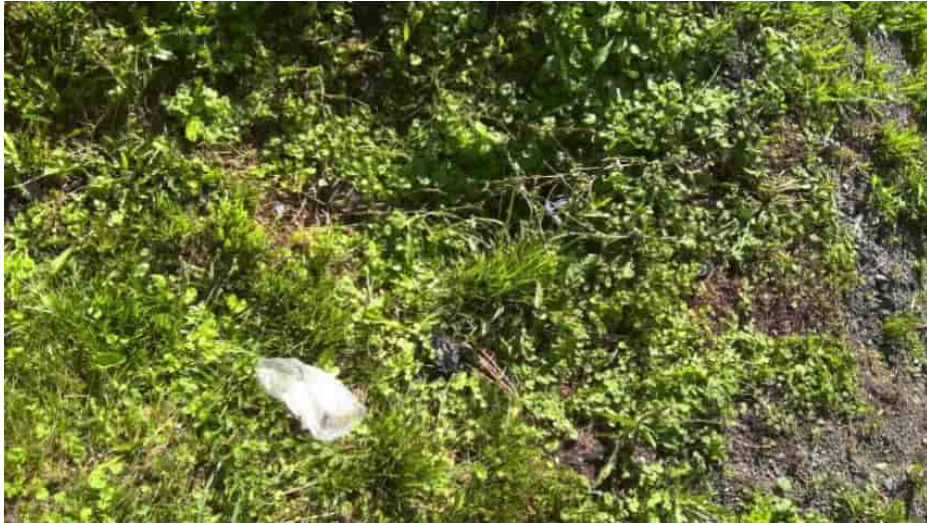
Inspection Notes: inlet protection, angled culvert extrusion
outlet embedded

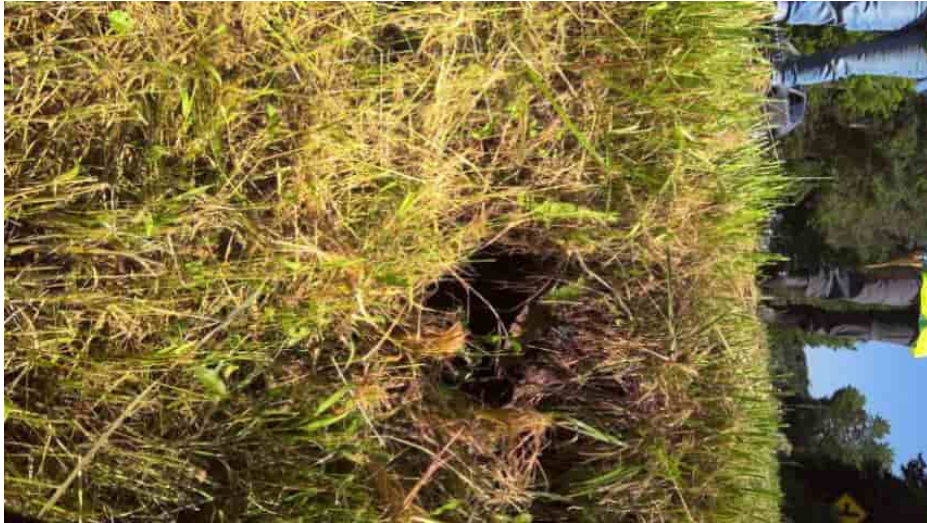
Vegetation:	Minor	Outlet Protection?	<input type="checkbox"/>
Condition:	2- Poor	Outlet Protection Type:	
Embedded?	0-25%	Inlet Protection?	<input type="checkbox"/>
Headwall Condition:		Inlet Protection Type:	
		Maintenance Recommended?	<input checked="" type="checkbox"/>

Inspection Notes: outlet mis-shaped

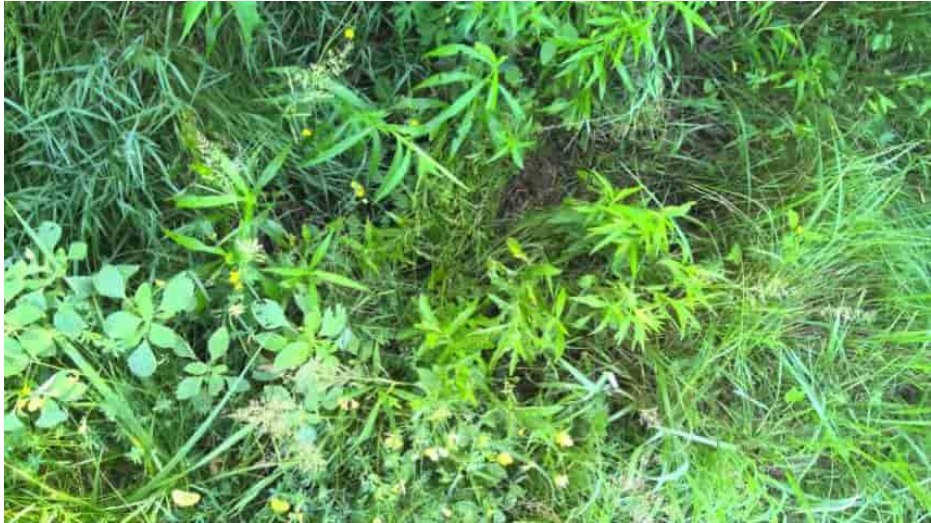
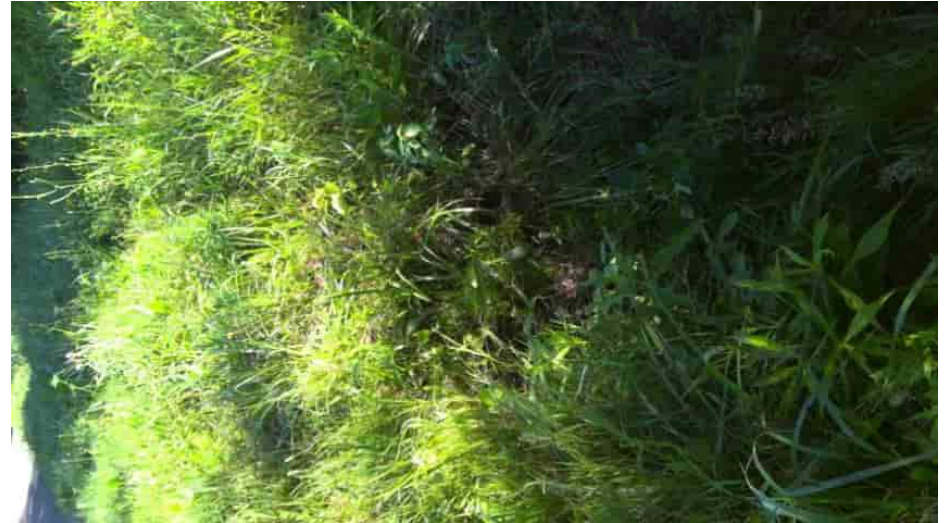
Vegetation:	Excessive	Outlet Protection?	<input type="checkbox"/>
Condition:	3- Severe	Outlet Protection Type:	
Embedded?	75-100%	Inlet Protection?	<input type="checkbox"/>
Headwall Condition:		Inlet Protection Type:	
		Maintenance Recommended?	<input type="checkbox"/>

Inspection Notes: cannot find outlet

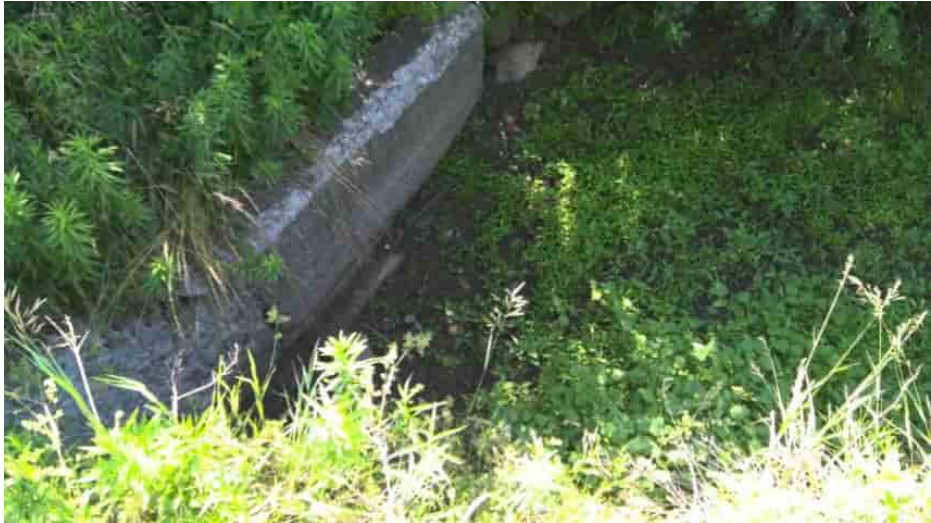
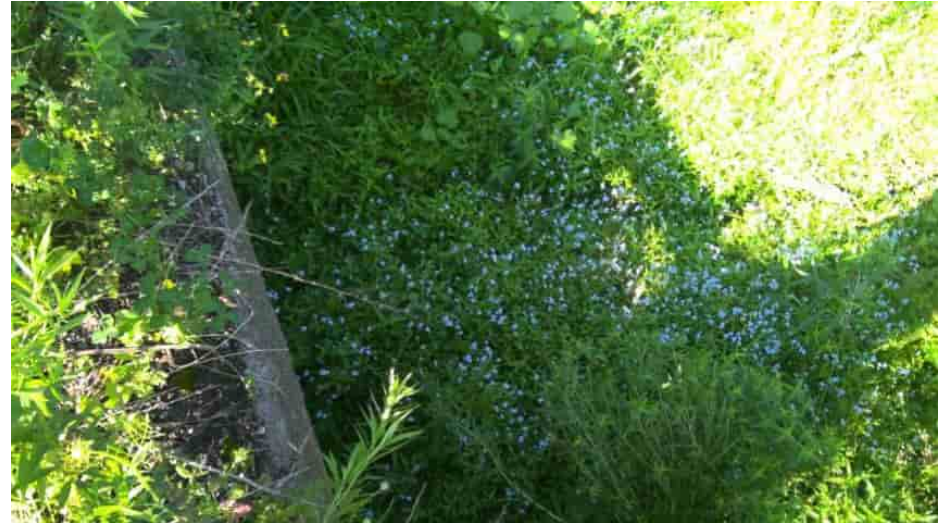
Vegetation:	Excessive	Outlet Protection?	<input type="checkbox"/>
Condition:	1- Good/Fair	Outlet Protection Type:	
Embedded?	0-25%	Inlet Protection?	<input type="checkbox"/>
Headwall Condition:	2- Poor	Inlet Protection Type:	
		Maintenance Recommended?	<input type="checkbox"/>

Inspection Notes: 4ft heightt /48 in
126 in diameter
minor erosion at outlet

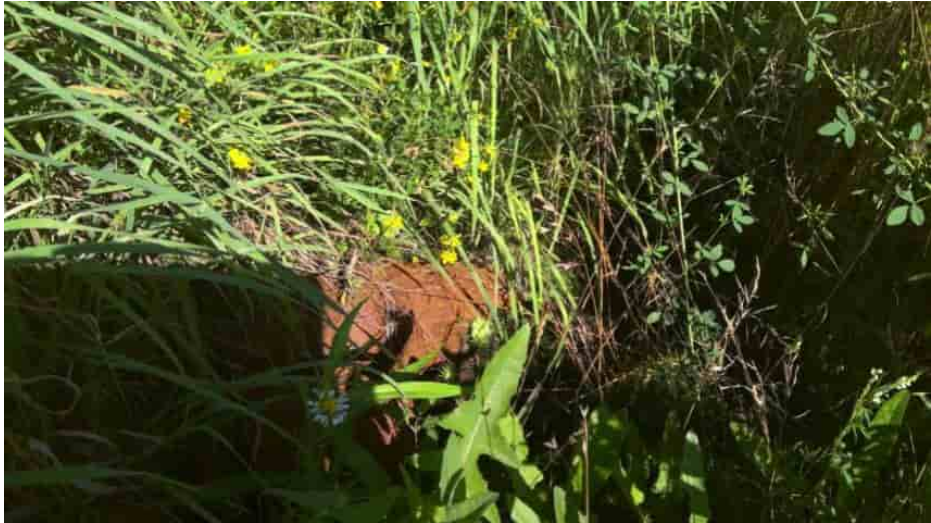
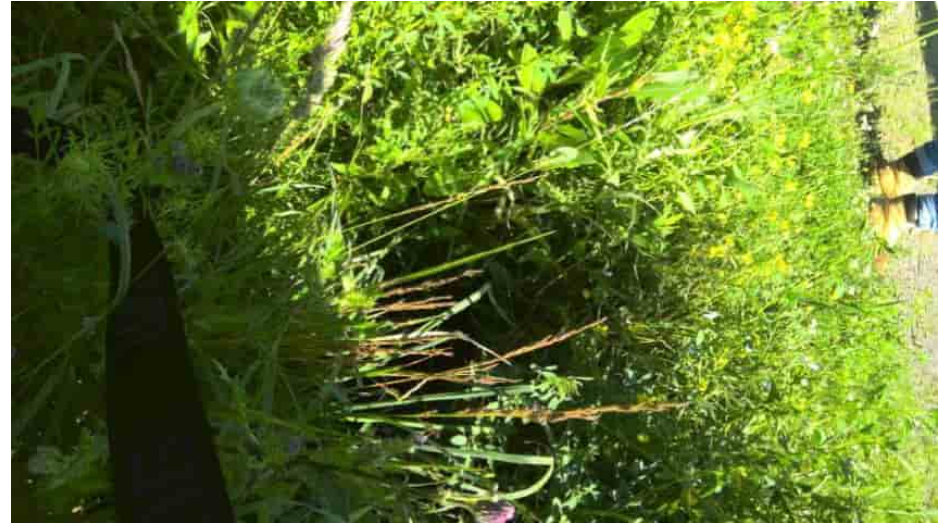
Vegetation:	Excessive	Outlet Protection?	<input type="checkbox"/>	
Condition:	1- Good/Fair	Outlet Protection Type:		
Embedded?	0-25%	Inlet Protection?	<input type="checkbox"/>	
Headwall Condition:		Inlet Protection Type:		
			Maintenance Recommended?	<input checked="" type="checkbox"/>

Inspection Notes: clear vegetation around culvert

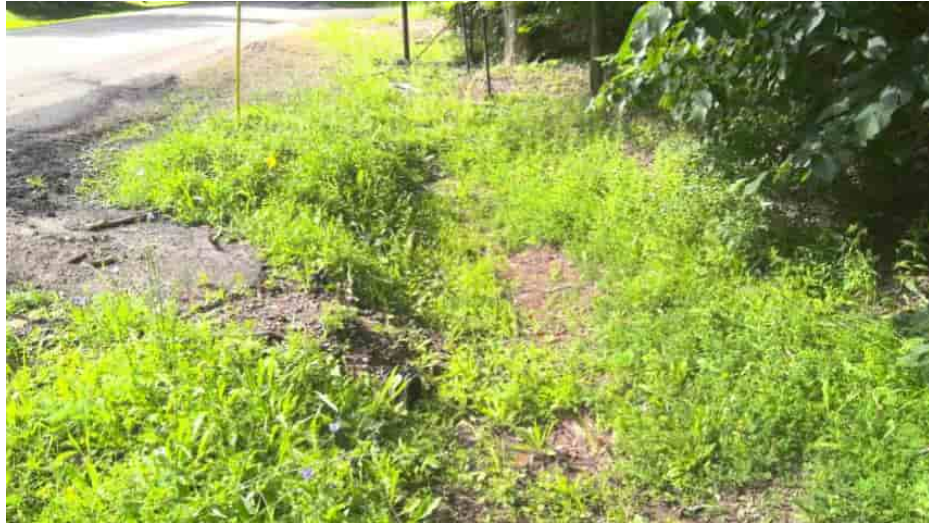
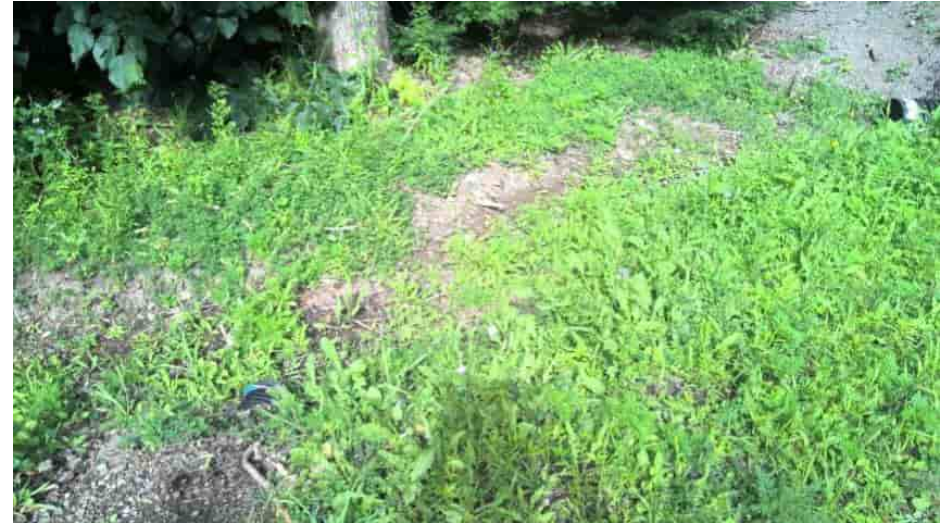
Inspection Notes: minor erosion at inlet

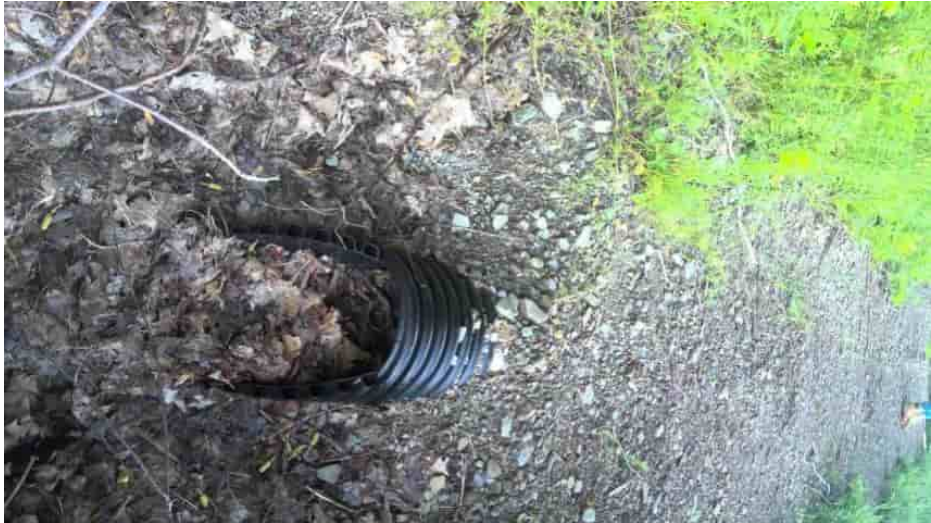
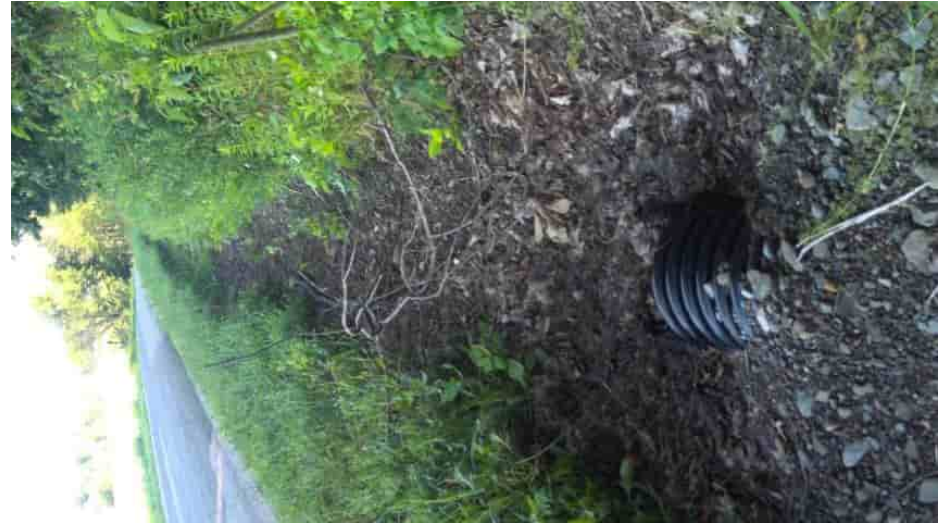
Inspection Notes: pagravel and extruding part of the cluvert for the inlet protectin
leaf debris in outlet

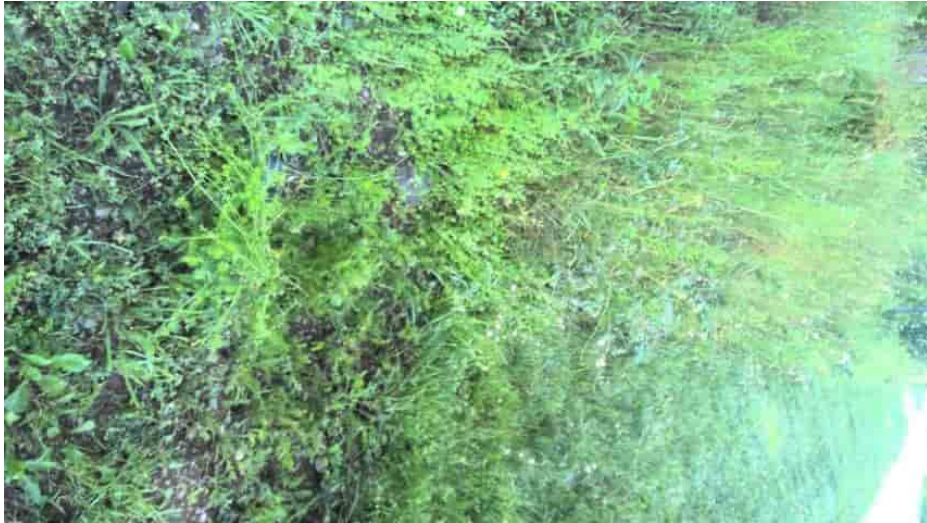
Inspection Notes: inlet in bad shape, pipe crushed

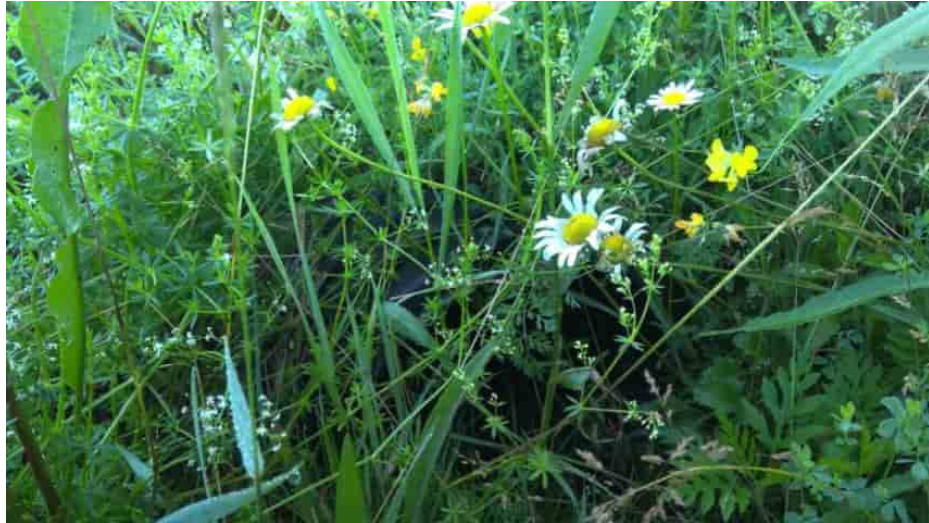
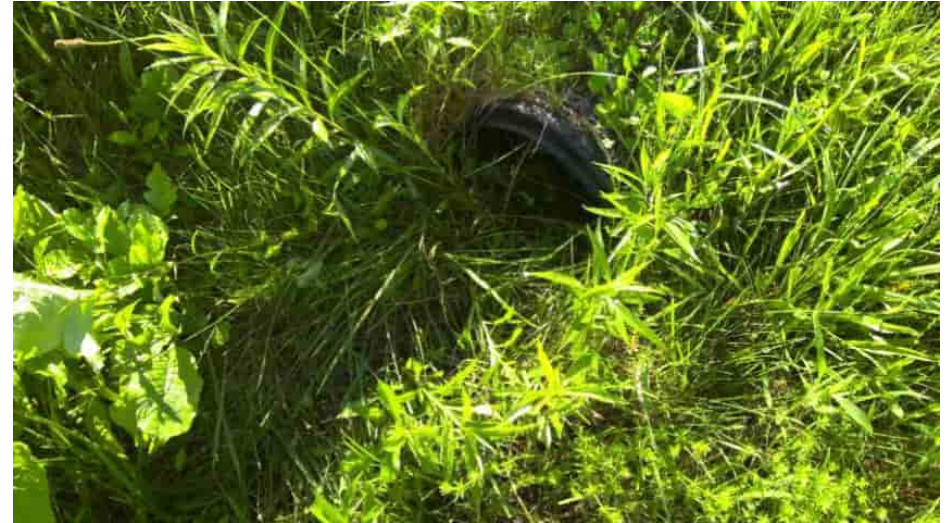
Vegetation:	Minor	Outlet Protection?	<input type="checkbox"/>
Condition:		Outlet Protection Type:	
Embedded?	25-50%	Inlet Protection?	<input type="checkbox"/>
Headwall Condition:		Inlet Protection Type:	
		Maintenance Recommended?	<input type="checkbox"/>

Inspection Notes: driveway culvert on Ball Diamond Road, vegetated

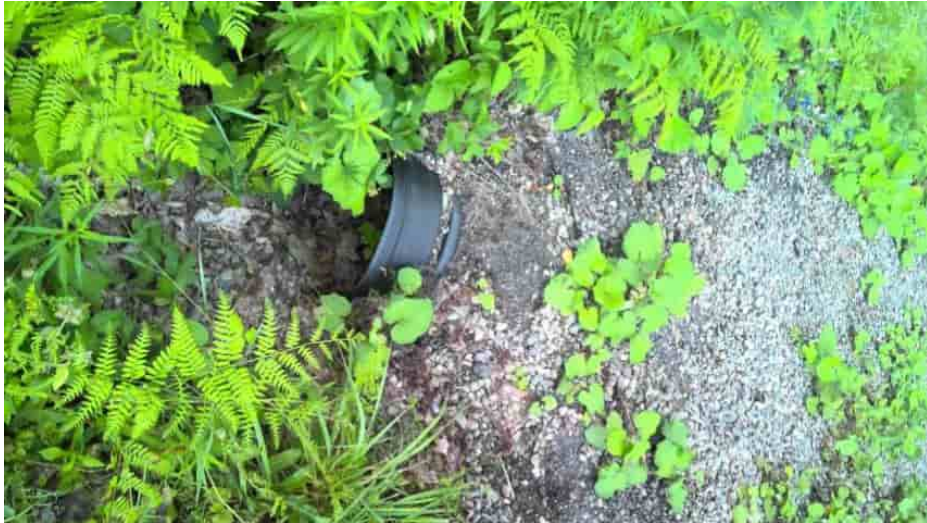
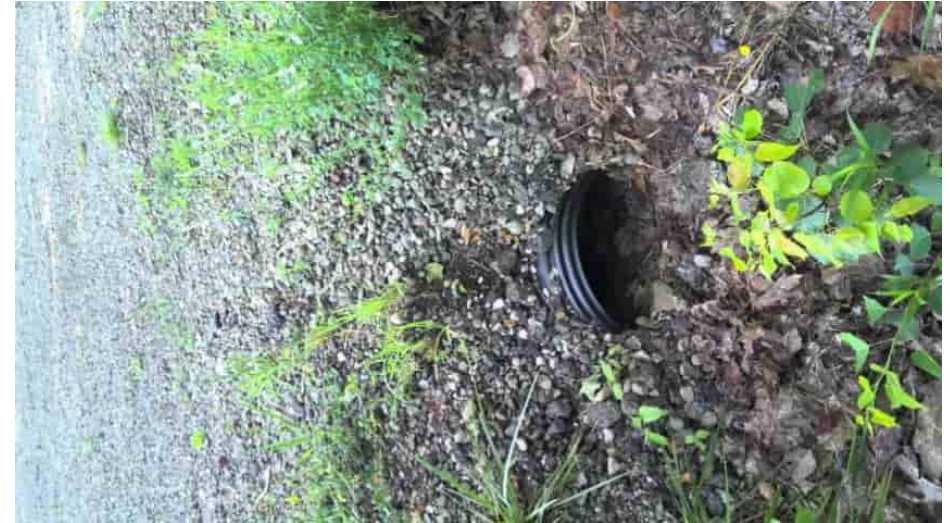
Vegetation:	Minor	Outlet Protection?	<input type="checkbox"/>
Condition:	2- Poor	Outlet Protection Type:	
Embedded?	25-50%	Inlet Protection?	<input type="checkbox"/>
Headwall Condition:		Inlet Protection Type:	
		Maintenance Recommended?	<input type="checkbox"/>

Inspection Notes: full of gravel

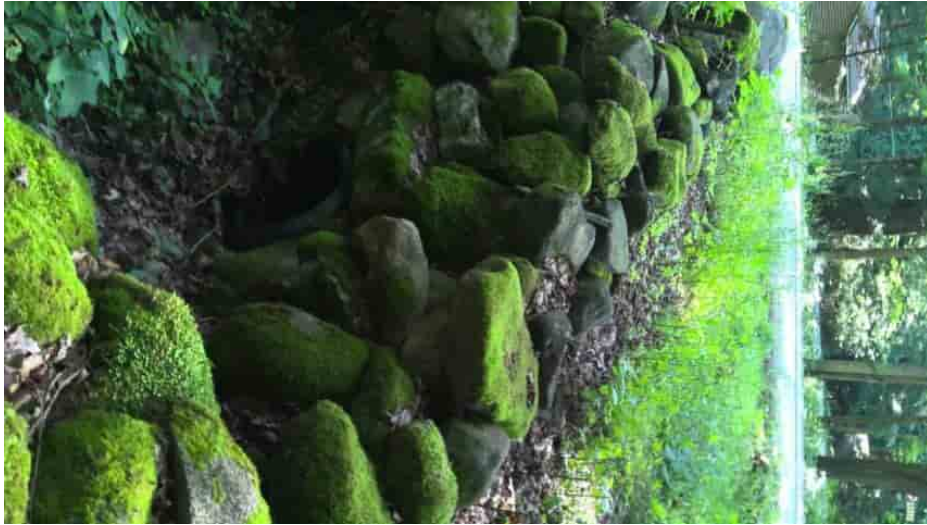
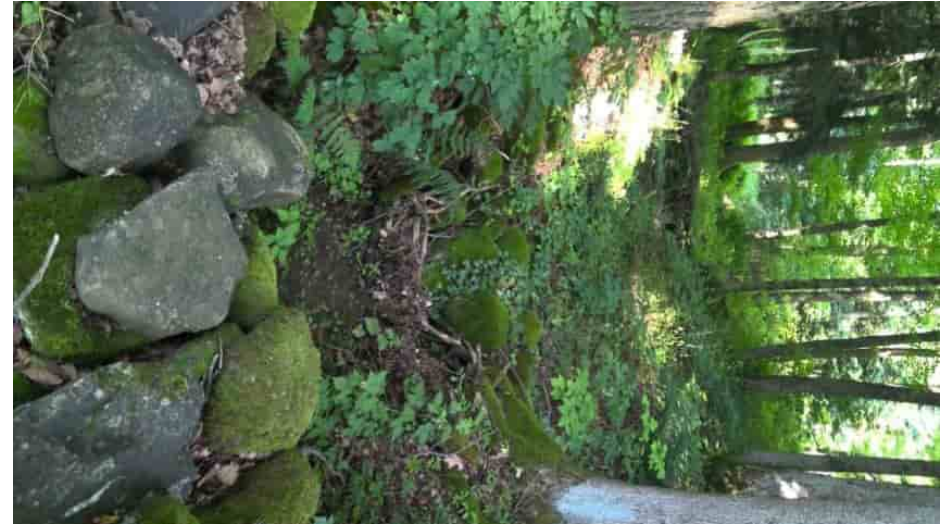
Vegetation:	Minor	Outlet Protection?	<input checked="" type="checkbox"/>
Condition:	1- Good/Fair	Outlet Protection Type:	
Embedded?	0-25%	Inlet Protection?	<input type="checkbox"/>
Headwall Condition:	1- Good/Fair	Inlet Protection Type:	
		Maintenance Recommended?	<input type="checkbox"/>

Inspection Notes: inlet has minor vegetation, minor erosion

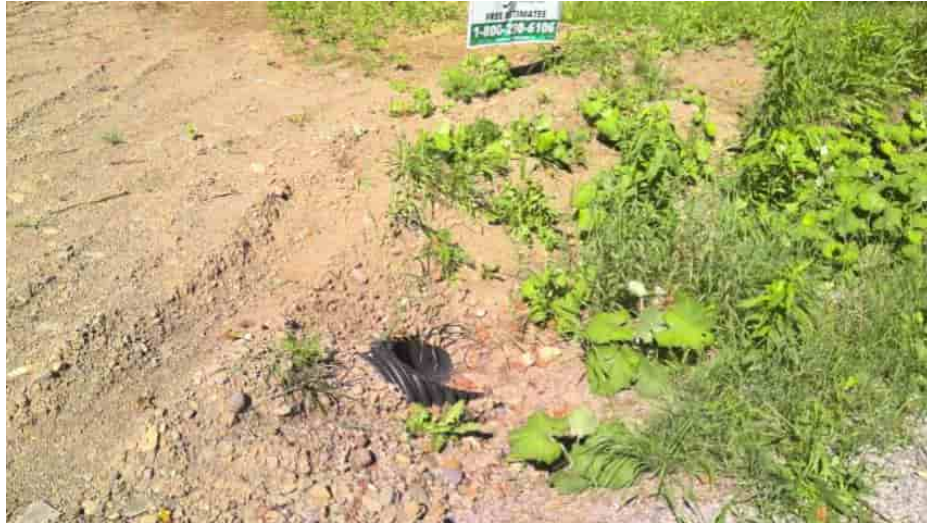
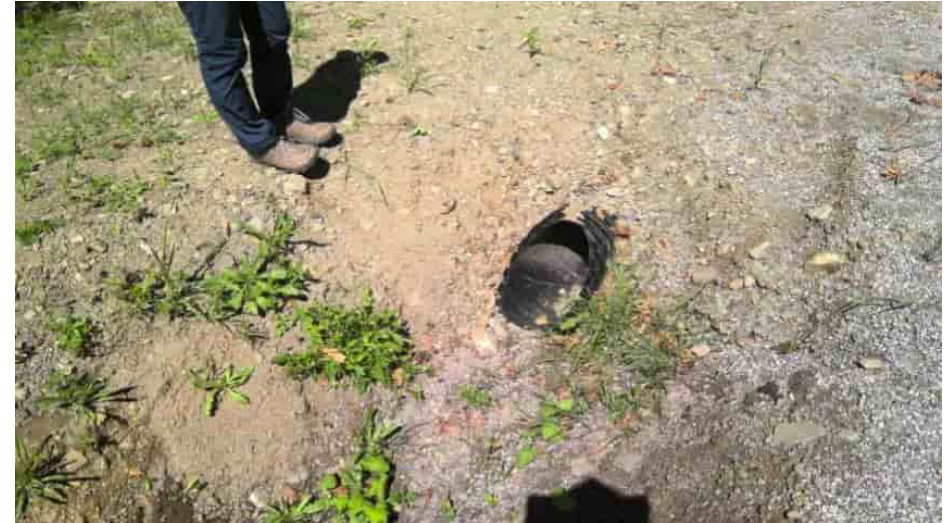
Vegetation:	None	Outlet Protection?	<input type="checkbox"/>
Condition:	1- Good/Fair	Outlet Protection Type:	
Embedded?	0-25%	Inlet Protection?	<input type="checkbox"/>
Headwall Condition:		Inlet Protection Type:	
		Maintenance Recommended?	<input type="checkbox"/>

Inspection Notes: erosion

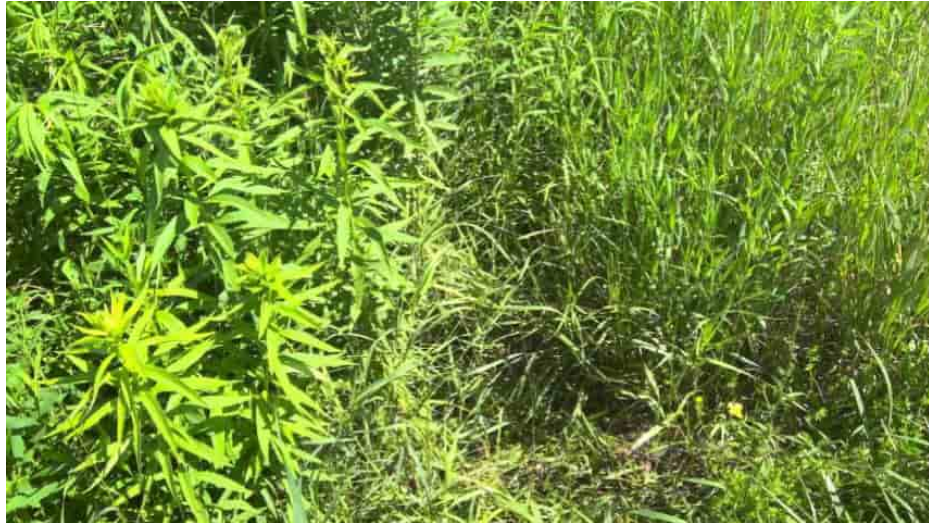
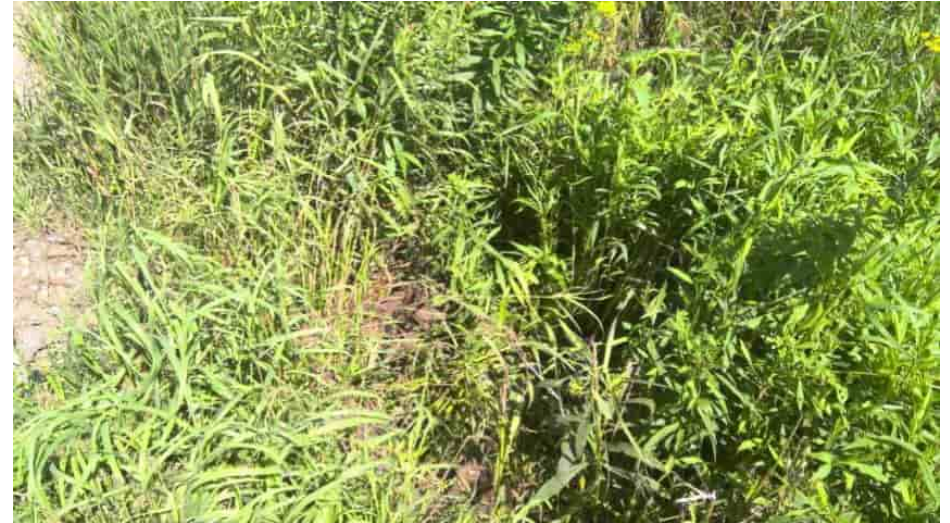
Vegetation:	Excessive	Outlet Protection?	<input type="checkbox"/>
Condition:	1- Good/Fair	Outlet Protection Type:	
Embedded?	25-50%	Inlet Protection?	<input type="checkbox"/>
Headwall Condition:		Inlet Protection Type:	
		Maintenance Recommended?	<input type="checkbox"/>

Inspection Notes: bit flattened
