Culvert Assessment Report

Findley Lake
Town of Mina

Chautauqua County, New York

April 2024

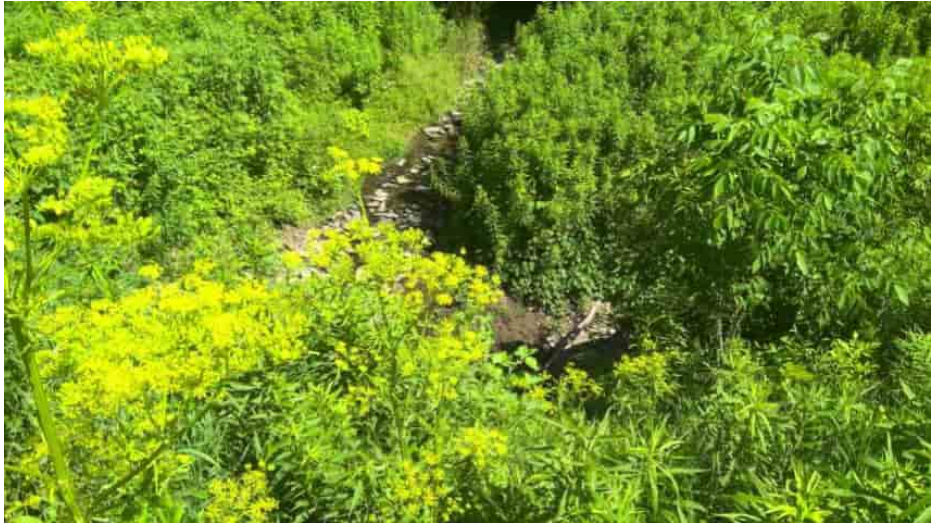
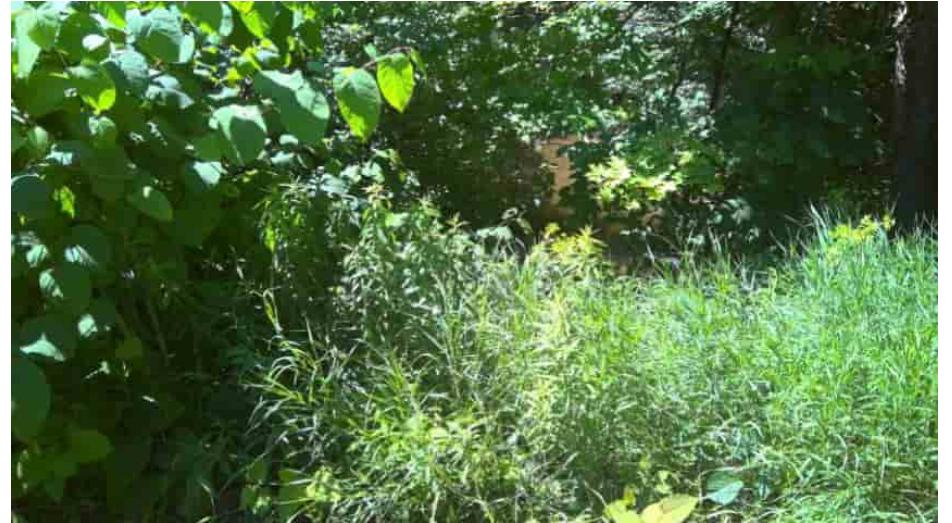
Inspection Notes: steep slopes, unable to access the stream which crosses under the road, heavily vegetated upstream and downstream, some erosion downstream

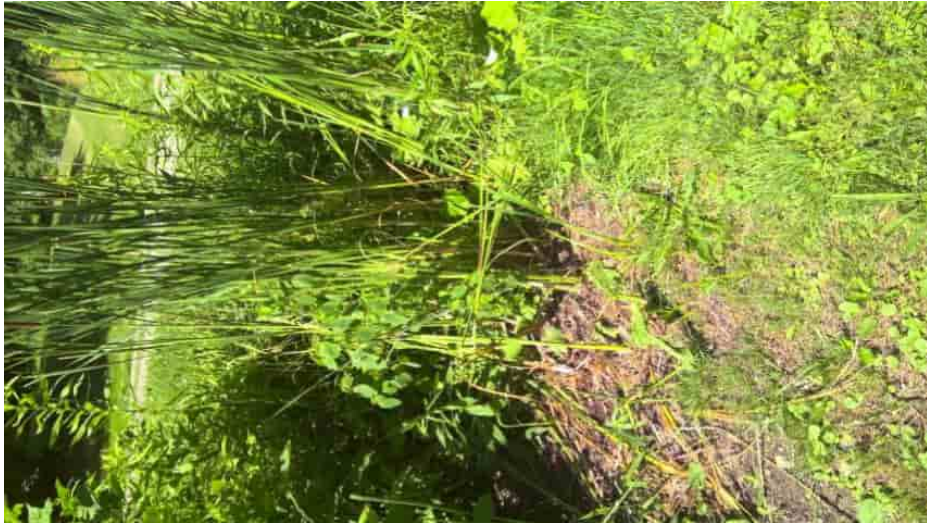
Road:	Bailey Hill Road	Corrugated?	<input type="checkbox"/>	Vegetation:	Excessive	Outlet Protection?	<input type="checkbox"/>
Shape:	Round	Smooth Interior?	<input checked="" type="checkbox"/>	Condition:	2- Poor	Outlet Protection Type:	
Size:	12	Driveway?	<input checked="" type="checkbox"/>	Embedded?	50-75%	Inlet Protection?	<input type="checkbox"/>
Material:	RCP	Headwall?	<input type="checkbox"/>	Headwall Condition:		Inlet Protection Type:	
Erodibility Rating:	2- Minor	Culvert Protruding?	<input type="checkbox"/>	Maintenance Recommended?			<input checked="" type="checkbox"/>

Inspection Notes: clear vegetation around inlet and outlet, clean out sediment in the pipe to allow more water flow, outlet is buried

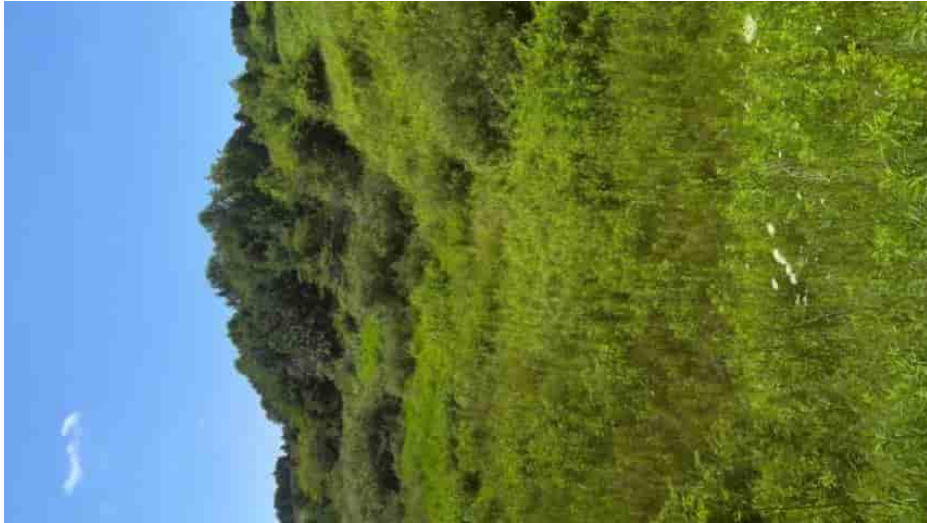
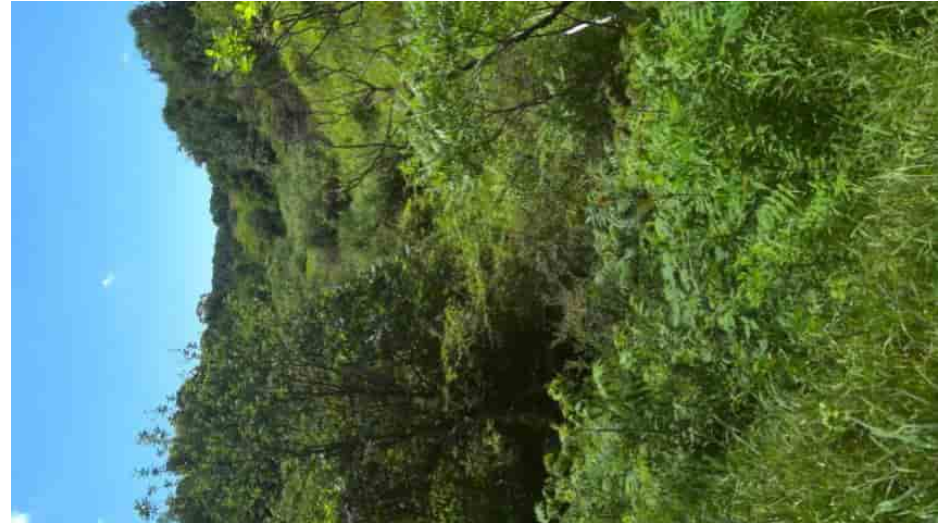
Road:	Bailey Hill Road	Corrugated?	<input type="checkbox"/>	Vegetation:	Excessive	Outlet Protection?	<input type="checkbox"/>
Shape:		Smooth Interior?	<input type="checkbox"/>	Condition:		Outlet Protection Type:	
Size:	0	Driveway?	<input type="checkbox"/>	Embedded?		Inlet Protection?	<input type="checkbox"/>
Material:		Headwall?	<input type="checkbox"/>	Headwall Condition:		Inlet Protection Type:	
Erodibility Rating:	2- Minor	Culvert Protruding?	<input type="checkbox"/>	Maintenance Recommended?			<input type="checkbox"/>

Inspection Notes: stream crossing under road, cannot view inlet/outlet, steep slopes

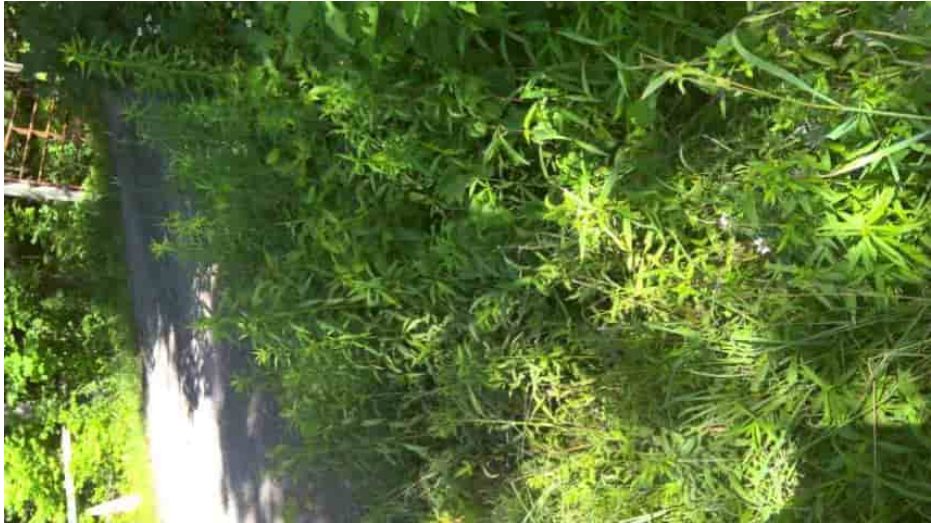
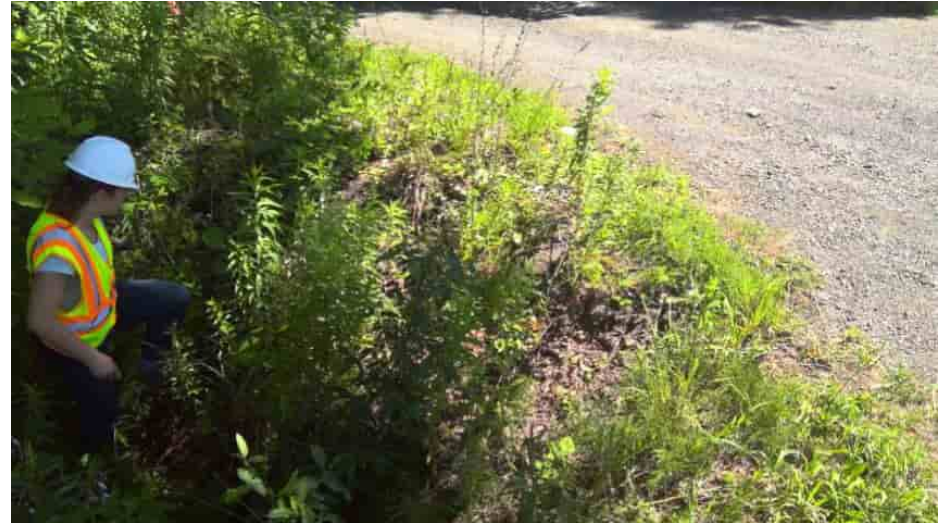
Vegetation:	Excessive	Outlet Protection?	<input type="checkbox"/>
Condition:	1- Good/Fair	Outlet Protection Type:	
Embedded?	No	Inlet Protection?	<input type="checkbox"/>
Headwall Condition:		Inlet Protection Type:	
		Maintenance Recommended?	<input type="checkbox"/>

Inspection Notes: some erosion at driveway

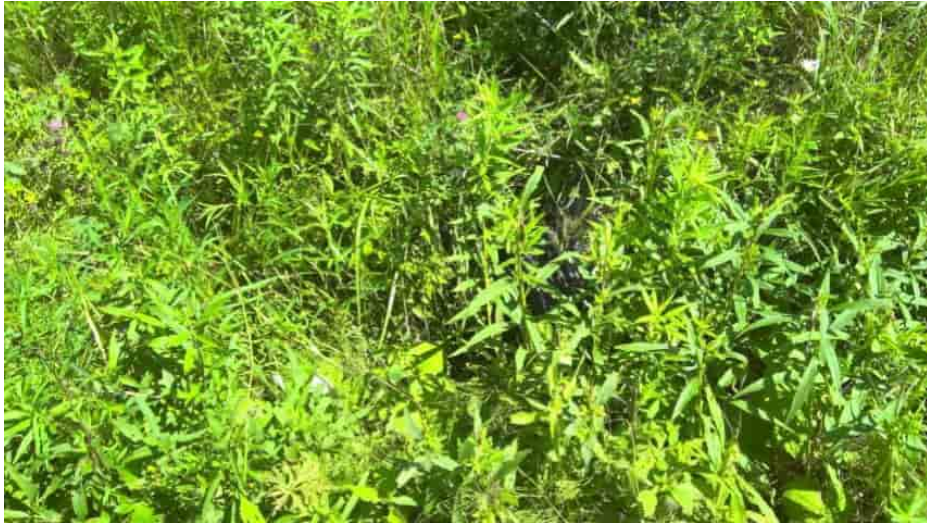
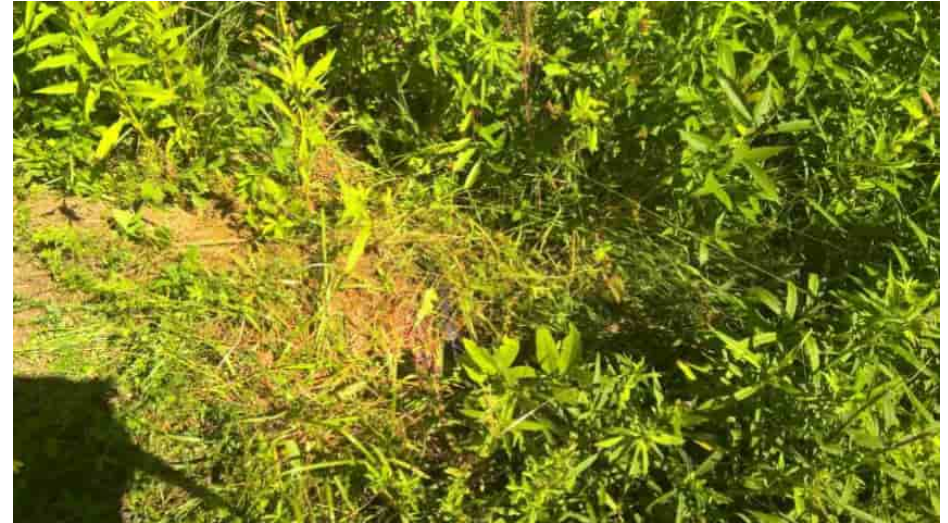
Vegetation:	Excessive	Outlet Protection?	<input type="checkbox"/>
Condition:	1- Good/Fair	Outlet Protection Type:	
Embedded?	0-25%	Inlet Protection?	<input type="checkbox"/>
Headwall Condition:		Inlet Protection Type:	
		Maintenance Recommended?	<input type="checkbox"/>

Inspection Notes: vegetated

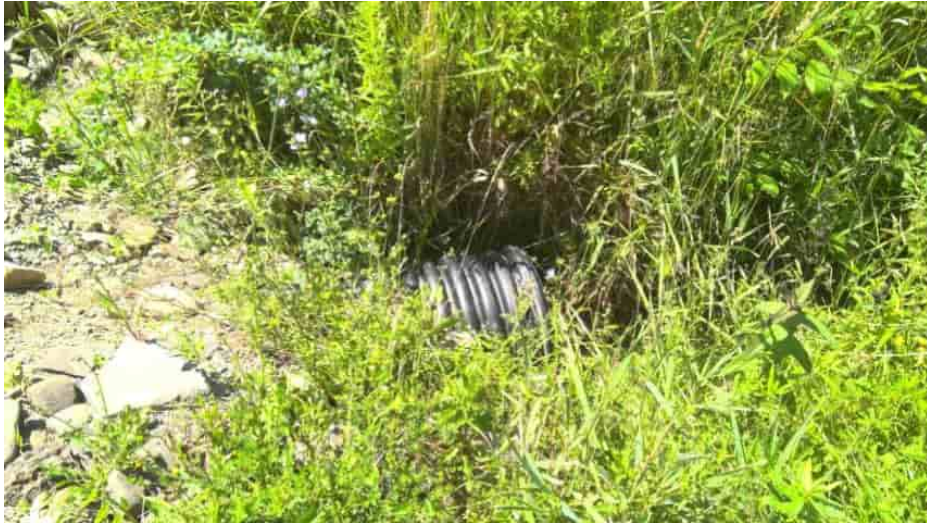
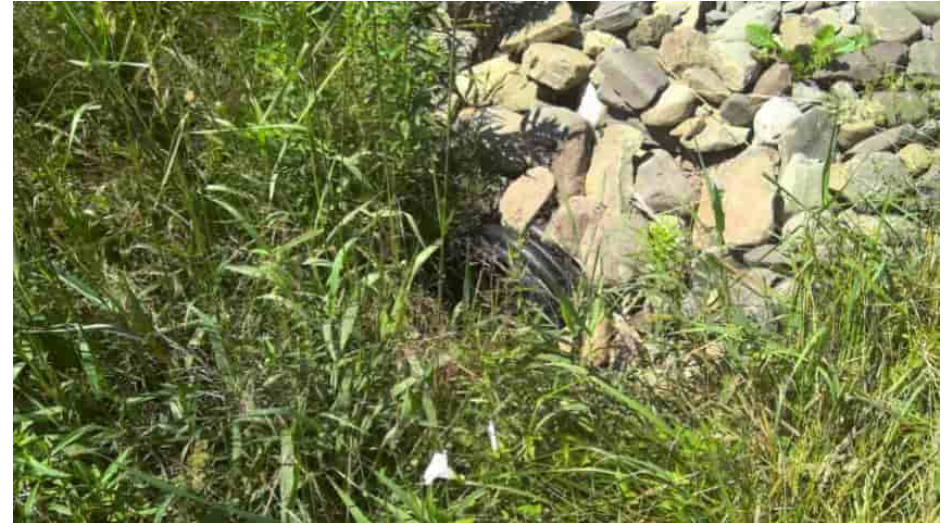
Inspection Notes: vegetated

Vegetation:	Minor	Outlet Protection?	<input type="checkbox"/>
Condition:	1- Good/Fair	Outlet Protection Type:	
Embedded?	0-25%	Inlet Protection?	<input type="checkbox"/>
Headwall Condition:	1- Good/Fair	Inlet Protection Type:	
		Maintenance Recommended?	<input type="checkbox"/>

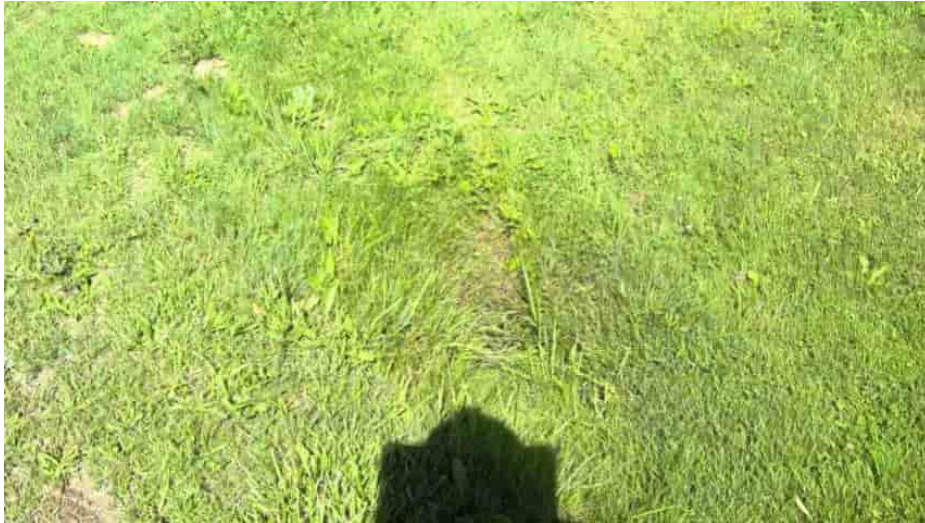
Vegetation:	Minor	Outlet Protection?	<input type="checkbox"/>
Condition:	3- Severe	Outlet Protection Type:	
Embedded?	75-100%	Inlet Protection?	<input type="checkbox"/>
Headwall Condition:		Inlet Protection Type:	
		Maintenance Recommended?	<input checked="" type="checkbox"/>

Inspection Notes: flattened, full of sediment poor condition

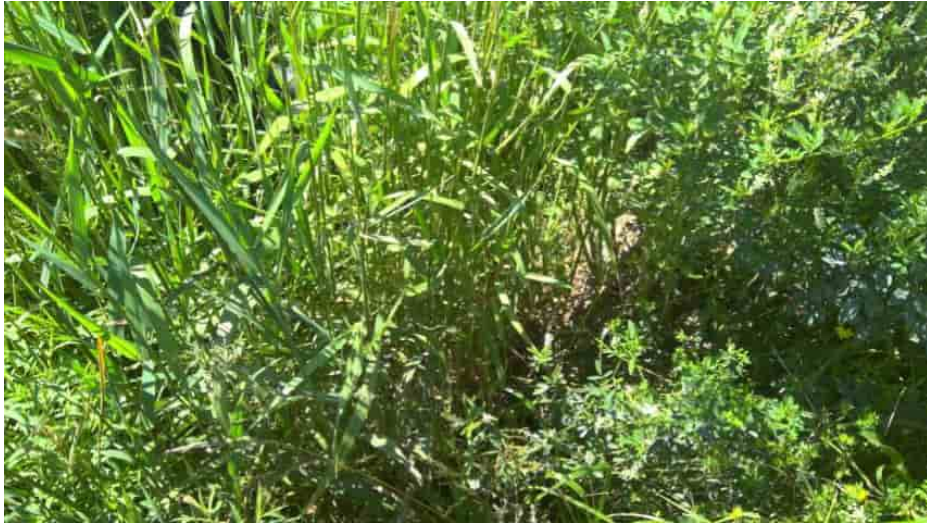
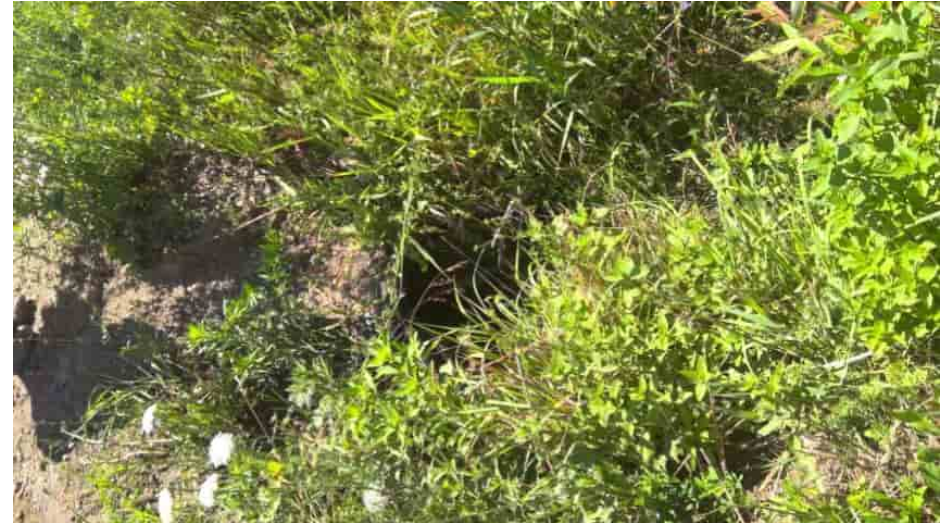
Vegetation:	Excessive	Outlet Protection?	<input type="checkbox"/>
Condition:	1- Good/Fair	Outlet Protection Type:	
Embedded?	0-25%	Inlet Protection?	<input type="checkbox"/>
Headwall Condition:		Inlet Protection Type:	
		Maintenance Recommended?	<input type="checkbox"/>

Inspection Notes: vegetation, eroded

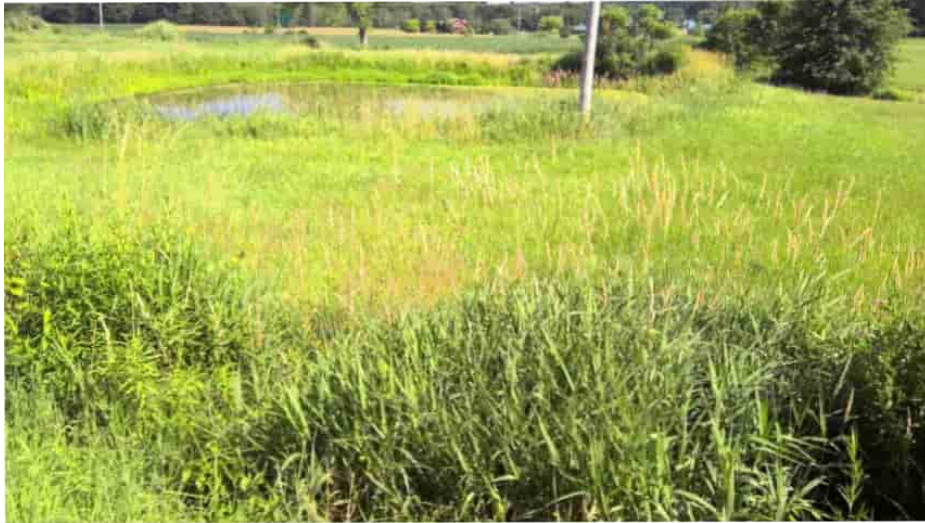
Vegetation:	Excessive	Outlet Protection?	<input type="checkbox"/>
Condition:	1- Good/Fair	Outlet Protection Type:	
Embedded?	0-25%	Inlet Protection?	<input type="checkbox"/>
Headwall Condition:		Inlet Protection Type:	
		Maintenance Recommended?	<input type="checkbox"/>

Inspection Notes: erosion upstream of inlet drains into pond, but can't find outlet

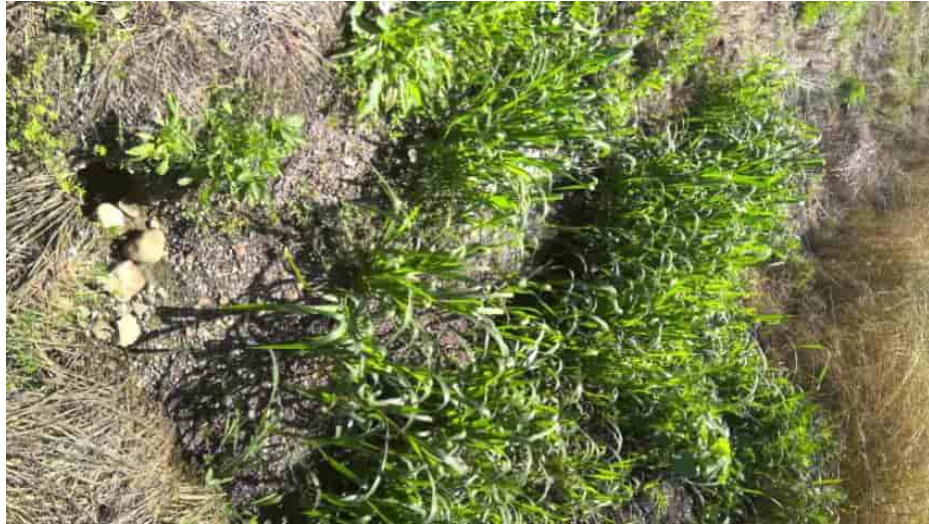
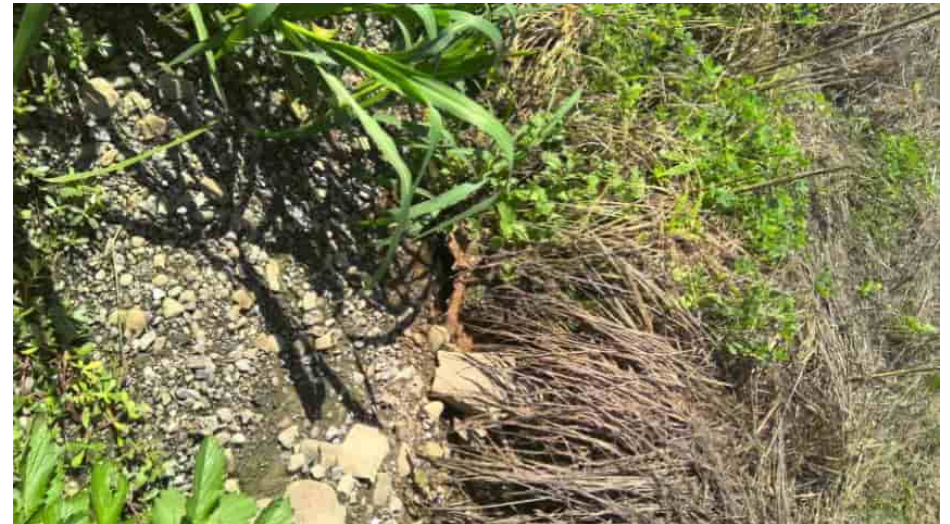
Road:	Harrington Hill Rd.	Corrugated?	<input checked="" type="checkbox"/>	Vegetation:	Minor	Outlet Protection?	<input type="checkbox"/>
Shape:	Round	Smooth Interior?	<input type="checkbox"/>	Condition:	2- Poor	Outlet Protection Type:	
Size:	12	Driveway?	<input type="checkbox"/>	Embedded?	75-100%	Inlet Protection?	<input type="checkbox"/>
Material:	STEEL/Metal	Headwall?	<input type="checkbox"/>	Headwall Condition:		Inlet Protection Type:	
Erodibility Rating:	2- Minor	Culvert Protruding?	<input type="checkbox"/>	Maintenance Recommended?			<input checked="" type="checkbox"/>

Inspection Notes: can't locate inlet, clear out material around outlet, standing water at outlet w/ algae

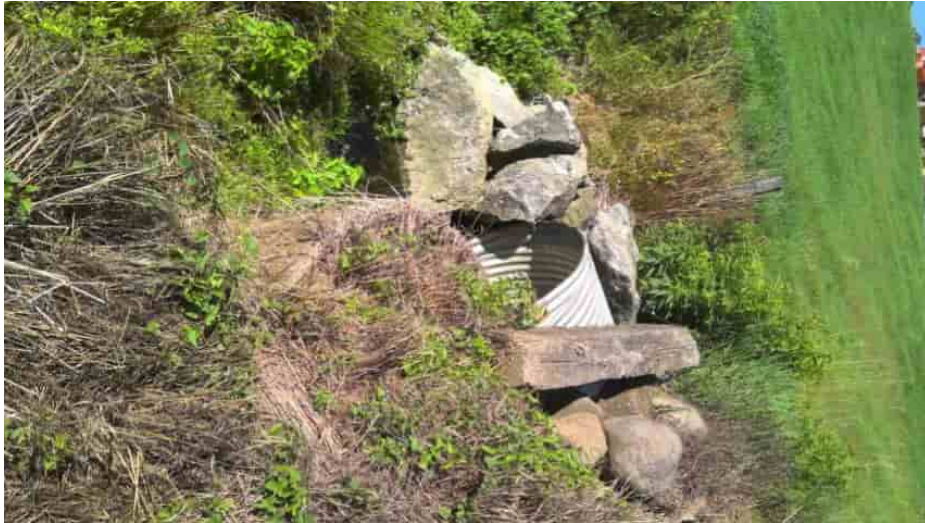
Inspection Notes: fix slope, can't locate outlet

Vegetation:	Excessive	Outlet Protection?	<input type="checkbox"/>
Condition:	1- Good/Fair	Outlet Protection Type:	
Embedded?	No	Inlet Protection?	<input type="checkbox"/>
Headwall Condition:		Inlet Protection Type:	
		Maintenance Recommended?	<input checked="" type="checkbox"/>

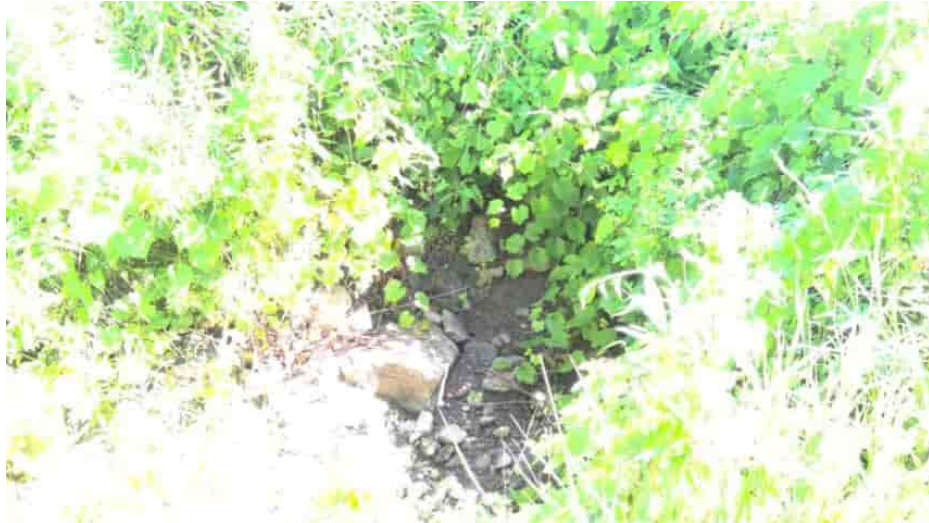
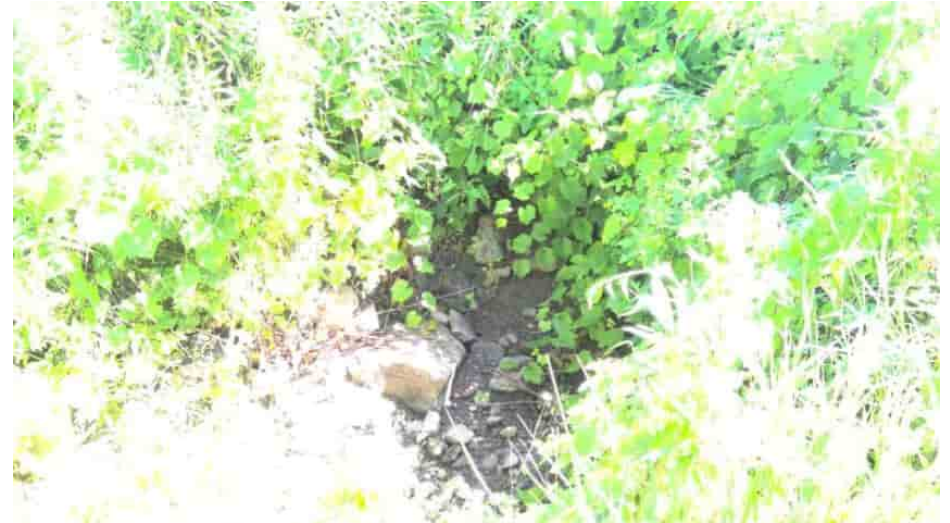
Inspection Notes: vegetated

Vegetation:	Excessive	Outlet Protection?	<input type="checkbox"/>
Condition:	1- Good/Fair	Outlet Protection Type:	
Embedded?	0-25%	Inlet Protection?	<input type="checkbox"/>
Headwall Condition:		Inlet Protection Type:	
		Maintenance Recommended?	<input type="checkbox"/>

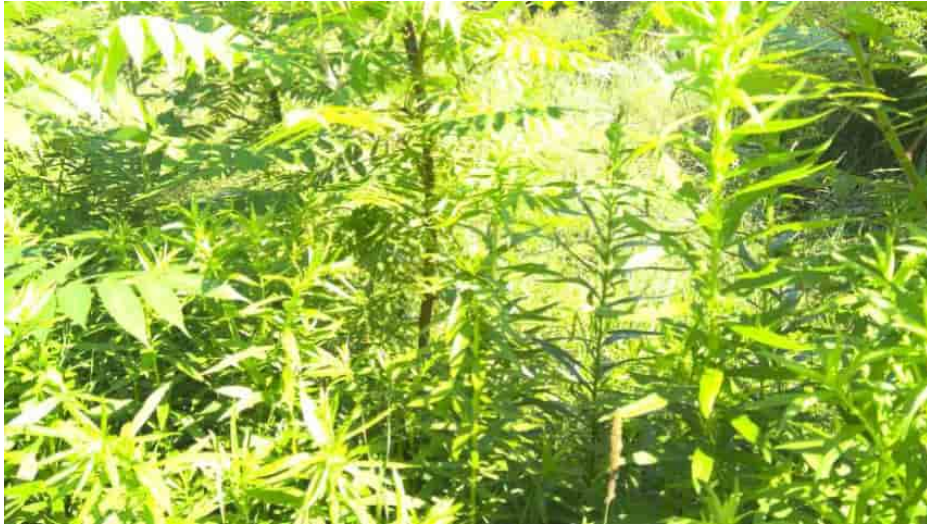
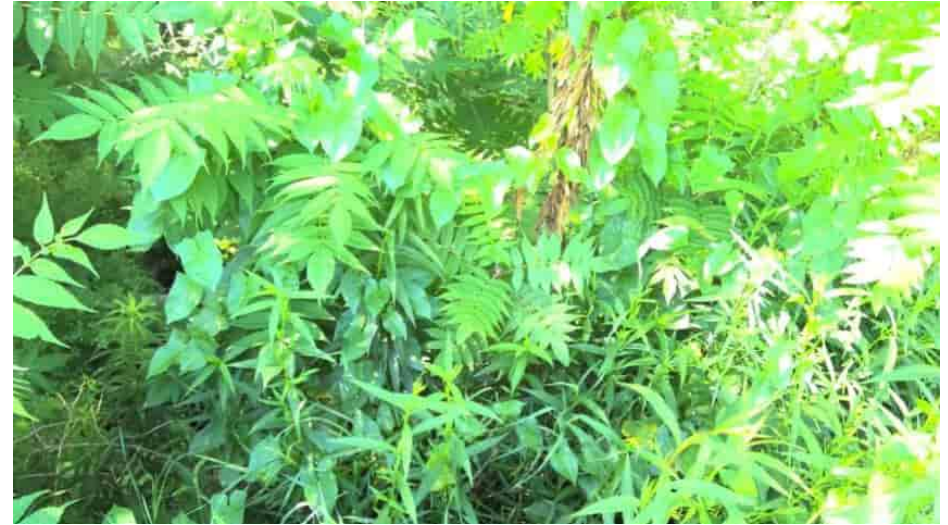
Vegetation:	Excessive	Outlet Protection?	<input type="checkbox"/>
Condition:	1- Good/Fair	Outlet Protection Type:	
Embedded?		Inlet Protection?	<input type="checkbox"/>
Headwall Condition:		Inlet Protection Type:	
		Maintenance Recommended?	<input type="checkbox"/>

Inspection Notes: dry stream crossing Harrington Hill Road

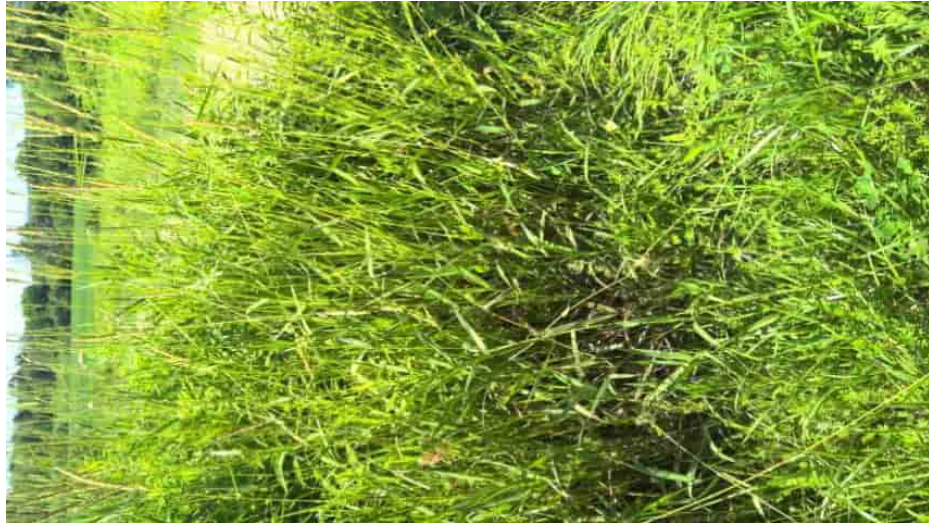
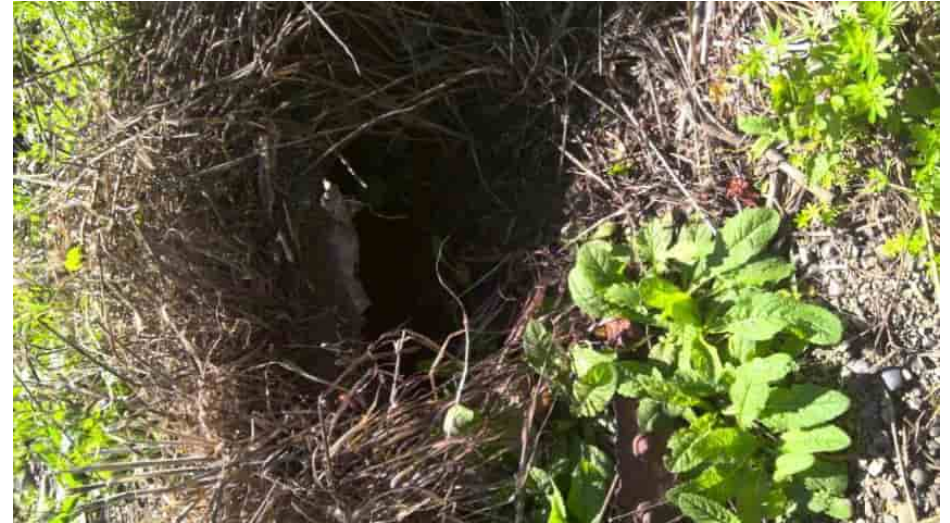
Vegetation:	Minor	Outlet Protection?	<input type="checkbox"/>
Condition:	2- Poor	Outlet Protection Type:	
Embedded?	25-50%	Inlet Protection?	<input type="checkbox"/>
Headwall Condition:		Inlet Protection Type:	
		Maintenance Recommended?	<input type="checkbox"/>

Inspection Notes: orangeburg clay not concrete

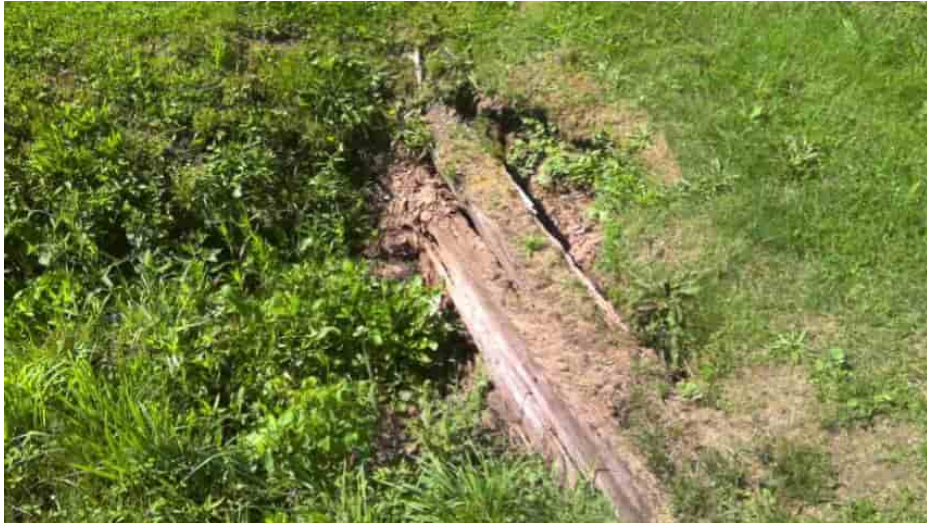
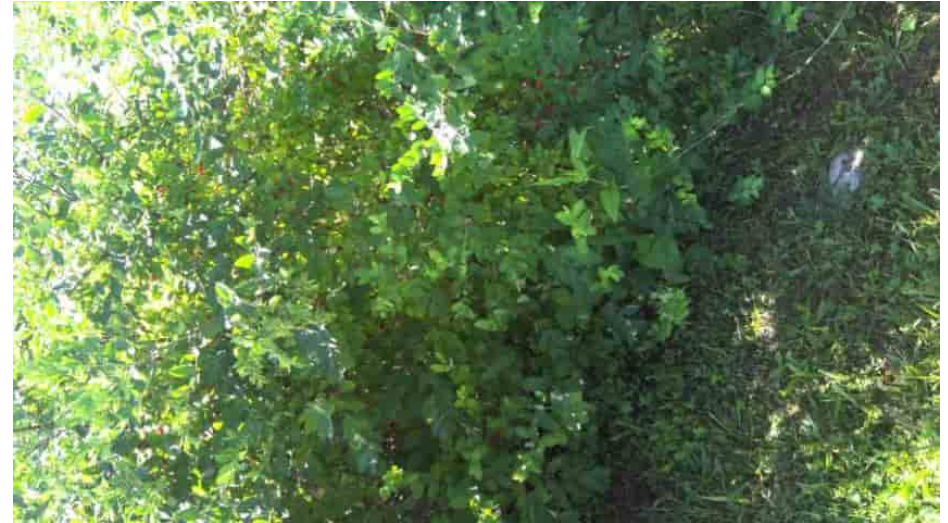
Inspection #: 84

Vegetation:	Minor	Outlet Protection?	<input type="checkbox"/>
Condition:	2- Poor	Outlet Protection Type:	
Embedded?	0-25%	Inlet Protection?	<input type="checkbox"/>
Headwall Condition:	3- Severe	Inlet Protection Type:	
		Maintenance Recommended?	<input checked="" type="checkbox"/>

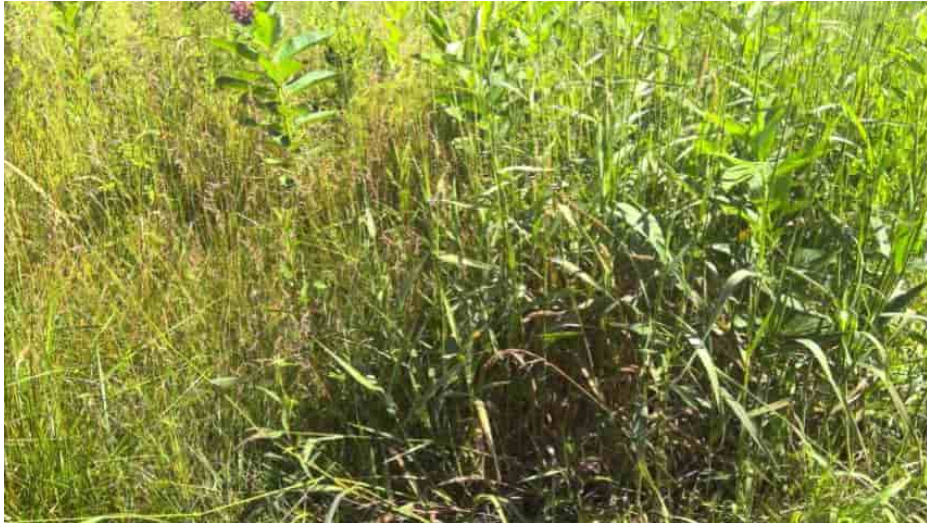
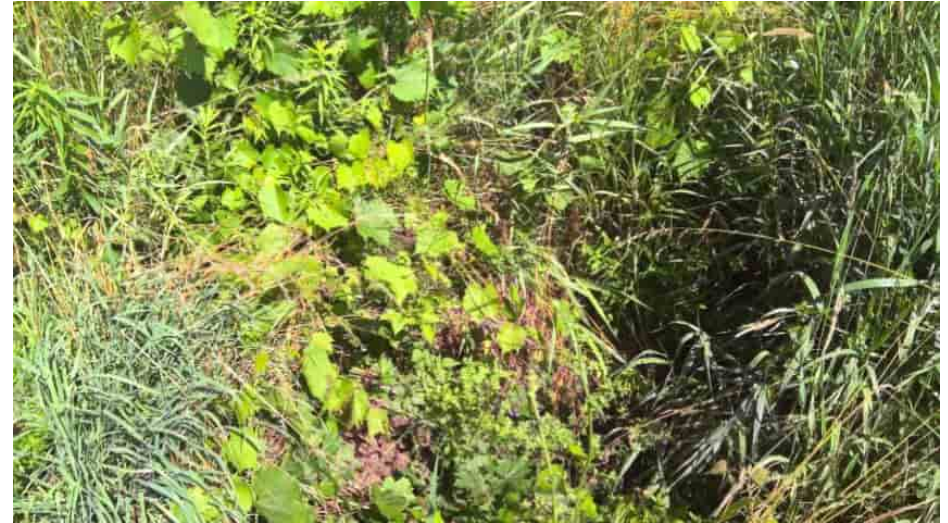
Inspection #: 46

Vegetation:	Excessive	Outlet Protection?	<input type="checkbox"/>
Condition:	2- Poor	Outlet Protection Type:	
Embedded?	0-25%	Inlet Protection?	<input type="checkbox"/>
Headwall Condition:		Inlet Protection Type:	
		Maintenance Recommended?	<input type="checkbox"/>

Inspection Notes: excessive thorny vegetation

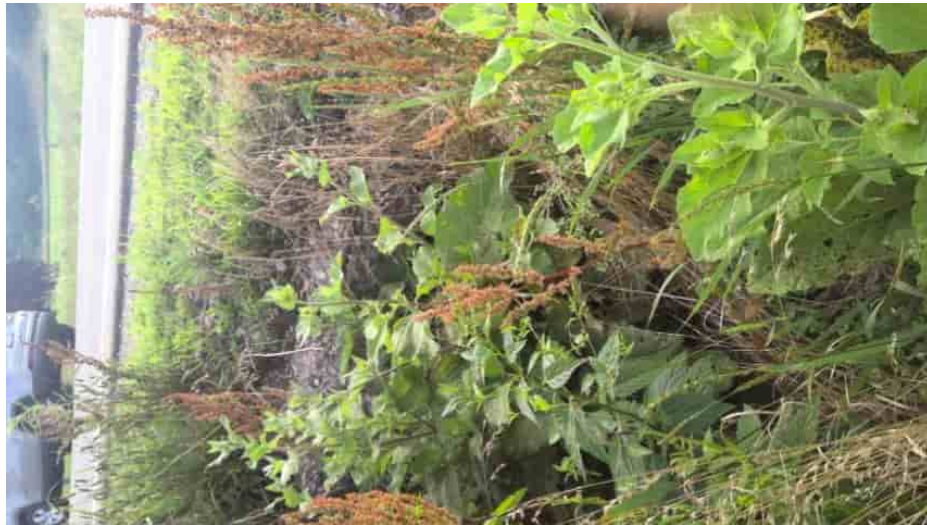
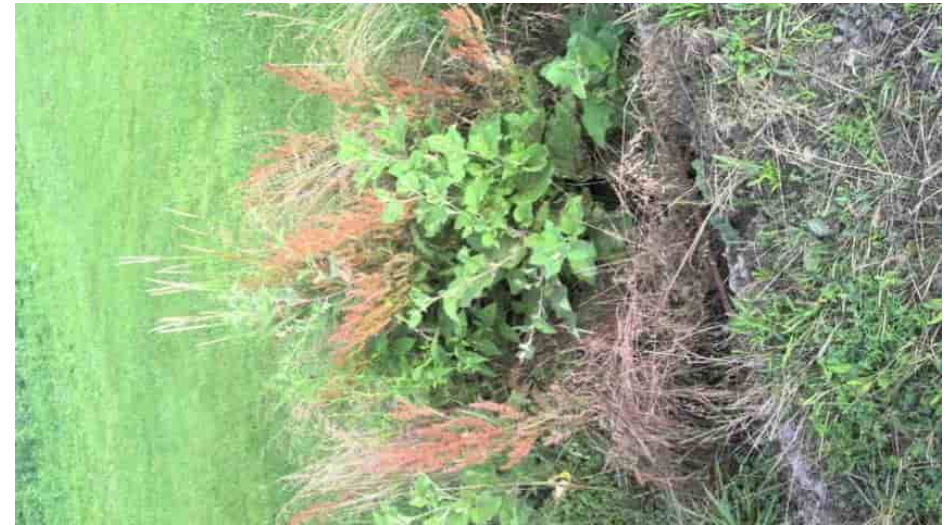
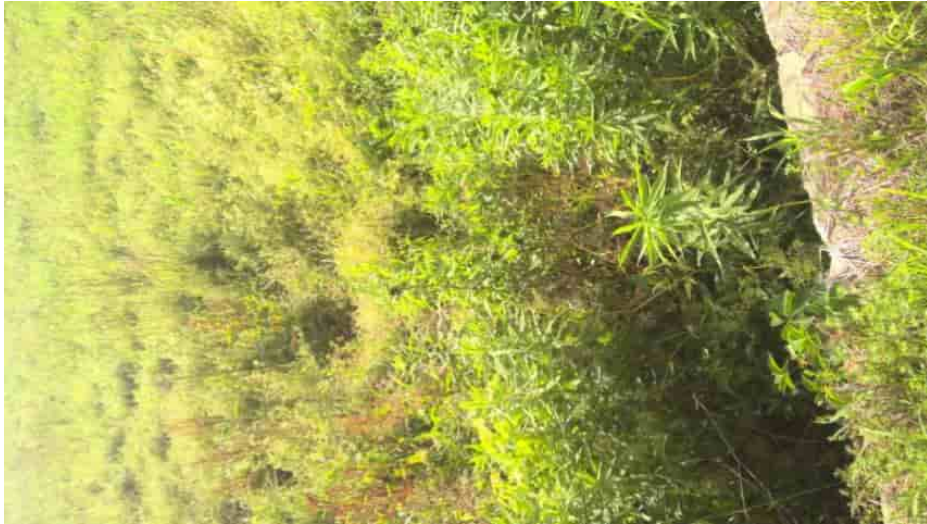
Inspection #: 46

Inspection Notes: 19"H x 41"W snails

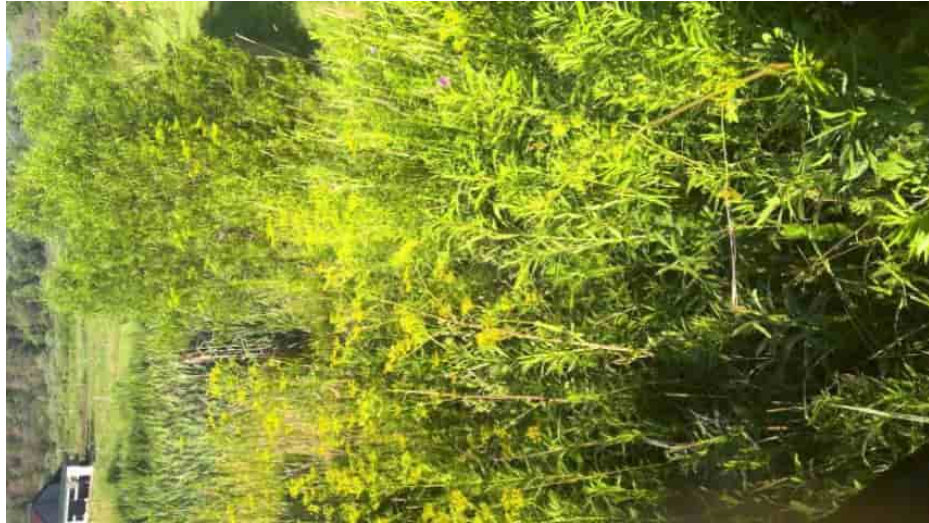
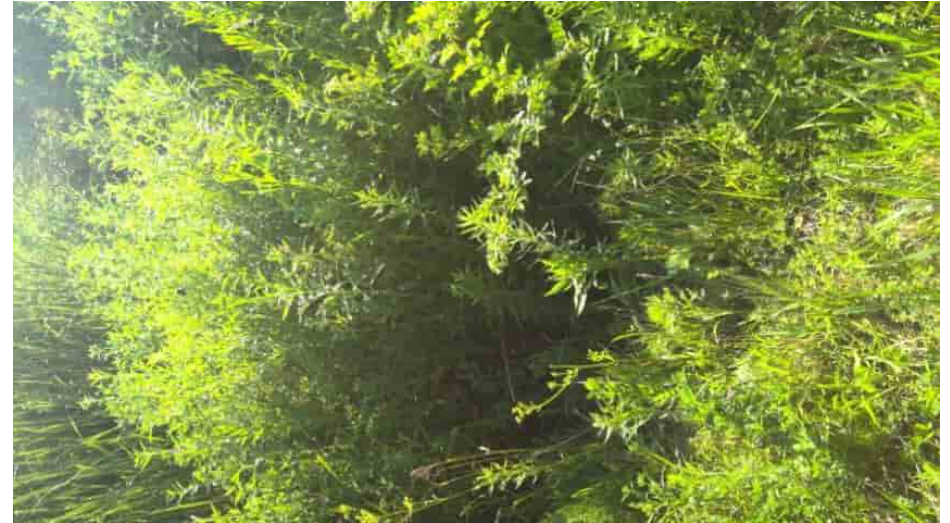
Inspection #: 52

Vegetation:	Excessive	Outlet Protection?	<input type="checkbox"/>
Condition:	poor	Outlet Protection Type:	
Embedded?	0-25%	Inlet Protection?	<input type="checkbox"/>
Headwall Condition:	poor	Inlet Protection Type:	
		Maintenance Recommended?	<input type="checkbox"/>

Inspection Notes: brown foam excessively vegetated, couldn't access outlet

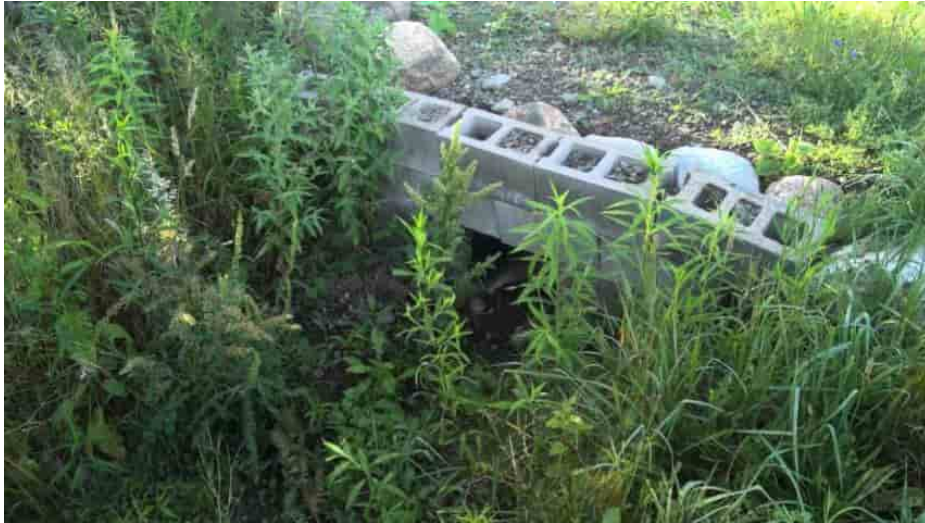
Inspection #: 54

Inspection Notes: headwall crushing pipe a bit

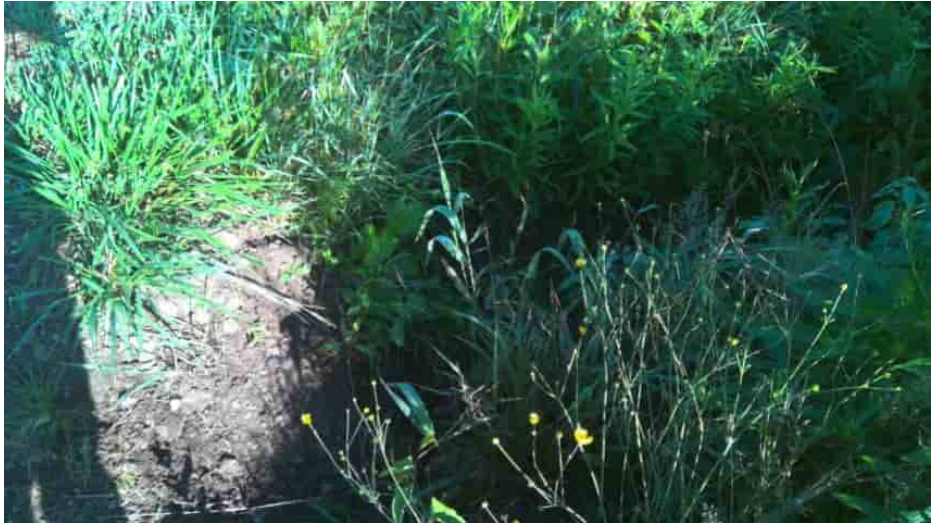
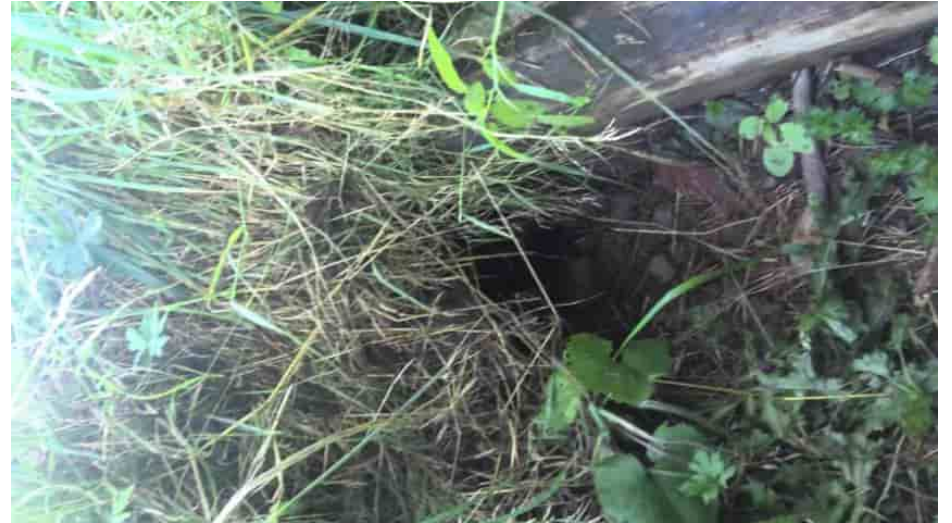
Inspection #: 55

Vegetation:	Minor	Outlet Protection?	<input type="checkbox"/>
Condition:	3- Severe	Outlet Protection Type:	
Embedded?	75-100%	Inlet Protection?	<input type="checkbox"/>
Headwall Condition:		Inlet Protection Type:	
		Maintenance Recommended?	<input checked="" type="checkbox"/>

Inspection Notes: outlet fully buried, inlet orangeburg clay not rcp

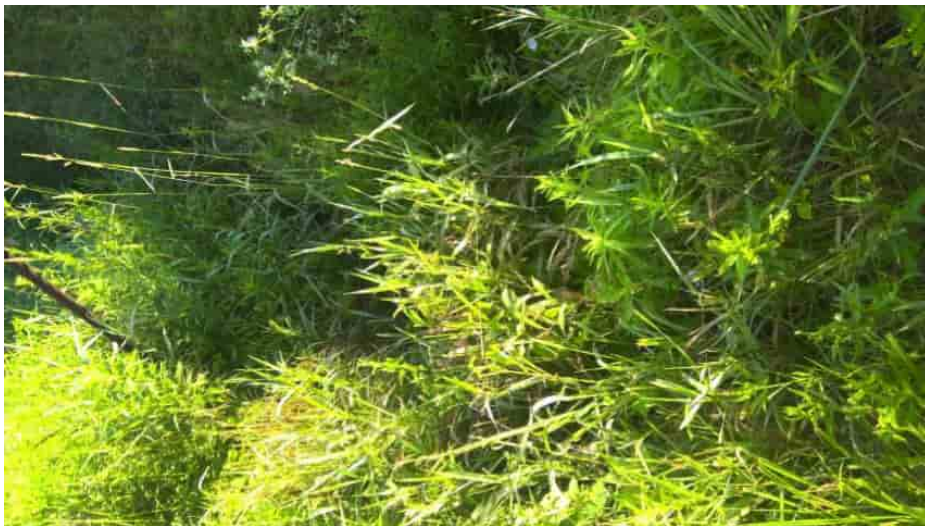
Inspection #: 56

Inspection Notes: cannot locate outlet

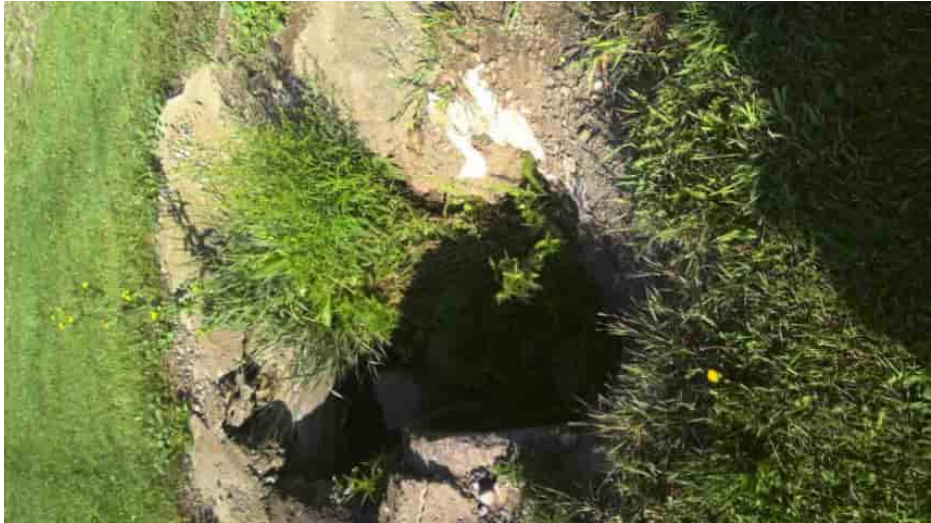
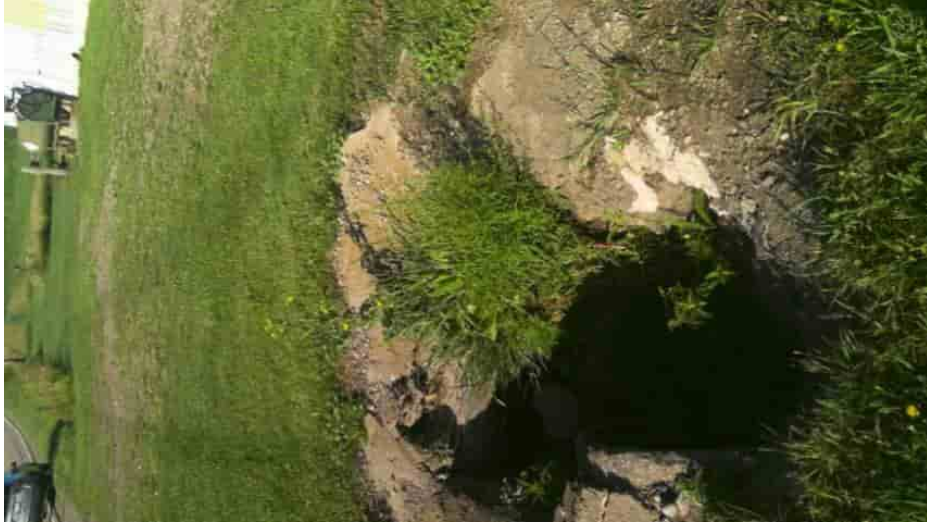
Inspection #: 56

Vegetation:	Excessive	Outlet Protection?	<input type="checkbox"/>
Condition:	3- Severe	Outlet Protection Type:	
Embedded?		Inlet Protection?	<input type="checkbox"/>
Headwall Condition:	3- Severe	Inlet Protection Type:	
		Maintenance Recommended?	<input type="checkbox"/>

Inspection Notes: extreme erosion at outlet

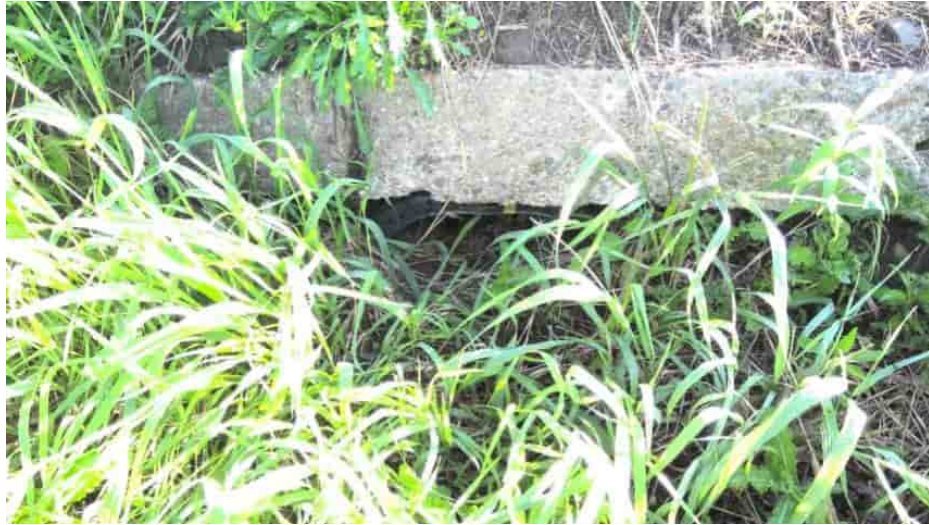
Inspection #: 58 **Date:** 7/14/2023
Culvert ID: MR-12 **Time:** 8:29:57 AM
Inspector: OCC

Road:	Mann Road	Corrugated?	<input checked="" type="checkbox"/>	Vegetation:	Minor	Outlet Protection?	<input type="checkbox"/>
Shape:	Round	Smooth Interior?	<input type="checkbox"/>	Condition:	3- Severe	Outlet Protection Type:	
Size:	18	Driveway?	<input checked="" type="checkbox"/>	Embedded?	75-100%	Inlet Protection?	<input type="checkbox"/>
Material:	IDPE/PVC/Plastic	Headwall?	<input checked="" type="checkbox"/>	Headwall Condition:	1- Good/Fair	Inlet Protection Type:	
Erodibility Rating:	2- Minor	Culvert Protruding?	<input type="checkbox"/>			Maintenance Recommended?	<input checked="" type="checkbox"/>
Inspection Notes:	outlet buried
