Culvert Assessment Report

Findley Lake
Town of Mina

Chautauqua County, New York

April 2024

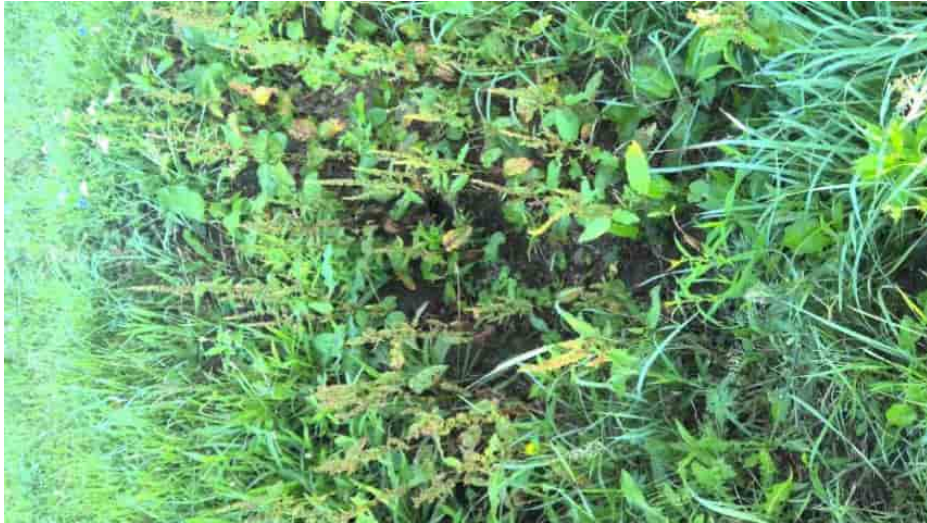
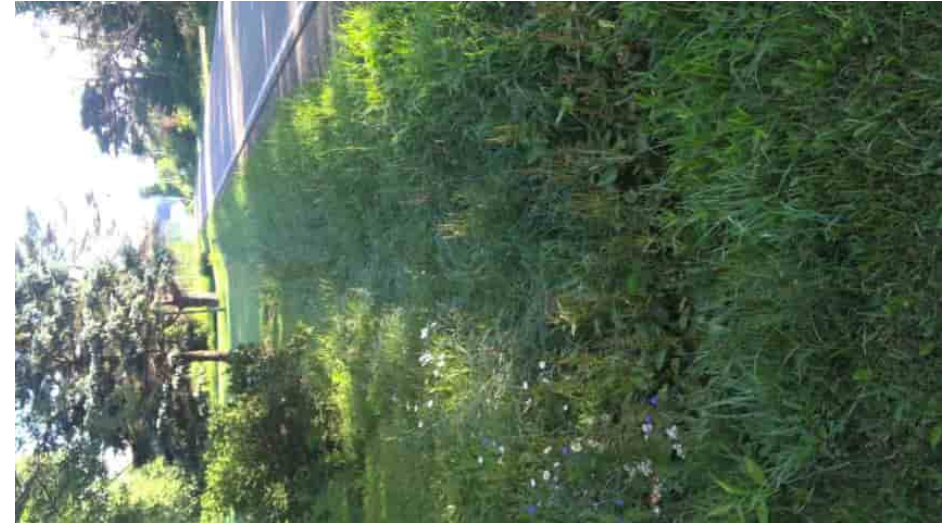
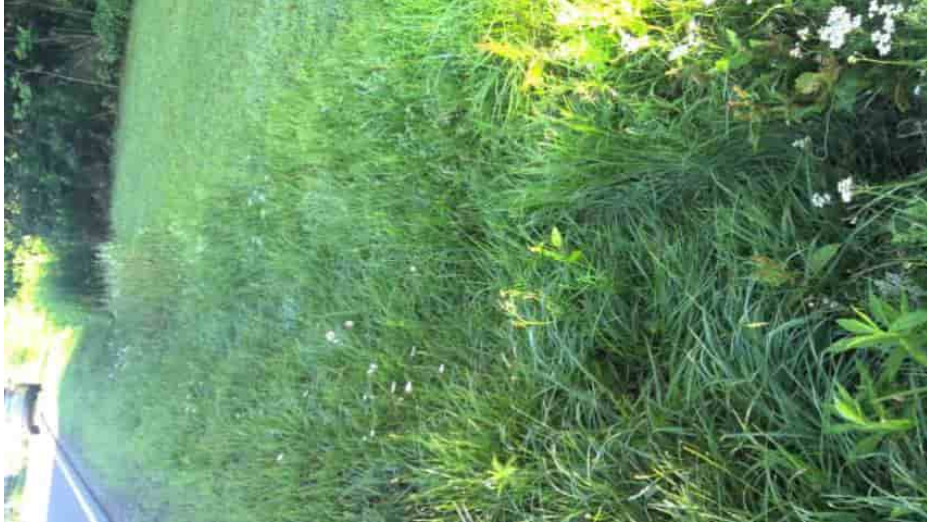
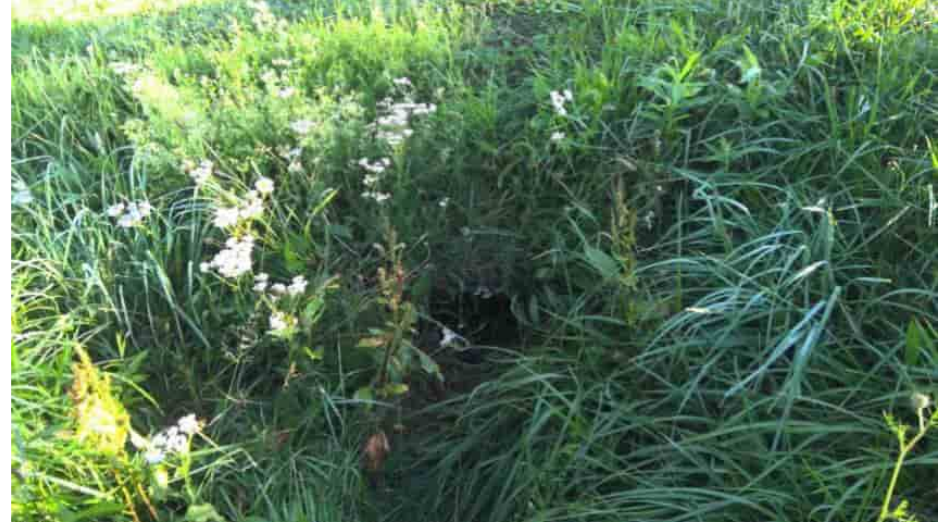
Inspection #: 51

Vegetation:	Excessive	Outlet Protection?	<input type="checkbox"/>
Condition:	2- Poor	Outlet Protection Type:	
Embedded?	0-25%	Inlet Protection?	<input type="checkbox"/>
Headwall Condition:		Inlet Protection Type:	
		Maintenance Recommended?	<input checked="" type="checkbox"/>

Inspection Notes: driveway culvert, excessive grass

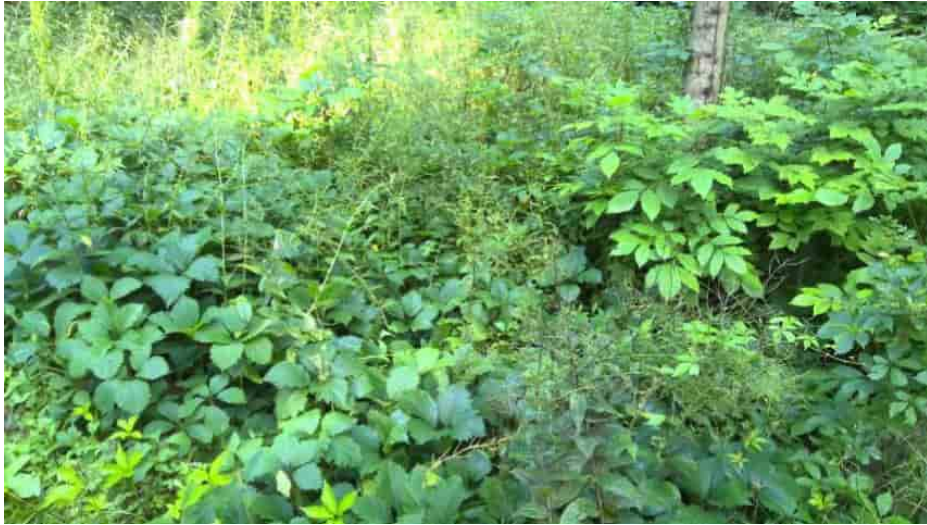
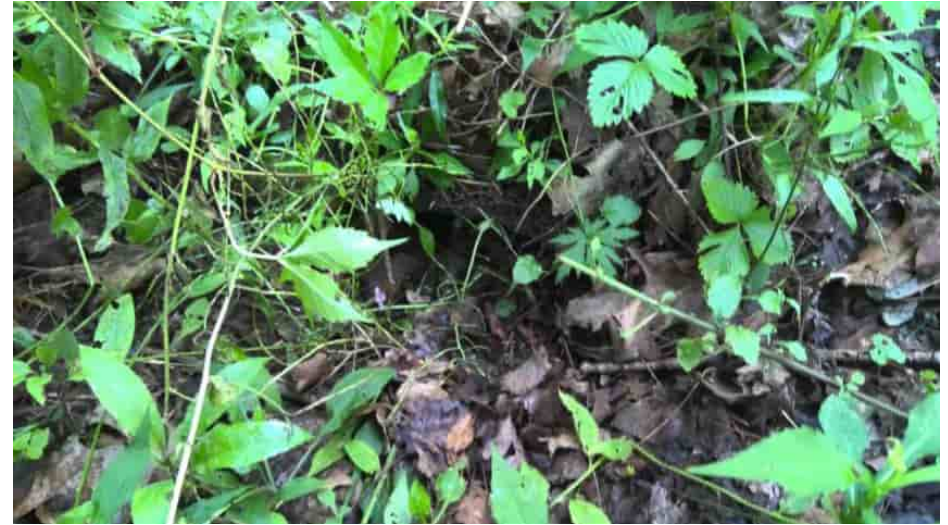
Inspection #: 26
Culvert ID: SS-1
Inspector: AC

Vegetation:	Excessive	Outlet Protection?	<input type="checkbox"/>
Condition:	3- Severe	Outlet Protection Type:	
Embedded?	75-100%	Inlet Protection?	<input type="checkbox"/>
Headwall Condition:		Inlet Protection Type:	
		Maintenance Recommended?	<input checked="" type="checkbox"/>

Inspection Notes: clean out, outlet unable to locate

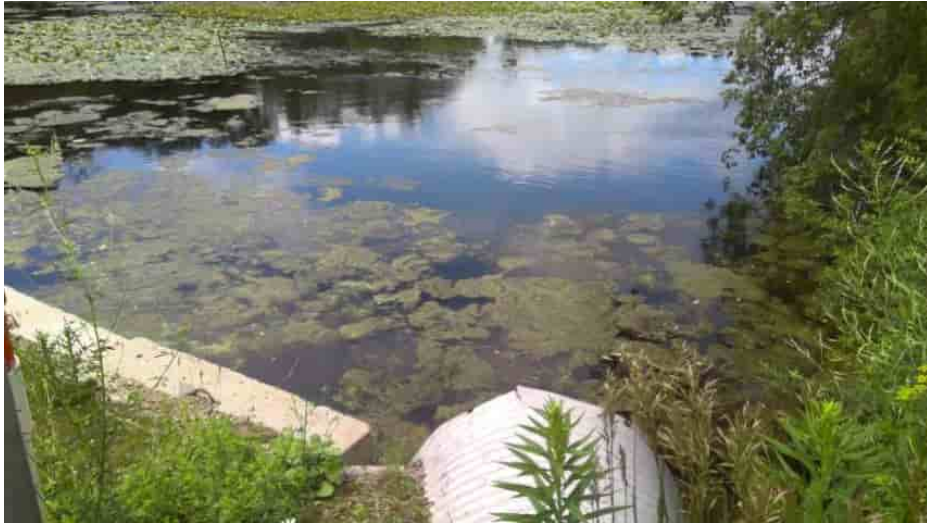
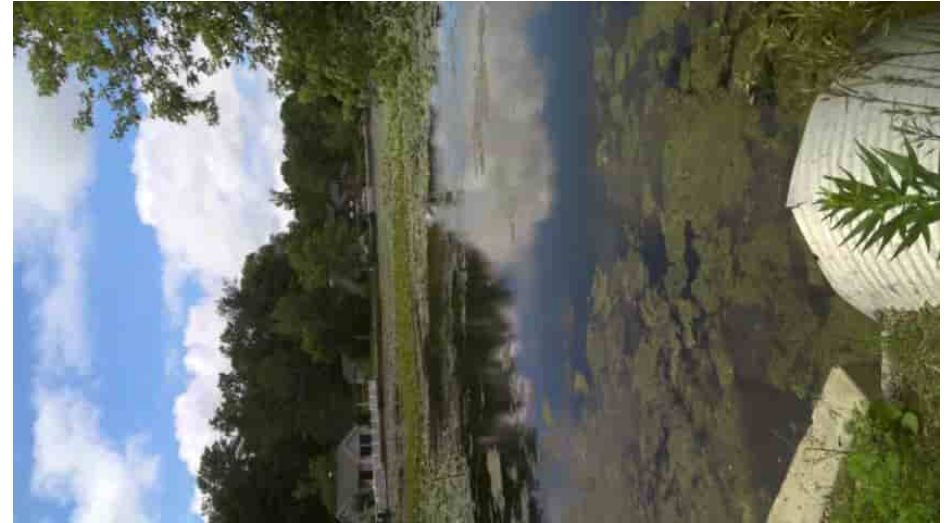
Vegetation:	Excessive	Outlet Protection?	<input type="checkbox"/>
Condition:	2- Poor	Outlet Protection Type:	
Embedded?		Inlet Protection?	<input type="checkbox"/>
Headwall Condition:		Inlet Protection Type:	
		Maintenance Recommended?	<input type="checkbox"/>

Inspection Notes: drain wetland/detention area into lake
diameter = 57 in

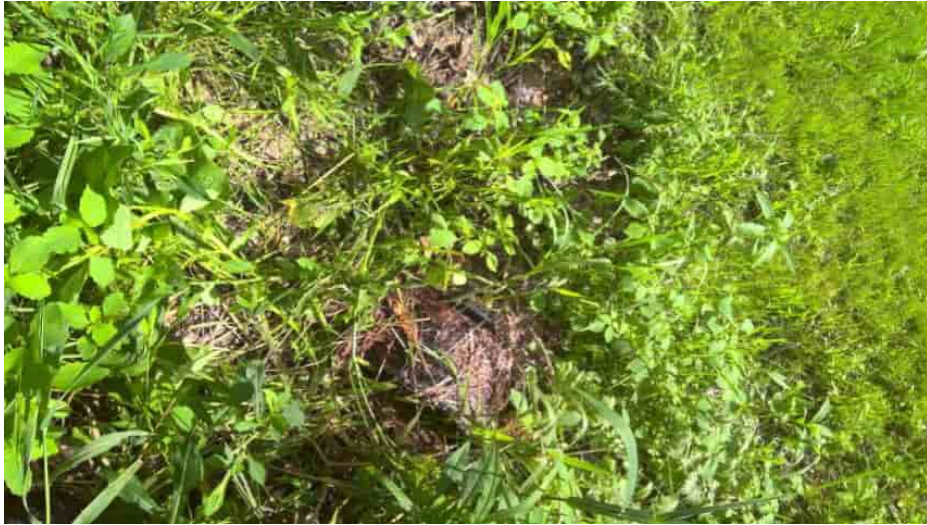
Inspection #: 27

Vegetation:	Minor	Outlet Protection?	<input type="checkbox"/>
Condition:	1- Good/Fair	Outlet Protection Type:	
Embedded?	50-75%	Inlet Protection?	<input type="checkbox"/>
Headwall Condition:		Inlet Protection Type:	
		Maintenance Recommended?	<input checked="" type="checkbox"/>

Inspection Notes: leaf litter debris clogging inlet, clean inlet
50-75 embedded outlet

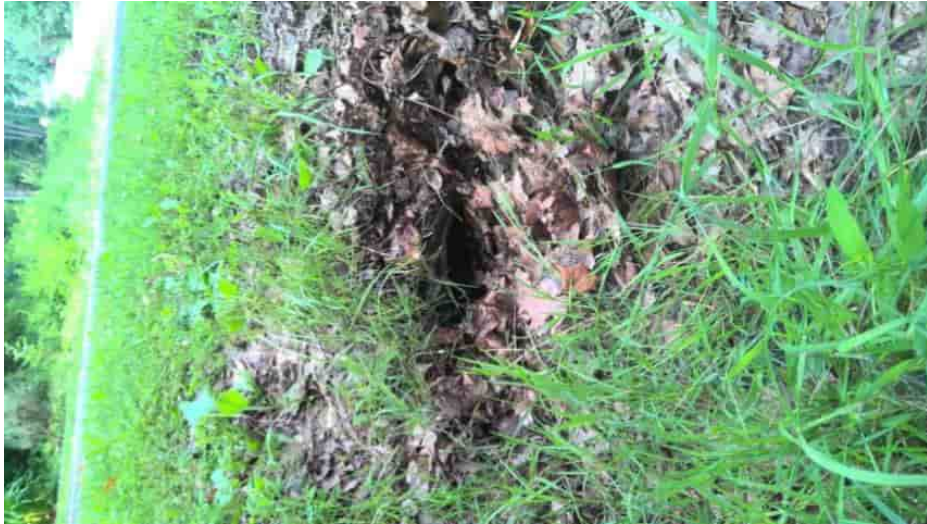
Inspection #: 28

Vegetation:	Excessive	Outlet Protection?	<input type="checkbox"/>
Condition:	1- Good/Fair	Outlet Protection Type:	
Embedded?	0-25%	Inlet Protection?	<input type="checkbox"/>
Headwall Condition:		Inlet Protection Type:	
		Maintenance Recommended?	<input type="checkbox"/>

Inspection Notes: drains wetland/detention area into lake
riprap/hravel in area draining from road

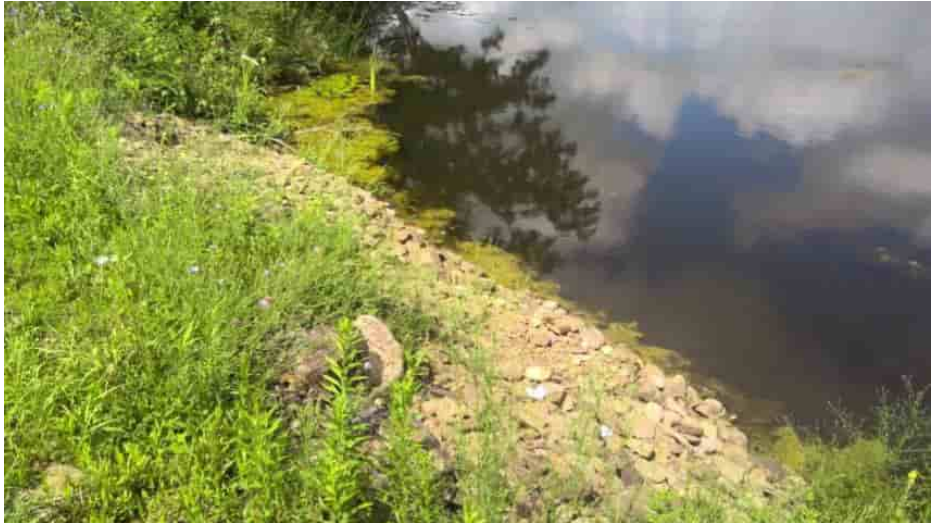
Inspection #: 29
Culvert ID: SS-4
Inspector: AC

Vegetation:	Minor	Outlet Protection?	<input type="checkbox"/>
Condition:	1- Good/Fair	Outlet Protection Type:	
Embedded?	0-25%	Inlet Protection?	<input type="checkbox"/>
Headwall Condition:	1- Good/Fair	Inlet Protection Type:	
		Maintenance Recommended?	<input type="checkbox"/>

Inspection Notes: some erosion pptential from the road

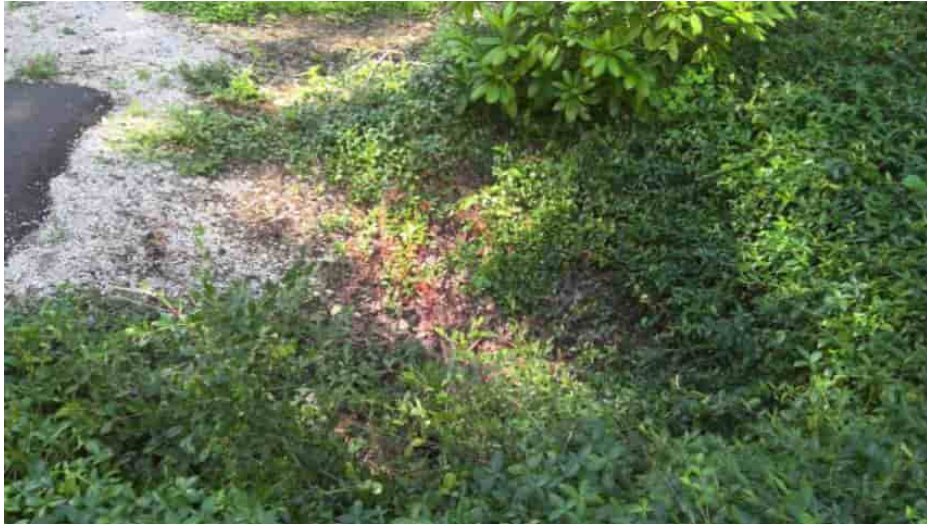
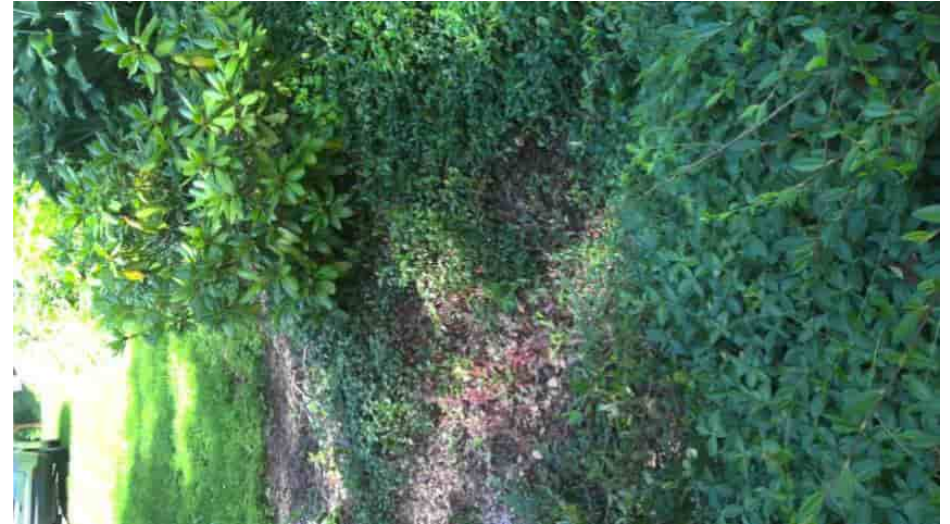
Inspection #: 30
Culvert ID: SS-5
Inspector: AC

Inspection Notes: metal inlet, plastic outlet

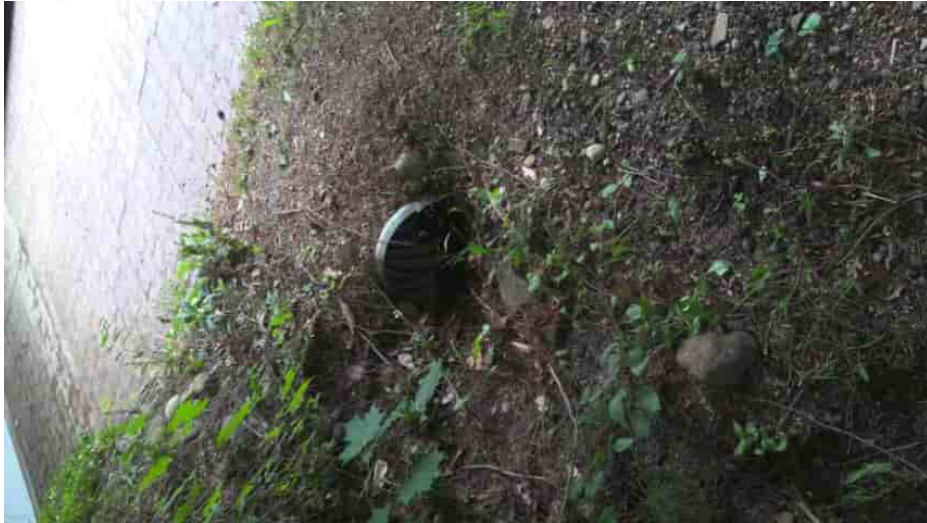
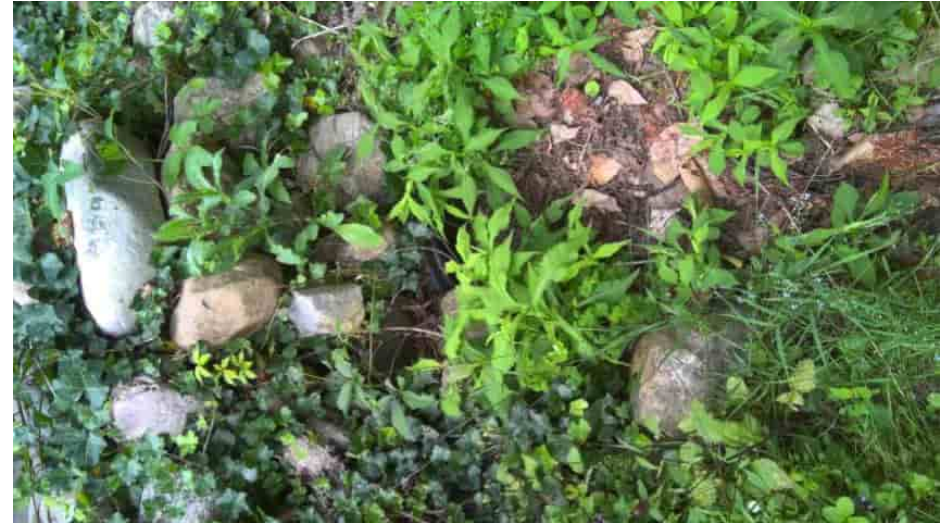
Inspection #: 31

Inspection Notes: series of 3 pipes, two clogged

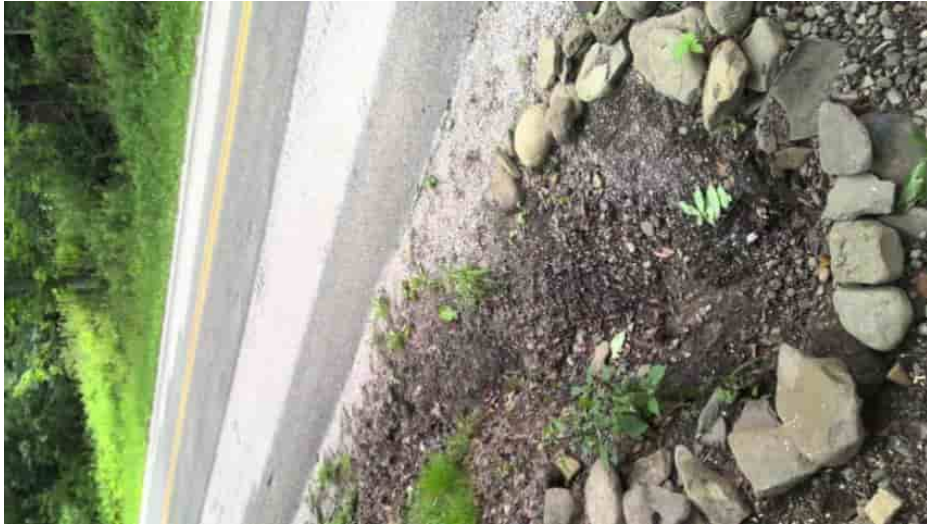
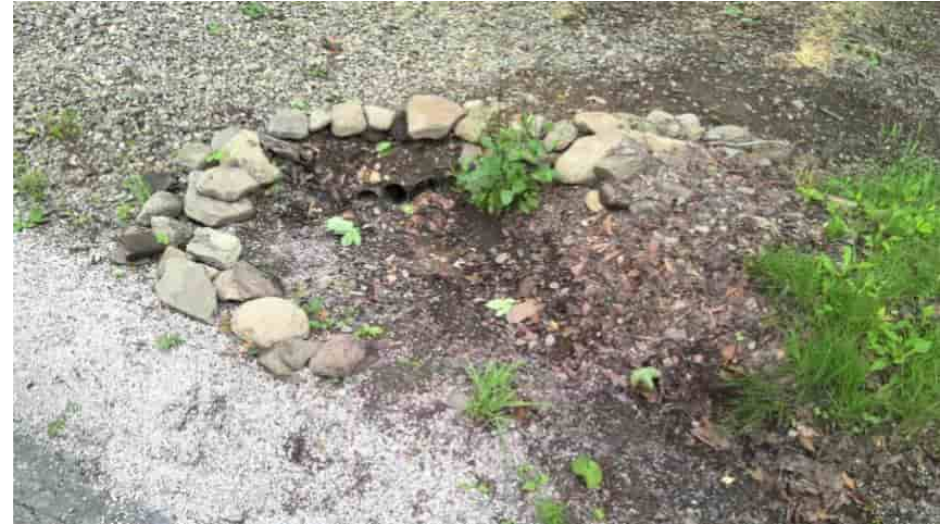
Inspection #: 32

Inspection Notes: gravel accumulation at outlet

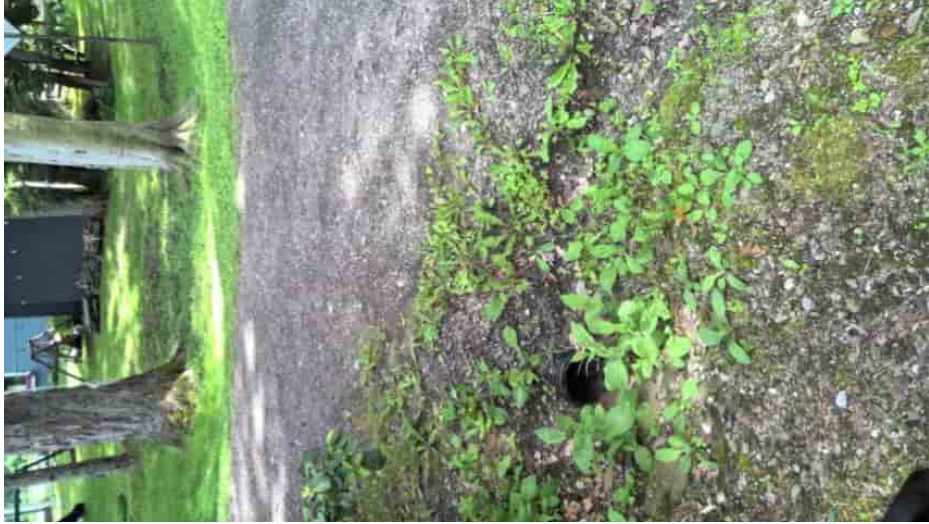
Inspection #: 33
Culvert ID: SS-8
Inspector: AC

Inspection Notes: deposition at outlet, stagnant water

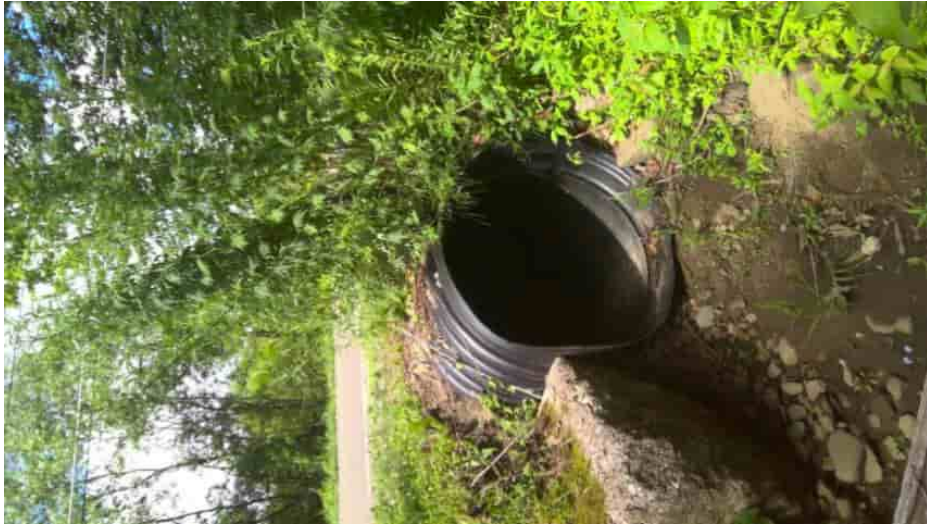
Inspection #: 34
Culvert ID: SS-9
Inspector: AC

Vegetation:	Excessive	Outlet Protection?	<input type="checkbox"/>
Condition:		Outlet Protection Type:	
Embedded?		Inlet Protection?	<input type="checkbox"/>
Headwall Condition:	2- Poor	Inlet Protection Type:	
		Maintenance Recommended?	<input type="checkbox"/>

Inspection Notes: private pond upstream, headwall at outlet

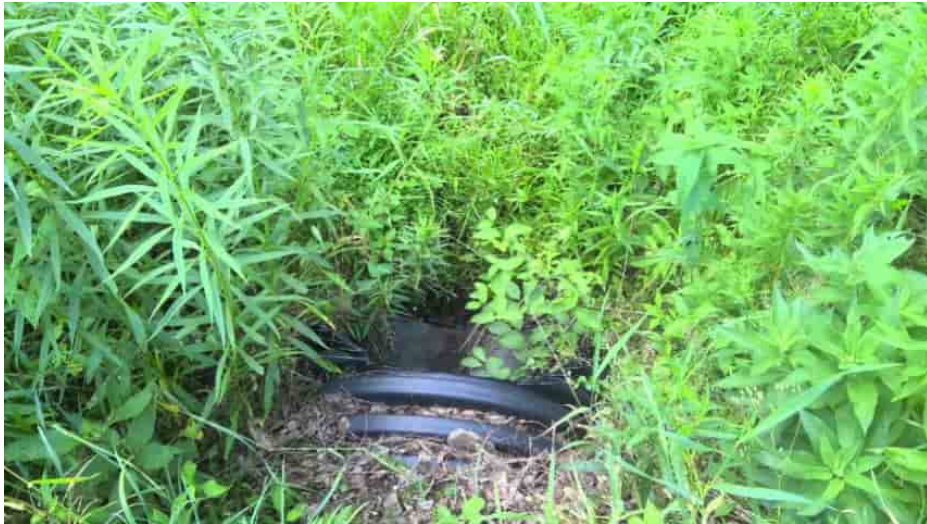
Inspection #: 35

Inspection Notes: Minor debris accumulation at inlet; lots of vegetation; outlet pipe snapped off but still functioning

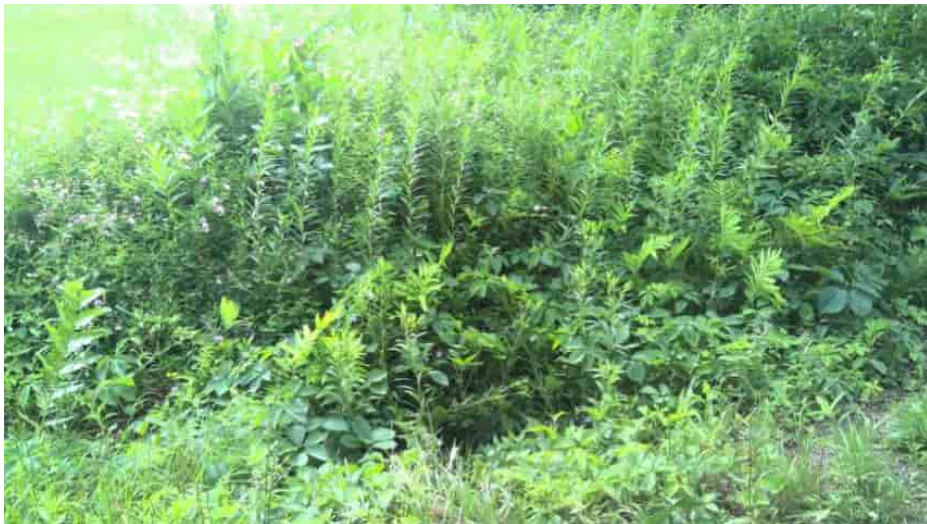
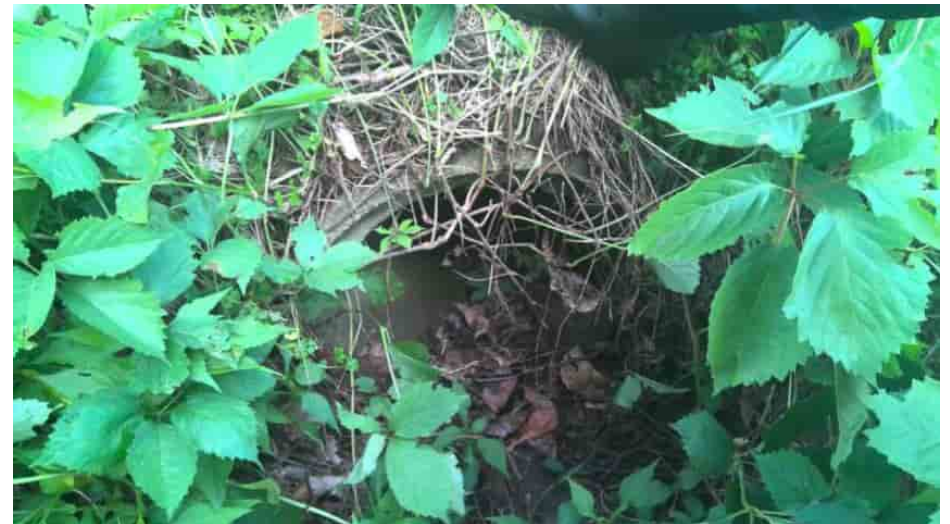
Inspection #: 36

Inspection Notes: sediment and debris accumulation

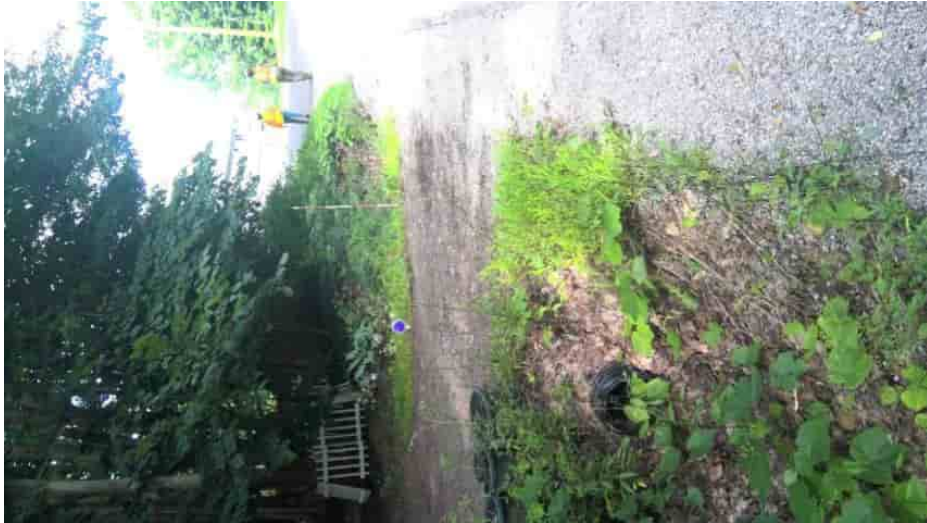
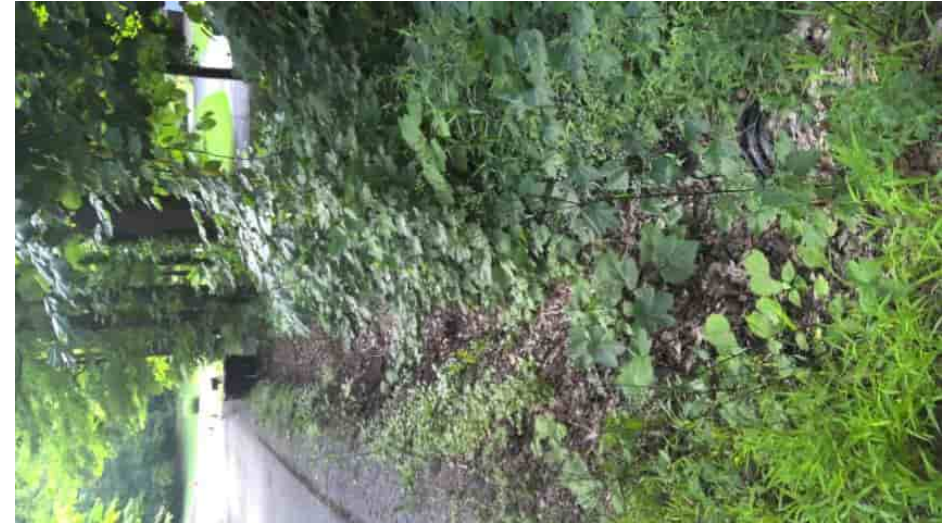
Vegetation:	Minor	Outlet Protection?	<input type="checkbox"/>
Condition:	1- Good/Fair	Outlet Protection Type:	
Embedded?		Inlet Protection?	<input type="checkbox"/>
Headwall Condition:		Inlet Protection Type:	
		Maintenance Recommended?	<input type="checkbox"/>

Inspection Notes: erosion on outlet side

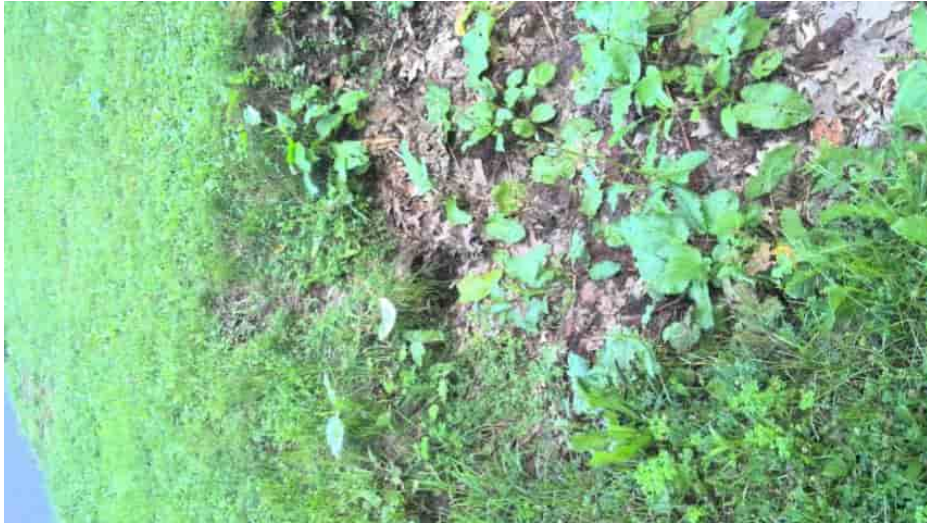
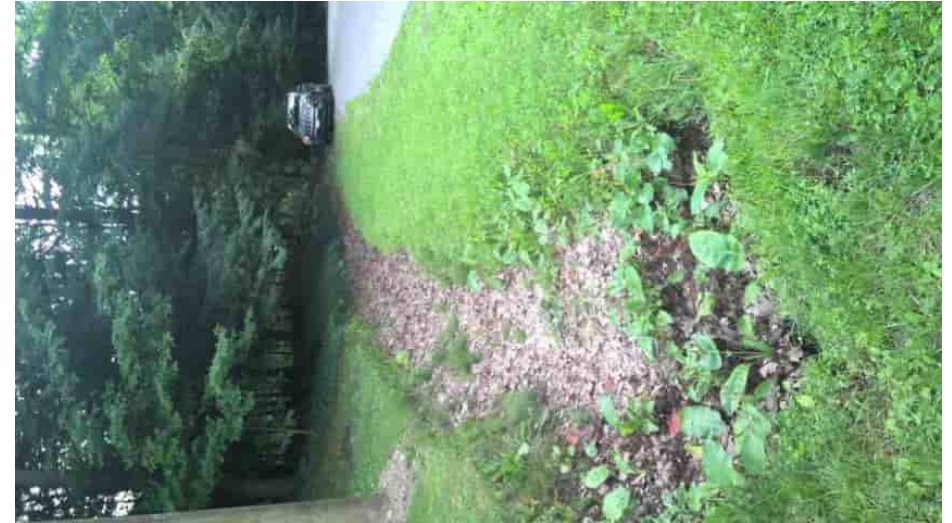
Vegetation:	Minor	Outlet Protection?	<input type="checkbox"/>
Condition:	1- Good/Fair	Outlet Protection Type:	
Embedded?	25-50%	Inlet Protection?	<input type="checkbox"/>
Headwall Condition:		Inlet Protection Type:	
		Maintenance Recommended?	<input type="checkbox"/>

Inspection Notes: 2 catch basins inlet to rcp pipe

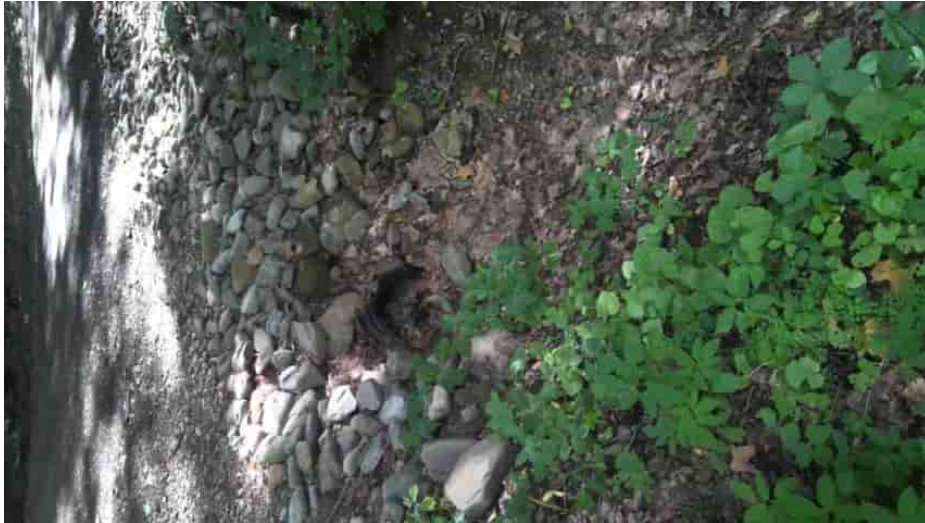
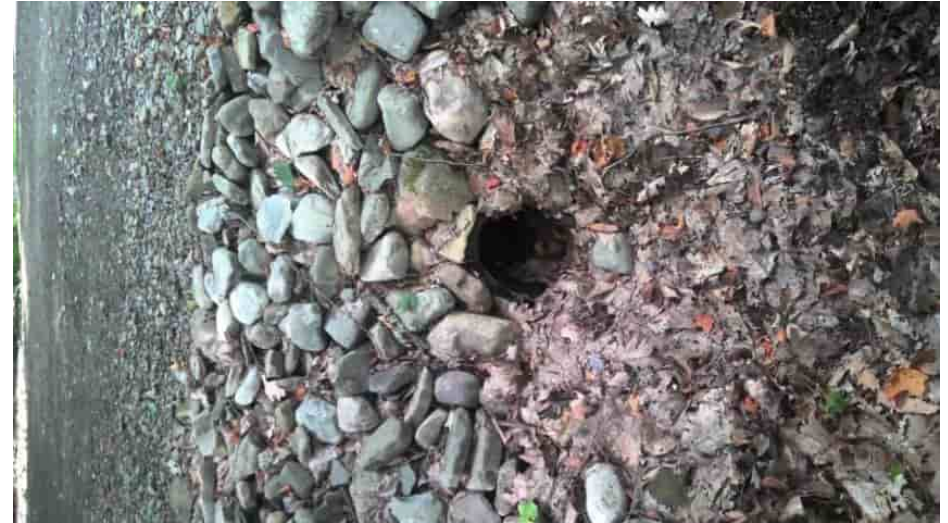
Inspection Notes: No GPS coordinate

Vegetation:	None	Outlet Protection?	<input checked="" type="checkbox"/>
Condition:	1- Good/Fair	Outlet Protection Type:	Rip Rap
Embedded?	0-25%	Inlet Protection?	<input checked="" type="checkbox"/>
Headwall Condition:		Inlet Protection Type:	Rip Rap
		Maintenance Recommended?	<input type="checkbox"/>

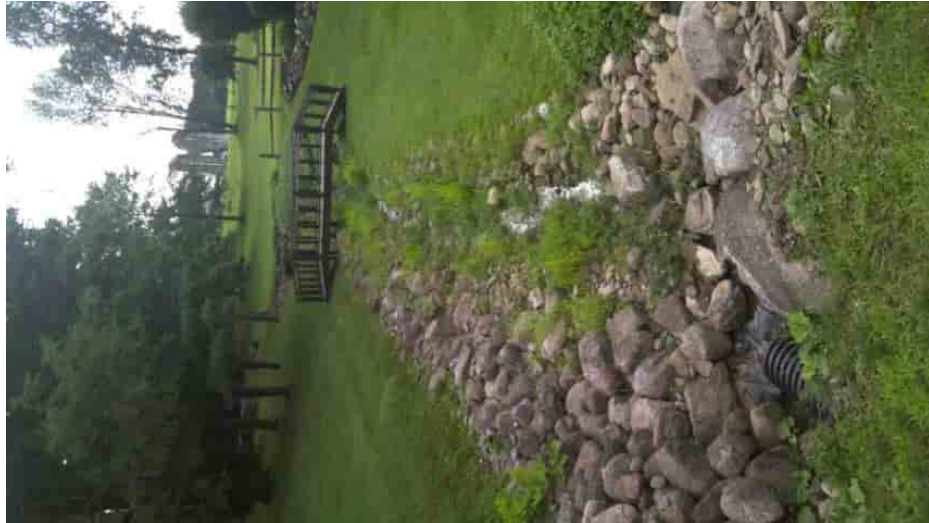
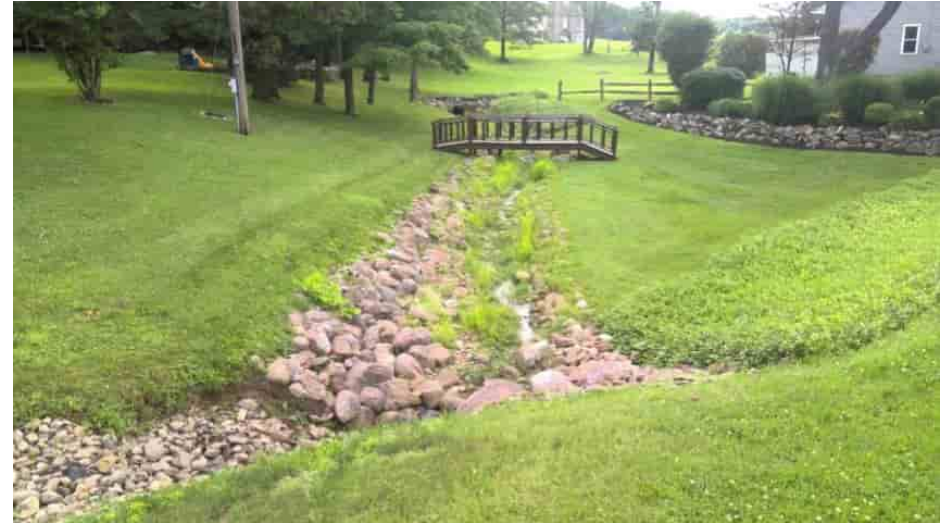
Vegetation:	Minor	Outlet Protection?	<input type="checkbox"/>
Condition:	2- Poor	Outlet Protection Type:	
Embedded?	0-25%	Inlet Protection?	<input checked="" type="checkbox"/>
Headwall Condition:		Inlet Protection Type:	Rip Rap
		Maintenance Recommended?	<input type="checkbox"/>

Inspection Notes: minor sed, plastic under riprap

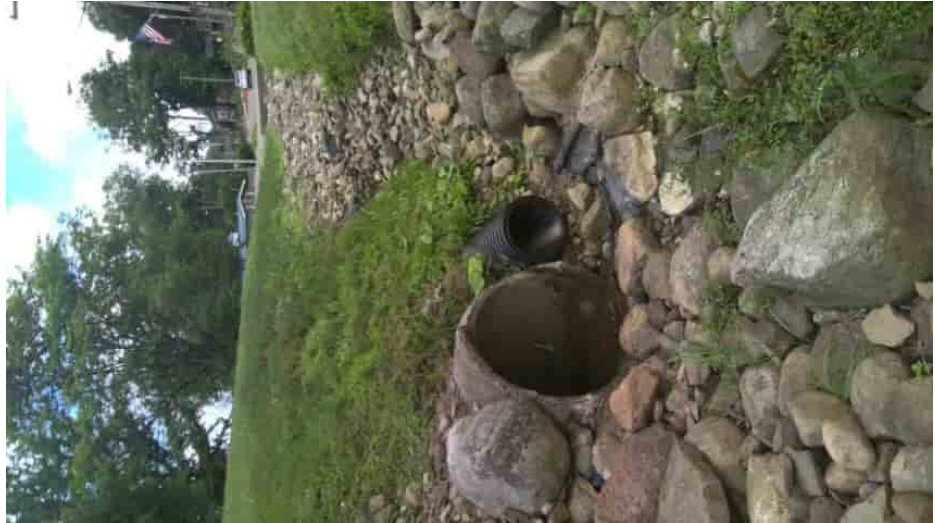
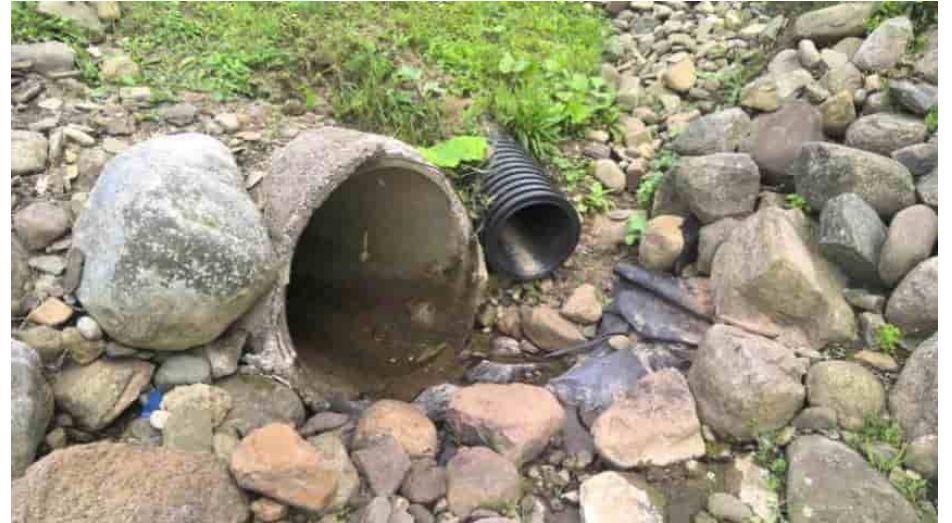
Inspection #: 44 **Date:** 7/13/2023
Culvert ID: SS-17b **Time:** 5:31:42 PM
Inspector: SCGM

Road:	Shadyside Road	Corrugated?	<input checked="" type="checkbox"/>	Vegetation:	Minor	Outlet Protection?	<input type="checkbox"/>
Shape:	Round	Smooth Interior?	<input checked="" type="checkbox"/>	Condition:	1- Good/Fair	Outlet Protection Type:	
Size:	12	Driveway?	<input type="checkbox"/>	Embedded?		Inlet Protection?	<input type="checkbox"/>
Material:	IDPE/PVC/Plastic	Headwall?	<input type="checkbox"/>	Headwall Condition:		Inlet Protection Type:	
Erodibility Rating:	2- Minor	Culvert Protruding?	<input checked="" type="checkbox"/>	Maintenance Recommended?			<input type="checkbox"/>

Inspection Notes: next to 17a, possible outlet for roadside drainage? Unable to find outlet to lake

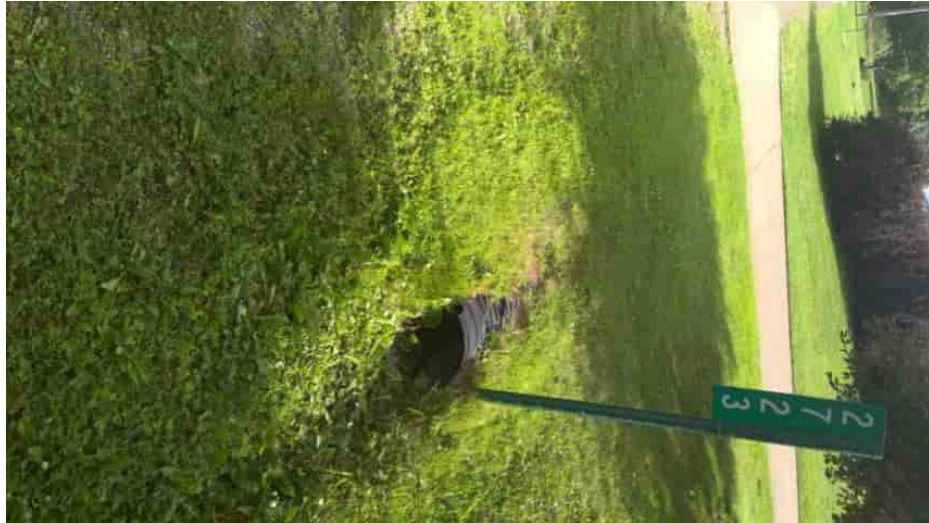
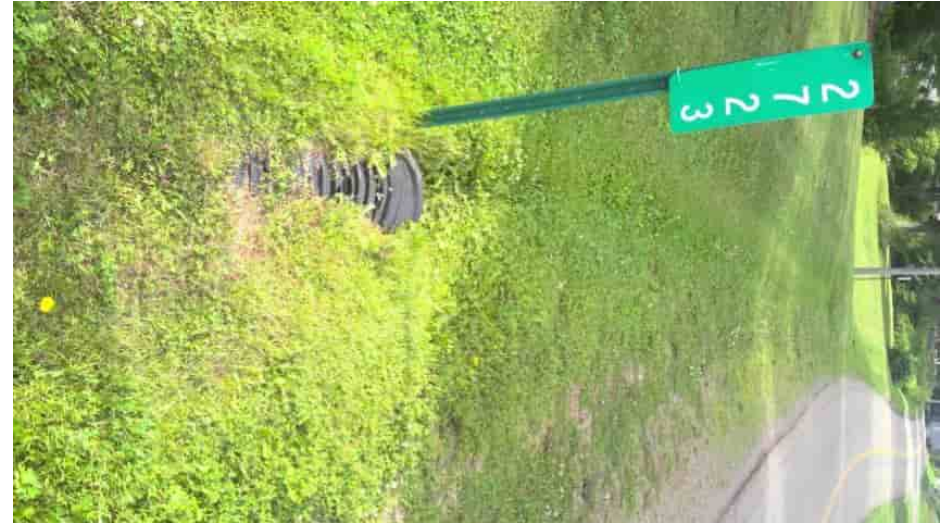
Vegetation:	None	Outlet Protection?	<input type="checkbox"/>
Condition:	1- Good/Fair	Outlet Protection Type:	
Embedded?	0-25%	Inlet Protection?	<input checked="" type="checkbox"/>
Headwall Condition:		Inlet Protection Type:	Concrete
		Maintenance Recommended?	<input type="checkbox"/>

Inspection Notes: two 4 inch pipes coming from household

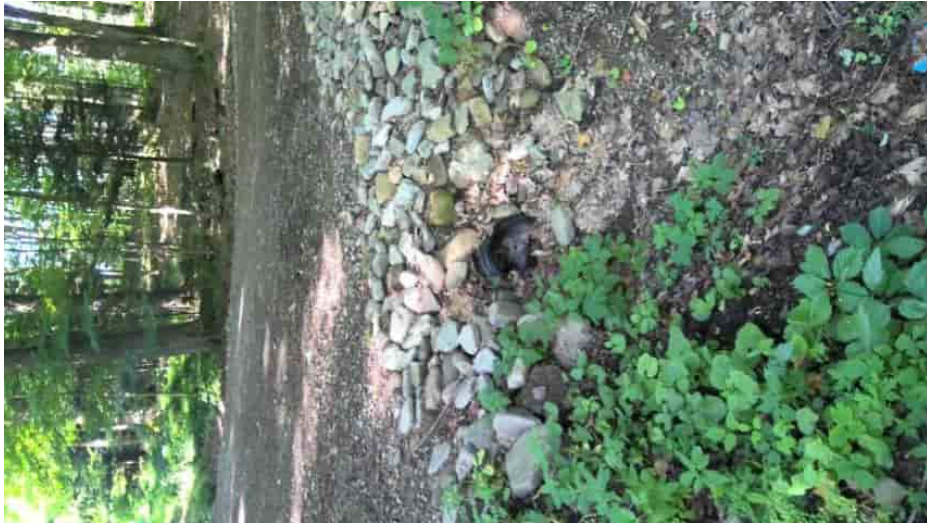
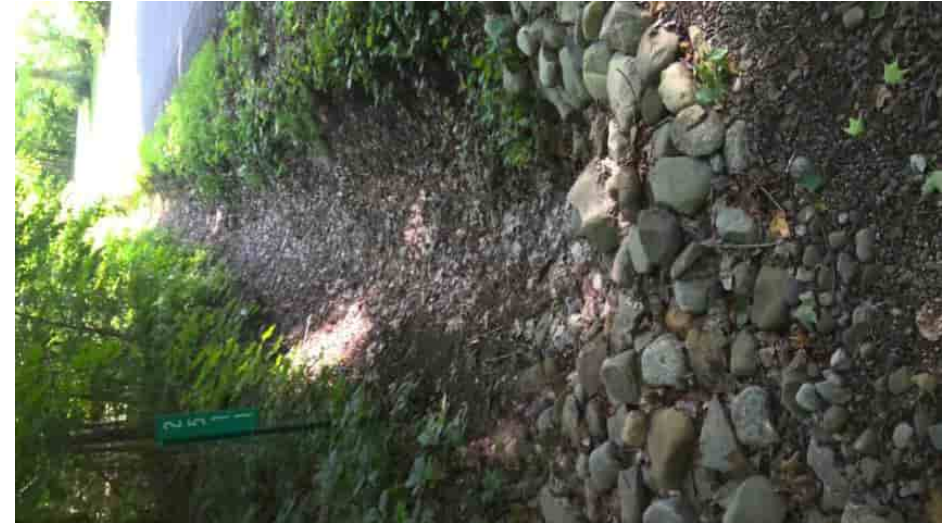
Vegetation:	None	Outlet Protection?	<input type="checkbox"/>
Condition:	1- Good/Fair	Outlet Protection Type:	
Embedded?	0-25%	Inlet Protection?	<input type="checkbox"/>
Headwall Condition:	1- Good/Fair	Inlet Protection Type:	
		Maintenance Recommended?	<input type="checkbox"/>

Inspection Notes: erosion at outlet

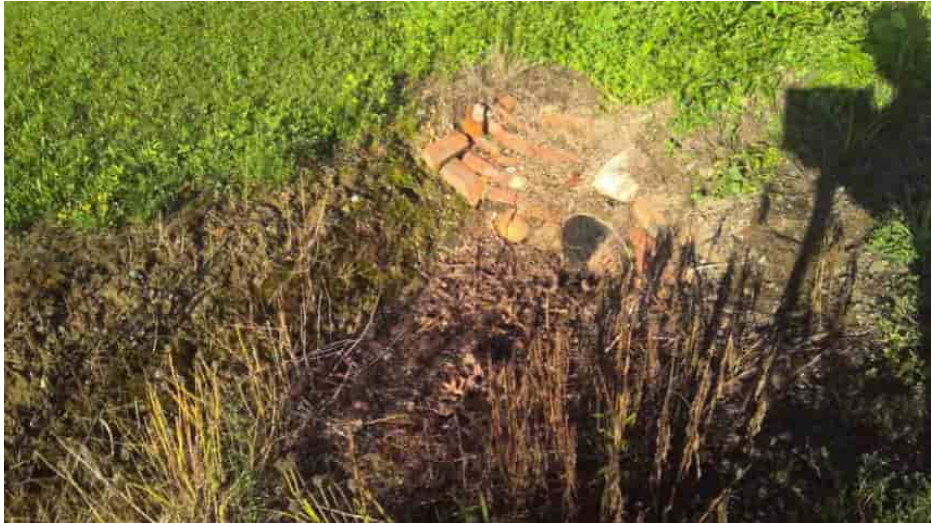
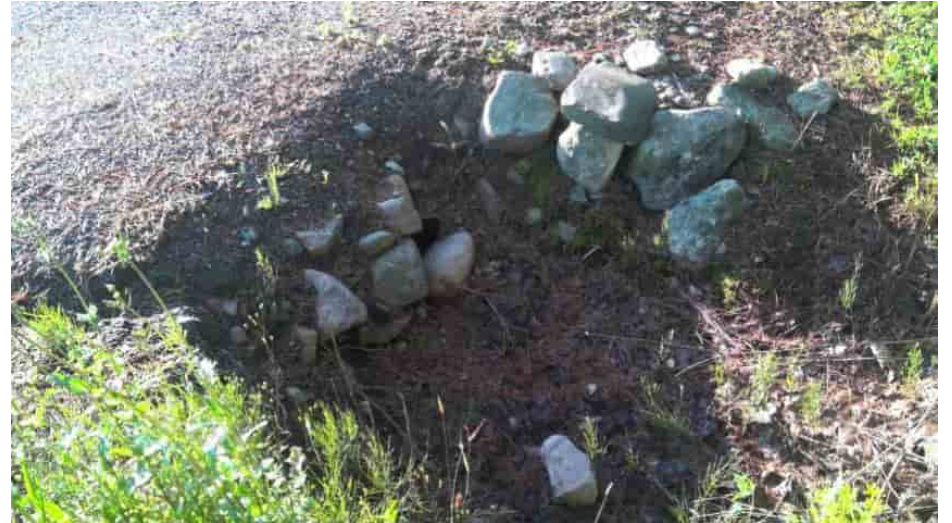
Inspection Notes: metal inlet, plastic outlet

Vegetation:	None	Outlet Protection?	<input type="checkbox"/>
Condition:	2- Poor	Outlet Protection Type:	
Embedded?	25-50%	Inlet Protection?	<input type="checkbox"/>
Headwall Condition:	2- Poor	Inlet Protection Type:	
		Maintenance Recommended?	<input checked="" type="checkbox"/>
